**Ronay Field Survey
2015-18**

**David Newman
June 2018**

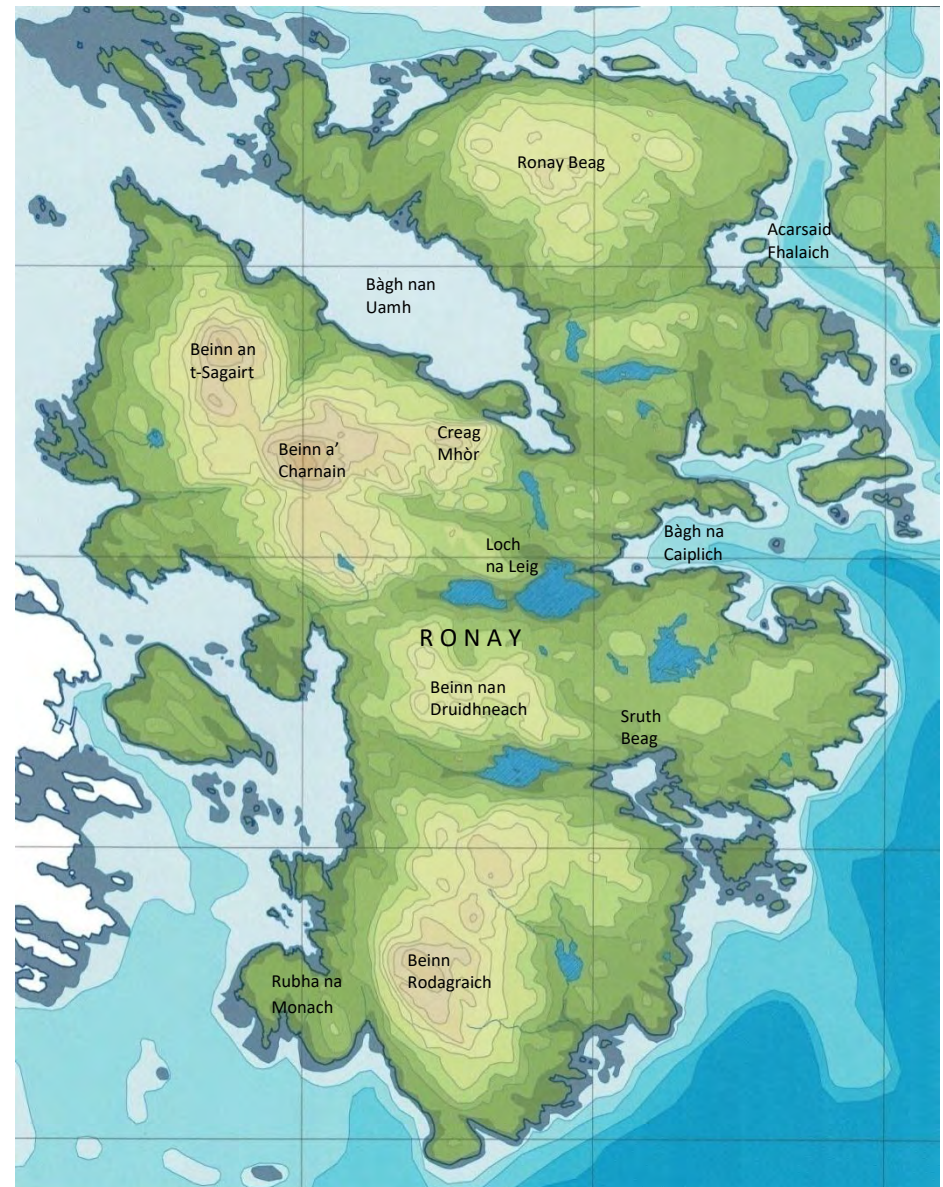
Fig 3: Ronay physical geography

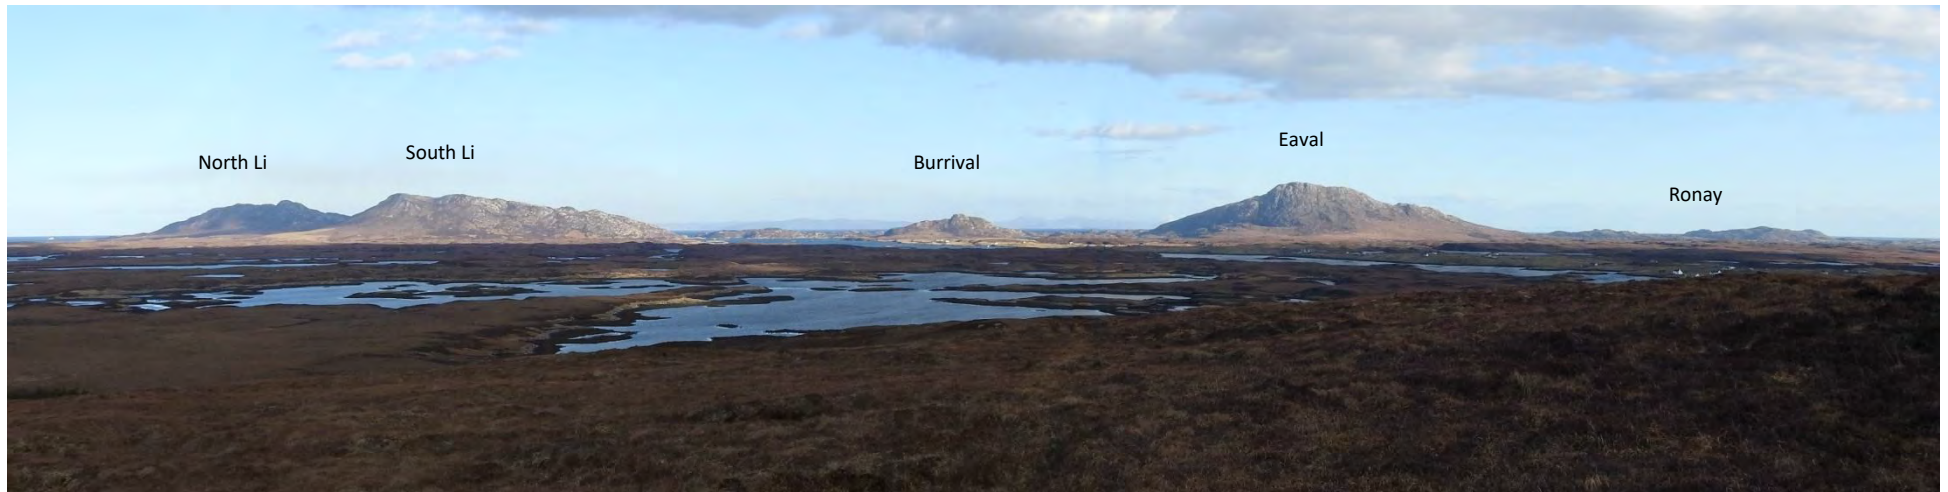
Fig 11: The main features of the Outer Hebrides thrust zone viewed from the west

The name Ronay is Norse in origin (*hraun-ey*) meaning 'rough island', presumably because of its rugged appearance in relation to the comparatively low lying and smooth terrain of the surrounding areas. Ronay's ruggedness reflects the fact that the island straddles part of the north-south line of rocks rendered exceptionally resistant to erosion by movement on the Outer Hebrides Thrust Zone (see figs 2, 11).

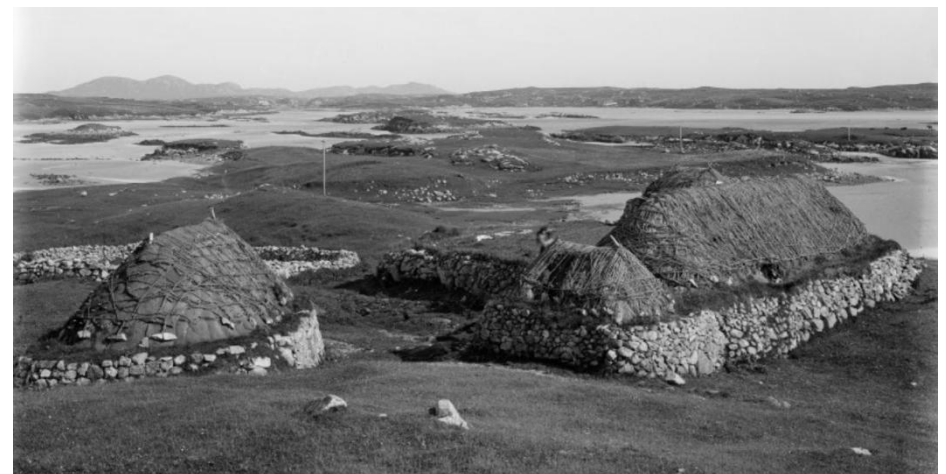
Fig 30: A typical 19th century North Uist farmstead comprising a blackhouse, two byres and an enclosure. The outline of Ronay is visible in the distance.

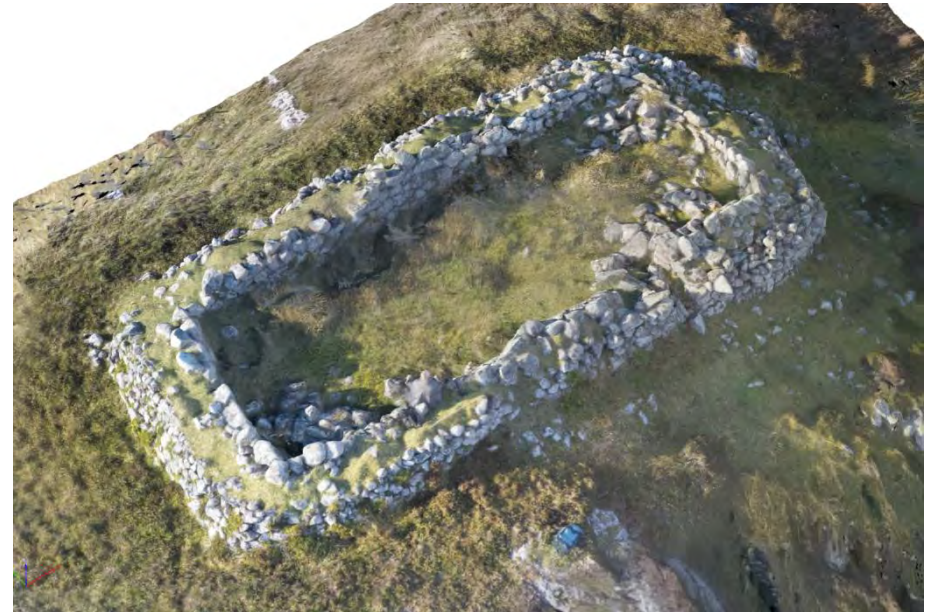
Fig 31: House BD 3 - an example of a typical early 19th century blackhouse on Ronay

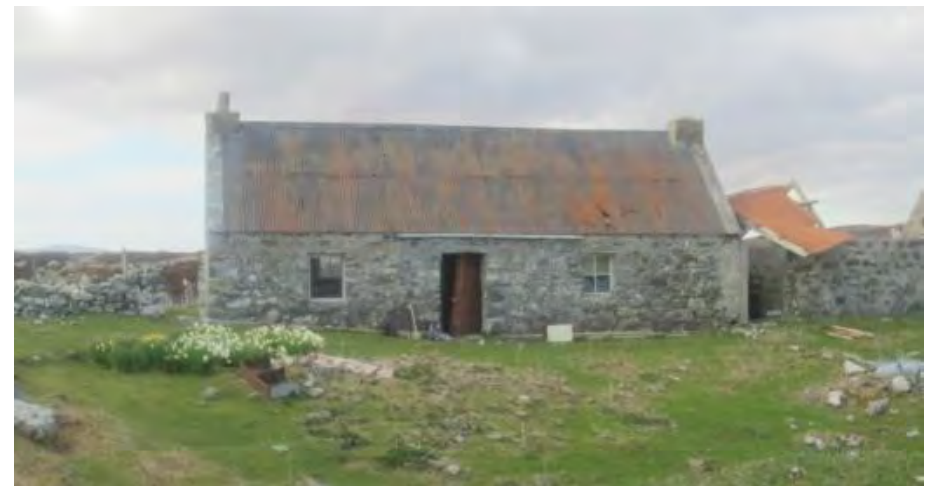
Fig 32: Shepherd's house at Eaval township, North Uist built in around 1850

their own houses. These changes included the adoption of design characteristics and construction techniques then already well-established on the mainland estates, including the use of lime mortar bound stonework walls, pitched and slated roofs with stone walled gables, fireplaces and chimneys, double hung sash windows, and internal linings in yellow pine or lath and plaster (*see fig 32*).

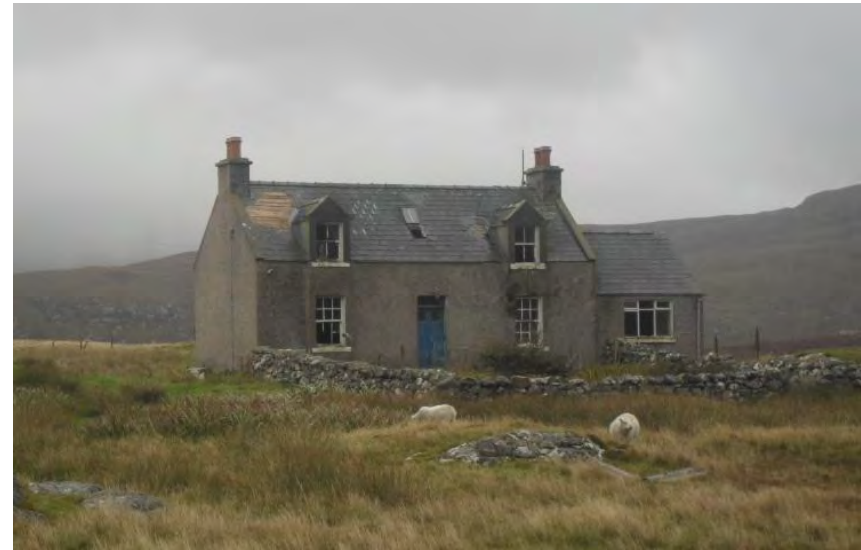
Fig 33: A 'Department' type house built in around 1920 at Loch Aineort, South Uist

The real push for change on a much wider scale came with the passing of the first Crofting Act in 1886. This saw responsibility for the design and construction of houses on the newly established crofts pass to the Department of Agriculture for Scotland and it was a condition of the financial and material support available to the new tenants that the Department's own house designs were used. These were based on a standard '2 up 2 down' format with a window and a fireplace in each room and a narrow winder stair leading up from a central hallway entered from the front door (*see fig 33*). A single storey three room version was also used. Around 400 of these houses were built on Uist between the late 1800s and the 1930s with several design variations making minor improvements as the years passed.

All of these houses used lime mortar (and eventually Portland cement) and locally quarried and part dressed stone in their wall construction. Other new materials adopted included fireclay chimney liners and pots, cast iron gutters and downpipes, slate (and latterly asbestos cement slate) roofs and pre-cast concrete quoins and lintols. Cement was provided free of charge and aggregate and sand collected from favoured locations in the fords and machair. As the years passed, the new concrete technology was used increasingly in these Department houses such that by the 1930s it was being used with formwork to produce window cills and mullions, chimney heads, and dormer window facings and cheeks. Crude concrete blocks were also produced on the island.

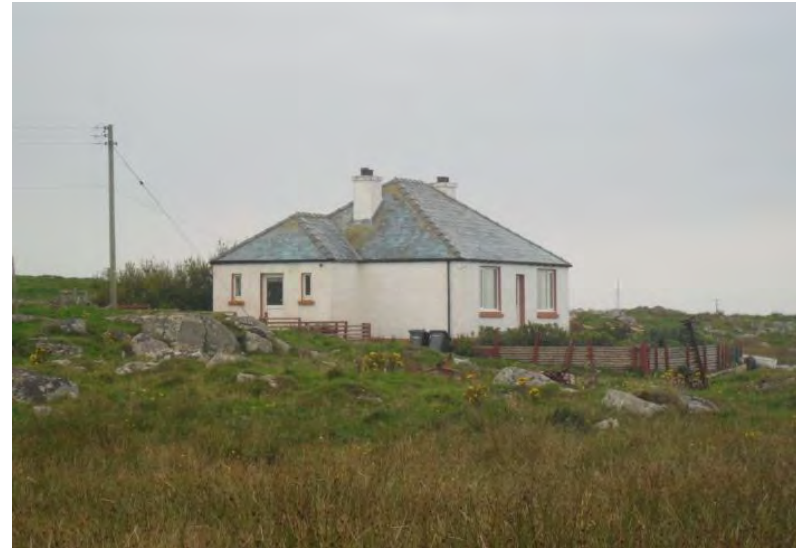
Fig 35: An in situ concrete croft house built in around 1950

By the 1930s, increasing skills with the use of concrete, together with the extensive and freely available resources of sand and aggregate from the islands' shores, led to a completely new single storey Department house design with walls made with poured in-situ concrete. Several plan designs were produced allowing different sized houses to be built, all of which included inside toilets for the first time. The houses also used distinctive hipped roofs covered in asbestos slate and large, timber framed windows (*see fig 35*). Although the new houses were light, airy and spacious inside, oral tradition is that crofting families moving into them from their blackhouses found them cold! Around 250 were built on Uist and a particularly clever use of limited timber resources meant that once the walls were complete, the shuttering timbers were suitable for re-use as roof rafters and sarking.

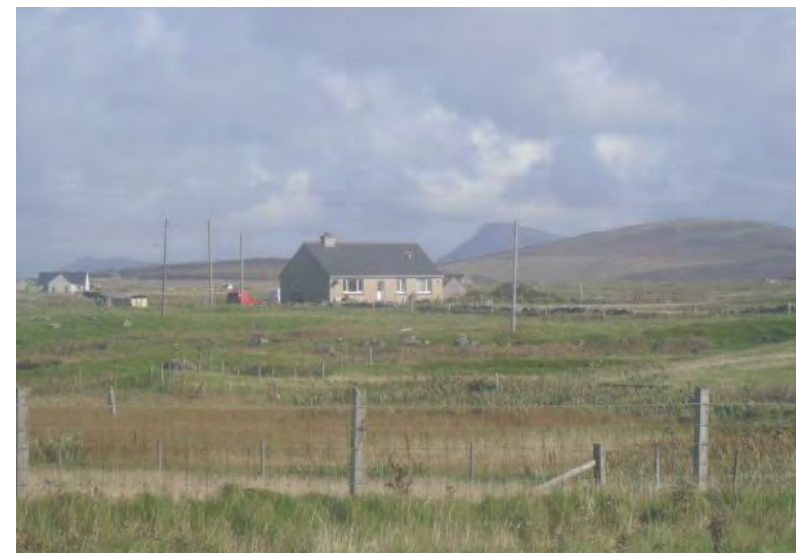
Fig 36: A cavity blockwork croft house from the late 1960s

This penultimate 'Department' house design was followed by a rather plain if eminently practical cavity blockwork house in the late 1960s (*see fig 36*). Its use was short-lived however, as by the mid 1970's the new timber frame 'kit' technology for houses was being developed. Its suitability for all-weather construction in the challenging Scottish climate led to a rapid expansion of both designs and manufacturers, and the standardisation of factory based construction methods, together with space planning compliant with Scottish Building Standards, meant that 'approved' house designs for crofts were no longer required.

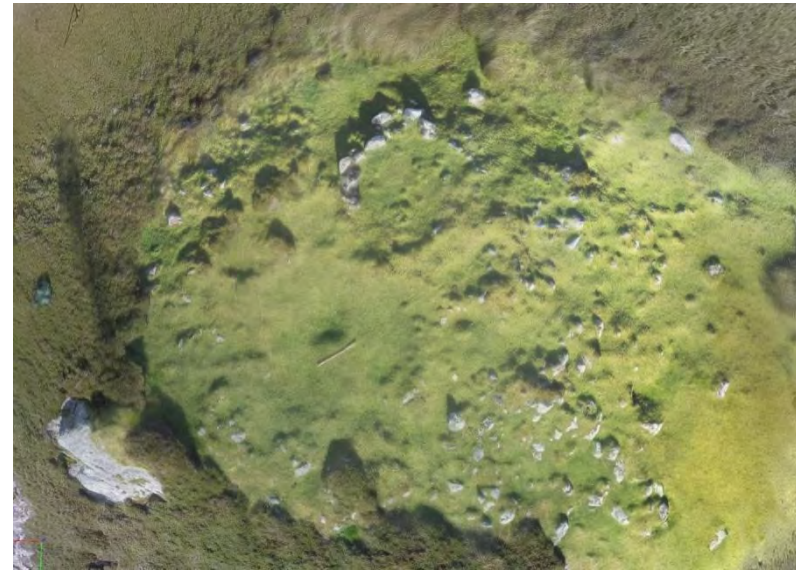
Fig 38: Possible hut circle at Bàgh nam Fiasgan RBE 11 – aerial view

The only structure on Ronay with any resemblance to a prehistoric building is the possible hut circle north of Bàgh nam Fiasgan RBE 11, (*see fig 38*), and, positioned as it is on the summit of a rock outcrop overlooking the Minch, it may have had some defensive or look-out related purpose. The remains of a similar drystone structure with a good viewing position are also located on Haunaraigh island (H 1), but both of these could equally be medieval or early modern period in date.

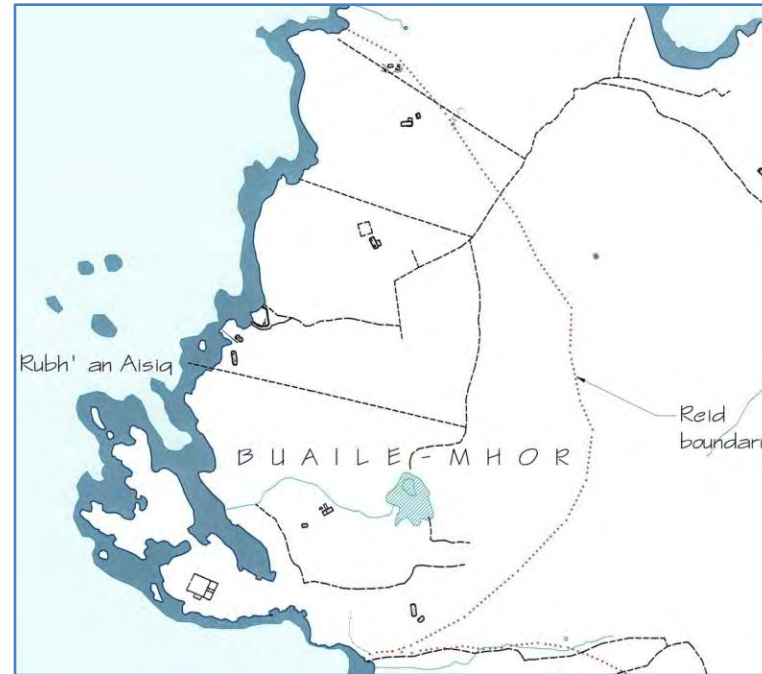
Fig 43: Reid survey features at Buaille-mhòr

Finally, although Reid shows no buildings in the Buaille-mhòr area, the number of building remains there exceeds the number of crofts, and it may well be that some of these represent the remains of houses already abandoned by 1799 (see fig 43).

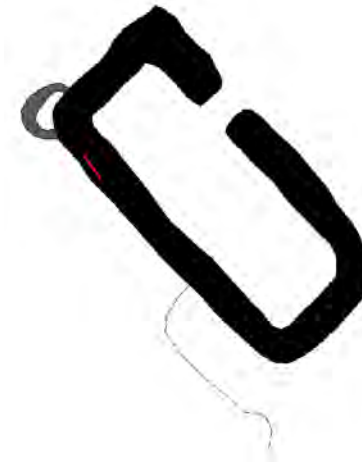
Fig 46: (left) BR 5 plan - an example of a single building farmstead

Fig 47: (right) BM 1 plan - an example of a two building farmstead

1. single buildings (around 9 out of 26) (*see fig 46*);
2. two buildings - presumably a house and a byre, but in two cases a house and a kiln barn (around 10 out of 26) (*see fig 47*);
3. two part buildings with a separate smaller building with its own access attached to one of the main building long elevations (around 7 out of 26) (*see fig 48*).

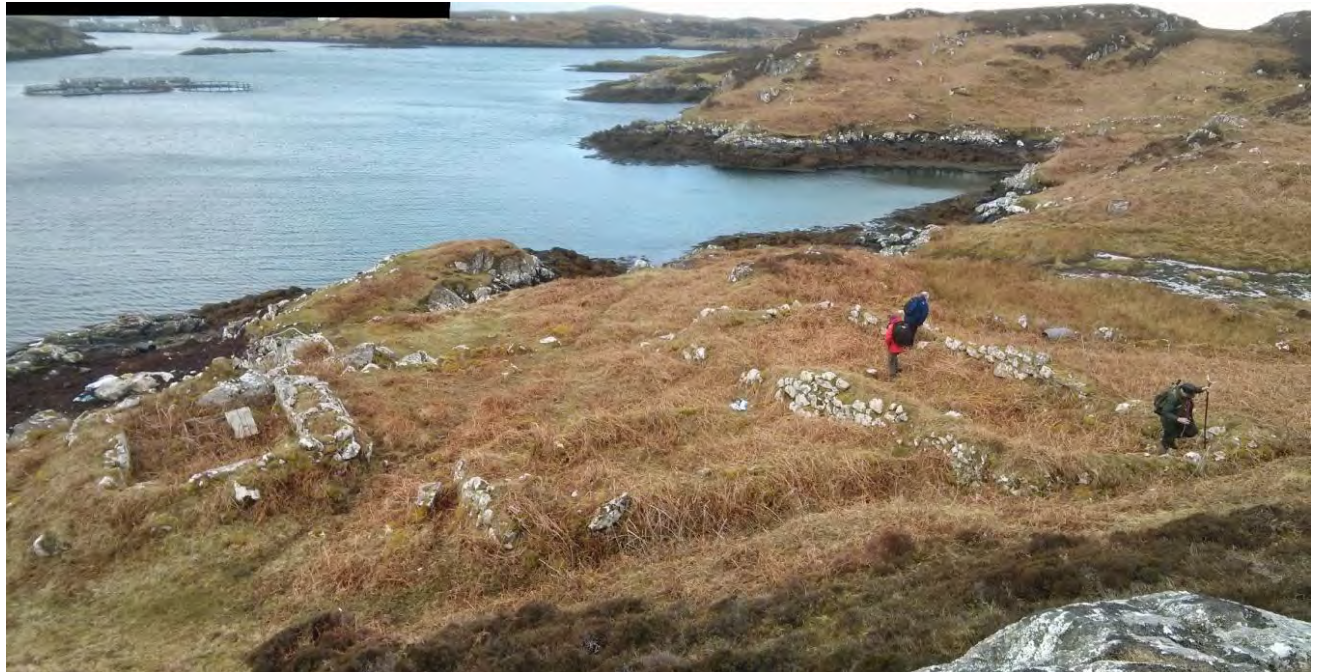
Fig 53: Farmstead RC 5 from NE with Kallin Harbour in the distance

Perhaps the most favoured location would have been the house on the shore of Bàgh Clann Nèill, RC 5 (see figs 52 & 53). Not only was this reasonably close to Kallin, but there are the remains of a sheepfold and other enclosures there which would have been essential for livestock management.

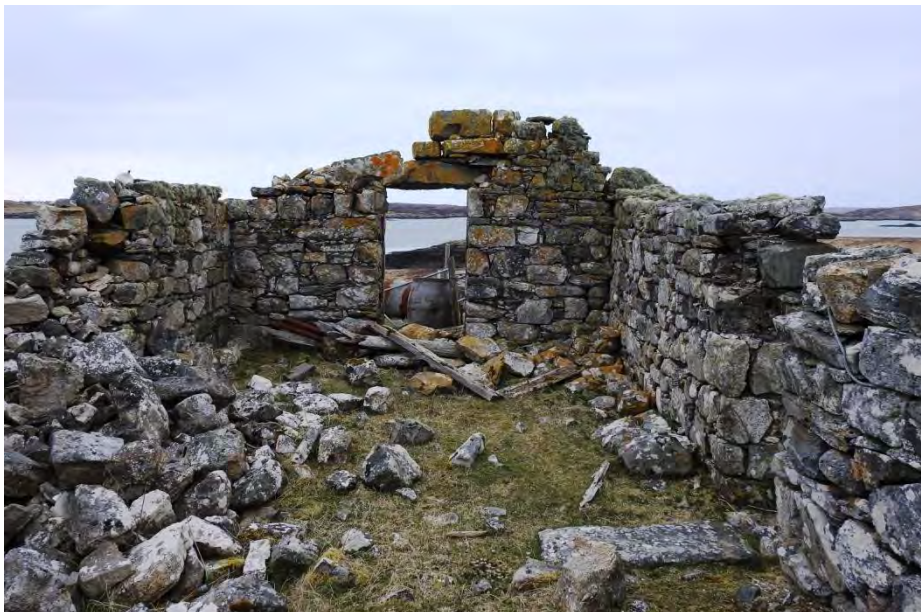
Fig 57: BM 4 interior looking west

BM 4, the building attached to the sheepfold (*see fig 57*), is built in a 'mainland' style with mortar bound stonework walls and a pitched, gabled, and probably slated roof. Its condition today does not provide definitive evidence as to whether this was used as a dwelling or not, although the arrangement of its two entrance doors, one in the west gable and one directly into the fold, suggest probably not.

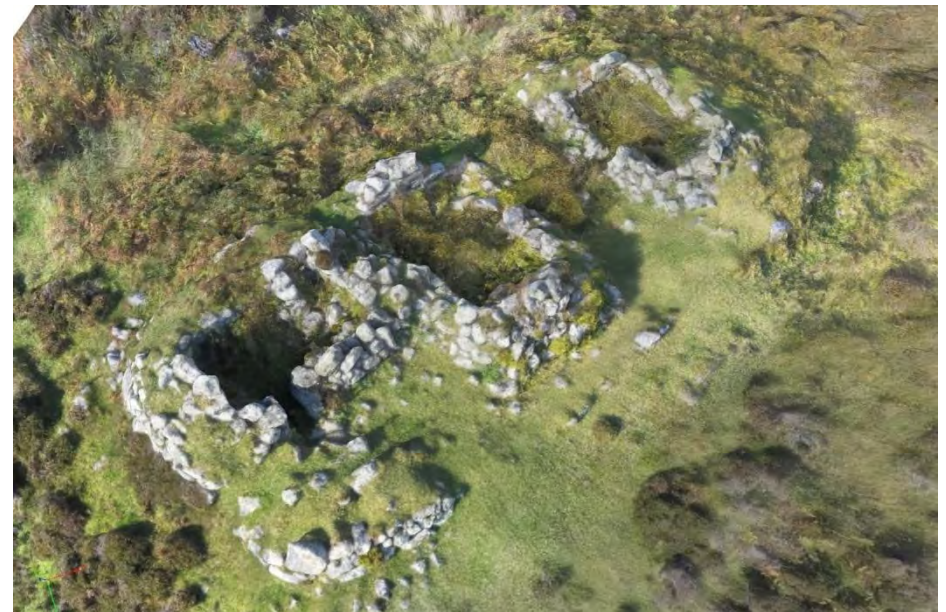
Fig 56: RB 4 aerial view from south showing adaptation for livestock management

On the ground many of the other former helping community houses from the early 1800s, particularly those in the remoter north and east parts of the island, show signs of post-abandonment adaptation for use in relation to livestock management, including small pens and folds, and possible huts (*see fig 56*). Viewed together perhaps these arrangements suggest a full time shepherd and family based near the main sheep fank at Rubh' an Aisig, and seasonal help brought in as and when required for gathering, lambing and shearing - a practice which continued on Ronay (and Uist generally) right up until the end of the 20th century.

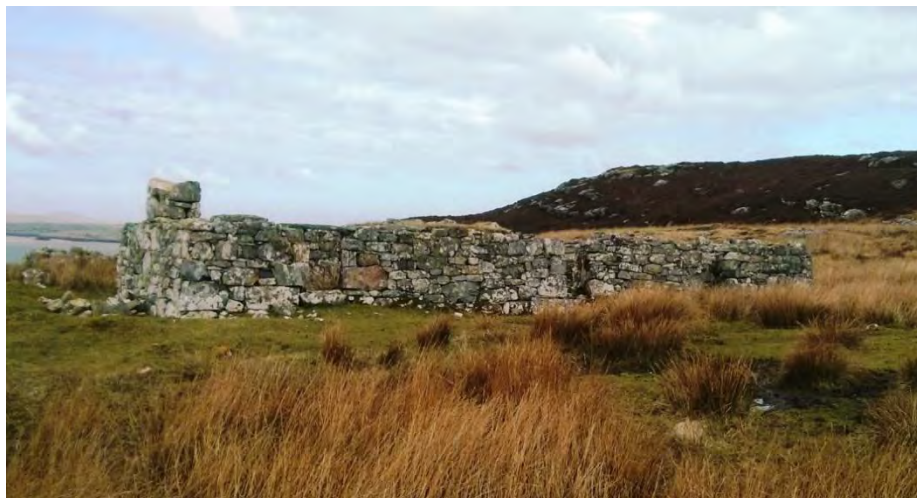
Fig 60: BM 8 view from south

In its final form, the farmstead BM 8 was built in the full 'taigh geal' style with mortar bound part dressed and coursed stone walls probably lime washed (if not rendered) externally, fully lintolled windows on both long elevations, a dividing partition and a fireplace and chimney (*see figs 59 & 60*). A similarly built extension on its north side may also have been used as living accommodation, as the census returns from the late 19th century show that by 1891 the house had 3 rooms with windows and the family had a 'house servant'. A small outbuilding also on the north side may have housed sheepdogs or chickens, and a byre a little way down the hill, the house cow. The remains of what was probably the original *Buaile-mhòr* lie to the south.

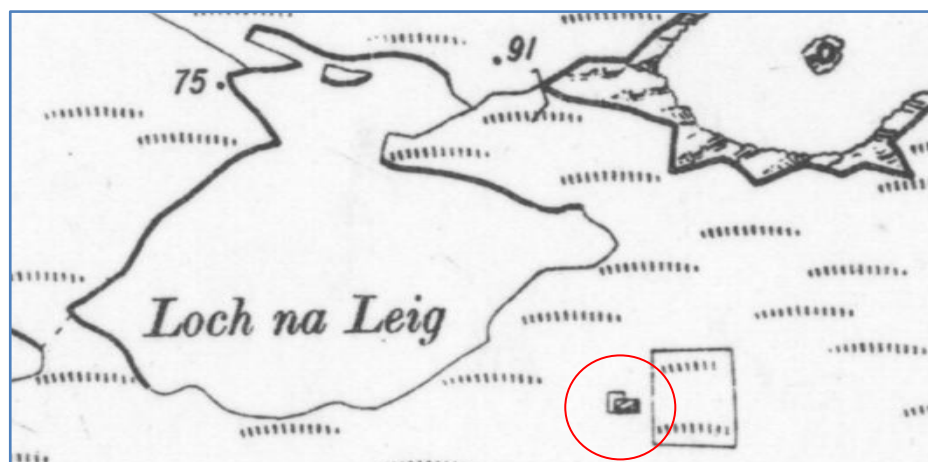
Fig 63: 1903 OS 6" map showing a roofed building at Bàgh na Caiplich

On the ground the house foundations are somewhat confused, with a well built set of rectangular planned foundations measuring around 10.5 X 7.5m internally, interrupted in their south-east corner by a second rectangular building with internal dimensions of 5.7 X 5.1m (see fig 62). The smaller building foundations have similarities with those built on Uist for pre-fabricated corrugated iron buildings, and that possibility ties in with both the remains of cast iron ogee guttering scattered around the site, and the fact that on the 2nd edition OS 6" mapping of the area surveyed in 1901, the site is shown partly occupied by a roofed building (see fig 63).

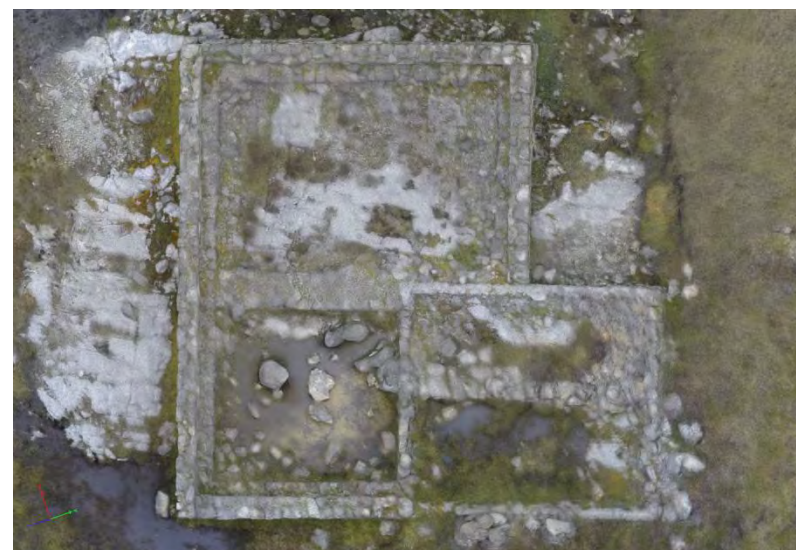
Fig 62: Bàgh na Caiplich house foundations – aerial plan view

It seems likely, therefore, that a temporary corrugated iron building was erected first and the main house foundations built up to it. Perhaps this was used by the builders or Captain Allan himself as accommodation while the works were in progress.

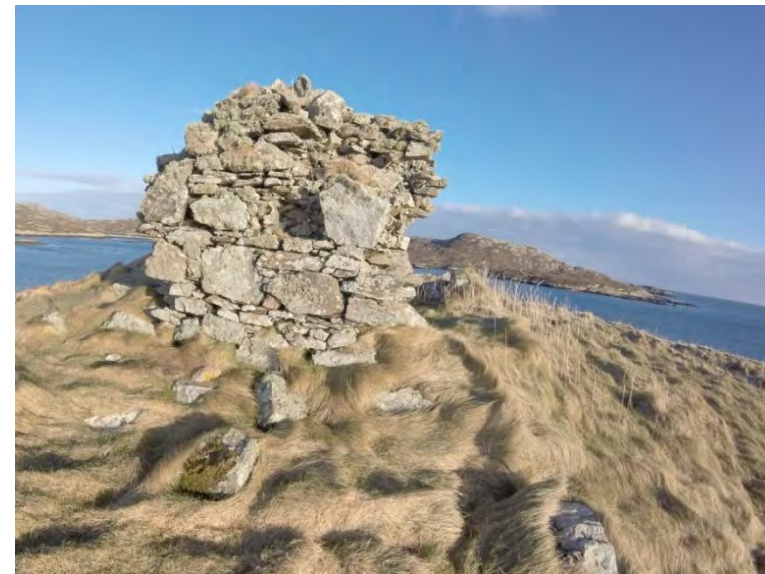
Fig 68: The ruins of St Michael's Chapel on Grimsay with Ronay behind

Looking at Beveridge's photograph of St Michael's, taken in around 1900 (see fig 70), it is clear that even less of its walls remain today (see figs 68 & 71), and the enclosure wall around it is now reduced to a low bank.

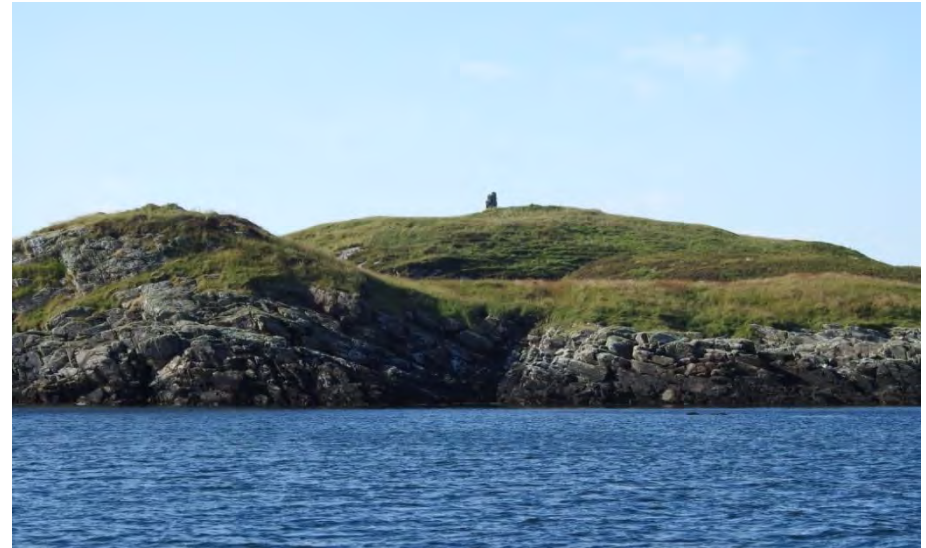
Fig 69: St Michael's Chapel viewed from the Kyle of Ronay

Secondly, St Michael's Chapel is located on a prominent headland on the east end of Grimsay island overlooking the south end of the Kyle of Ronay, and this structure would have been one of the most important buildings and landmarks in the area at the time (see figs 68 & 69).

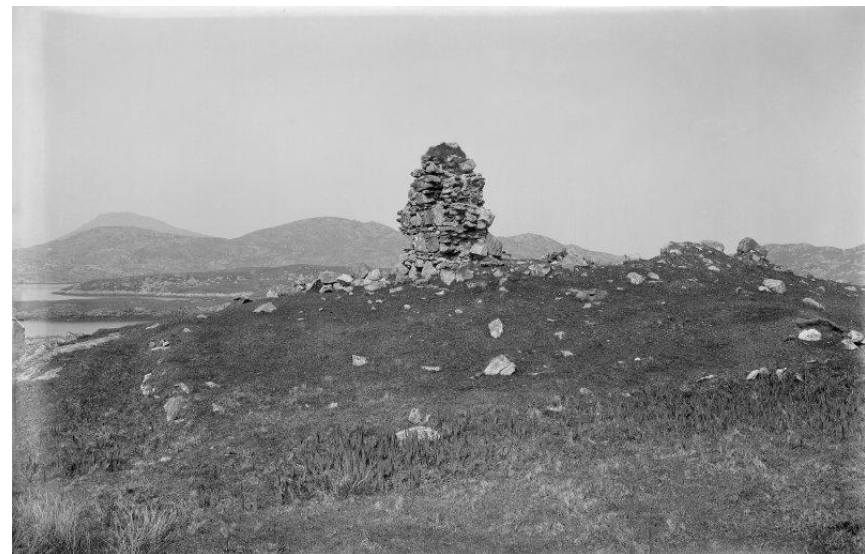
Fig 70: Erskine Beveridge's view of St Michael's from the south in around 1900

'The ruins of St Michael's Chapel on Grimsay are on a small plateau on the highest point of a promontory. They are oblong, 23ft 2ins by 13ft 8ins, within walls 28 to

30ins thick. In 1915 the west gable was about 8ft height. The chapel stands in an enclosure, 63ft by 54ft, 'evidently once serving as a graveyard but disused for many years'. (E Beveridge 1911) The foundations of the boundary wall are overgrown with grass.'

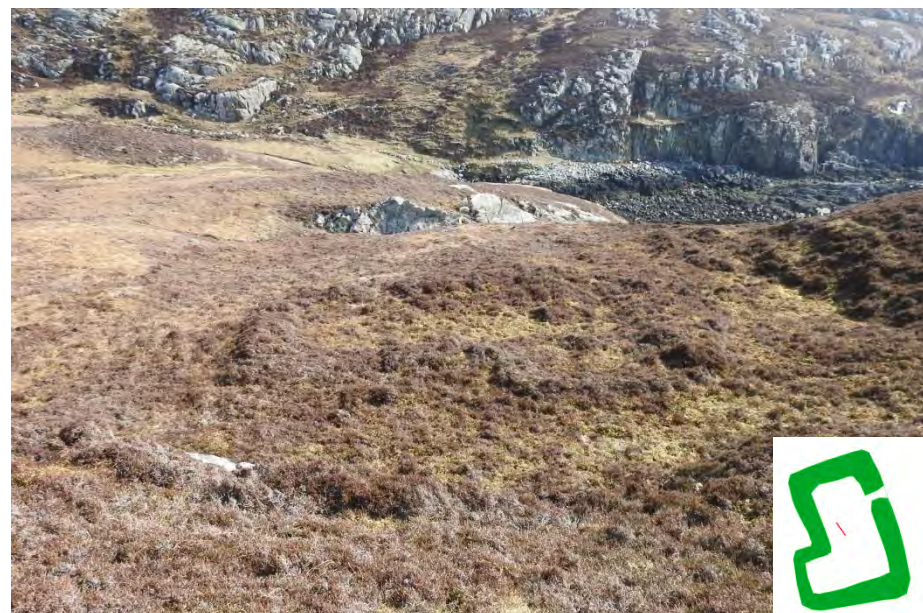
BR 1: view from W and thumbnail plan

Site name: **Rubha Breac**
 RFS no: **BR 1**
 NGR: NF 89140 5489
 Site type(s): Farmstead (poss), enclosure (poss)
 Condition: Poor

A possible farmstead and enclosure lie amongst areas of cultivation and peat cutting on the SE edge of the peninsula Rubha na Monach at the far SW end of Ronay island. Lying in the shelter of a rock outcrop and constructed entirely of turf, the L plan shaped main building measures 6.8m NNW - SSE and between 3.4 and 5.4m transversely. The remains of an entrance lie towards the N end of the E facing elevation. Around 25m N lie the faint remains of what might have been a rectangular enclosure, together with a second turf walled structure of unknown purpose. It is not clear whether this possible farmstead is part of the early 18th C kelping settlement or from another period before or afterwards, but it does sit within a bounded area of land of around 5ha in extent which probably does represent one of the 26 kelping crofts.

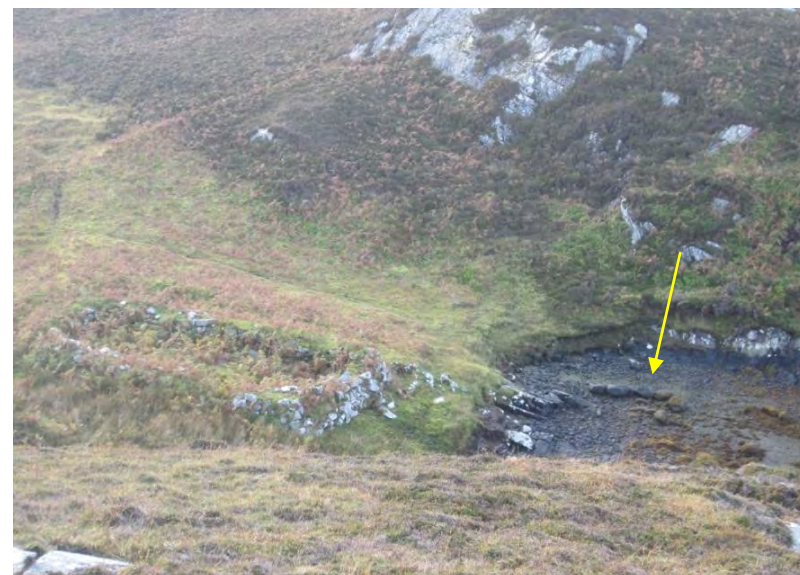
BR 4 (arrowed): view from E with BR 5 to left

This farmstead lies a few metres from the shore of Poll an t-Suicair at the S extremity of a dyke bounded area of croft land extending to around 5.5ha. It consists of a single rectangular building which measures 10.5m from NW to SE by 3.5m transversely, within drystone walls up to 1.5m thick and 1.2m high, both internal and external corners of which are generally rounded. There is an entrance door towards the NW end of the NE facing elevation and the remains of a possible lamb pen within. Attached to the building at its W corner is the outline of a small cellular stone structure barely 1.5m across, and at the SE end of its SW facing elevation, the faint remains of a possible turf walled outbuilding.

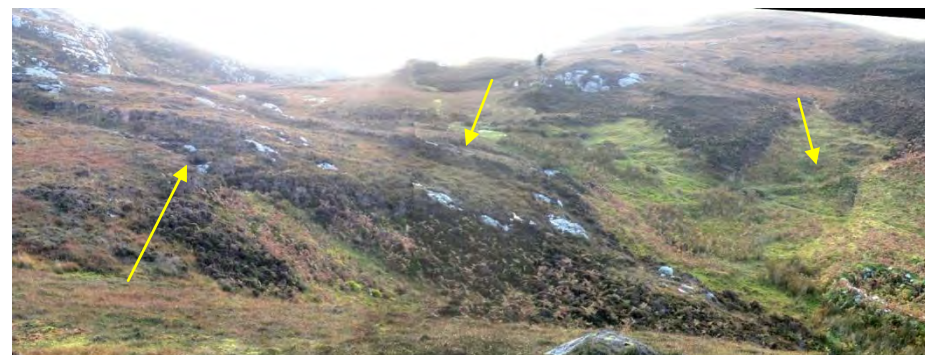
BR 6: view from N, BR 5 visible in lower RH corner

Site name: **Poll an t-Suicair**
 RFS no: **BR 6**
 NGR: NF 89160 54560 (centre)
 Site type(s): Turf dyke(s)
 Condition: Fair

A turf dyke connects the head dyke BR 24 to the shore of Poll an t-Suicair and appears to define the boundary between the two crofts related to farmsteads BR 1 and BR 5. Around 150m long the dyke runs in a W – E direction between NF 89210 54550 and the top of a low cliff at NF 89080 54560. Just beyond the SE gable of the farmstead BR 5, the dyke may have acted as the S side of a small enclosure. A second 75m long section of dyke runs parallel with the first around 15m further N, but its purpose is unclear.

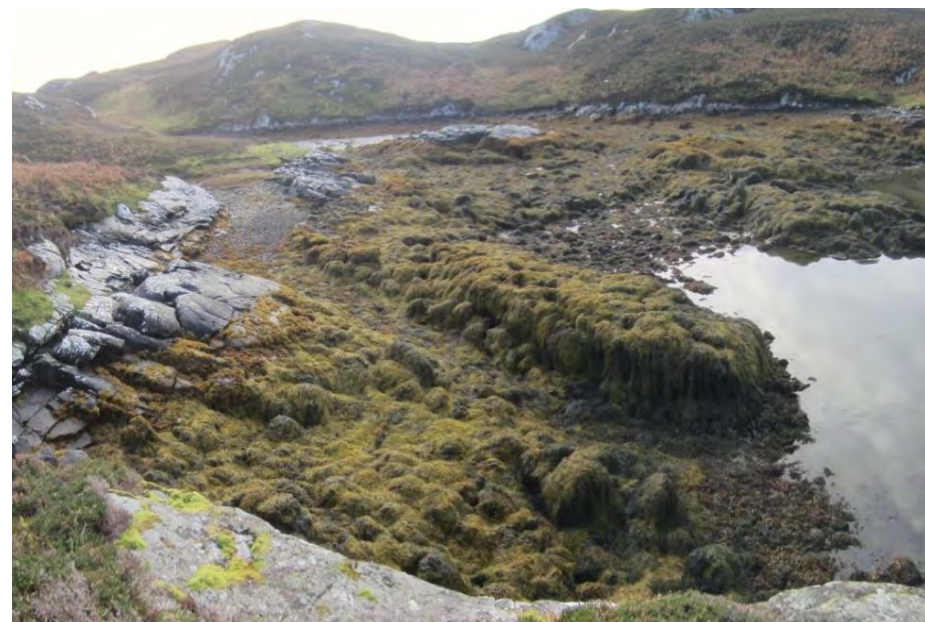
BR7: view from N

Site name: **Poll an t-Suicair**
 RFS no: **BR 7**
 NGR: NF 89075 54625 (centre)
 Site type(s): Landing place, jetty (poss)
 Condition: Poor

A boat landing point lies at the head of an inlet on the E shore of Poll an t-Suicair. In local tradition this area was where the Ronay kelpers brought their processed seaweed to trade for goods (hence the name) or money. The landing point comprises an area of beach measuring around 30m N - S and between 2 and 4m transversely which has been cleared of larger stones, and defined on its E side by the rocky coast edge and to its W by a combination of a natural rock outcrop, and, towards its end at the LWM, a partially ruined drystone jetty.

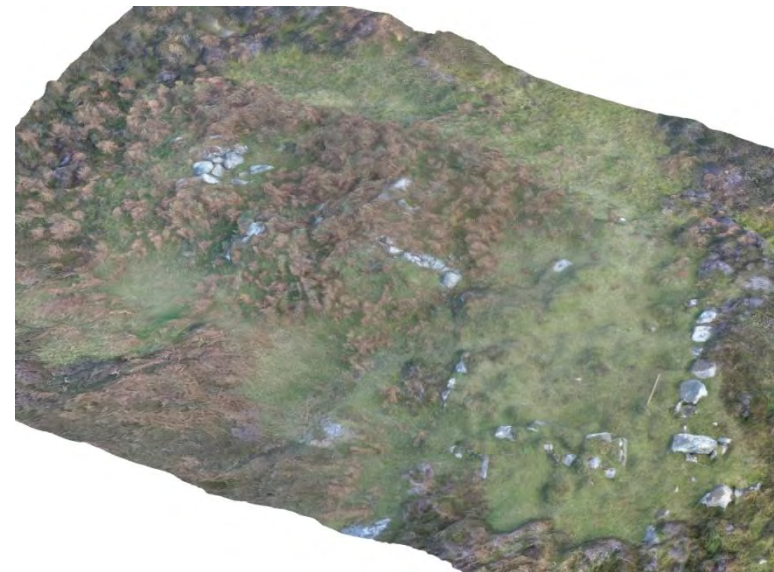
BR 8: aerial view from SW and thumbnail plan

Site name: **Poll an t-Suicair**
 RFS no: **BR 8**
 NGR: NF 89105 54665
 Site type(s): Building(s), enclosure (poss)
 Condition: Poor

A two compartment building, possibly a store, lies around 30m E of the E shore of Poll an t-Suicair. Measuring around 9m N - S and 2m transversely within turf walls up to 1.2m thick and 0.6m high, lined internally with single leaf dry stone walling, the building is divided by a drystone wall near its centre point, and both compartments created have a centrally located entrance door facing W. The much reduced remains of a second rectangular building, or possibly an enclosure, lie immediately adjacent to the S though are set at a slightly different angle to the first. The single course of remaining stonework suggests these walls were possibly all drystone construction.

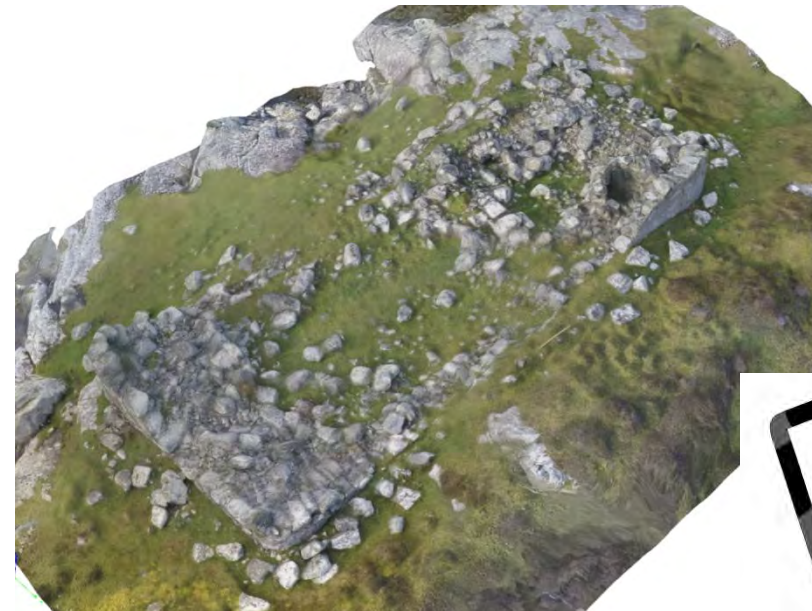
BR 9: aerial view from SE and thumbnail plan

Site name: **Poll an t-Suicair**
 RFS no: **BR 9**
 NGR: NF 89045 54690
 Site type(s): Building, pen.
 Condition: Fair

A part demolished rectangular building lies a few m. from the E shore of Poll an t-Suicair. It measures around 11.6m NNW - SSE by 4.5m transversely within twin leaf dressed stone walls bound with lime mortar around 1m thick and up to 1.5m high. The external corners are rounded and well built and external stonework joints finished to form a smooth external surface. Most of the long elevation walls have been removed so it is not possible to locate any openings, and although the gables are more extant, nor is it possible to discern any fireplaces or chimneys. A cellular drystone structure, probably a lambing pen, has been built into the NE corner.

Along and outside the NE facing elevation and the SW corner the remains of other walls can be seen at ground level and these may represent the external outline of an earlier, slightly larger building on the same site.

Despite its condition, it is clear that this building design and construction fits with the 'taigh geal' or white house tradition associated with the second half of the 19th, and early 20th centuries on Uist. As such, and in common with the only other house of this type on the island at Buaile-mhòr (BM 8), it would be expected to appear on either the 1st or 2nd OS editions from 1880 and 1904, but it does not, although an un-roofed structure is shown at this location when the 1st edition was surveyed in 1878.

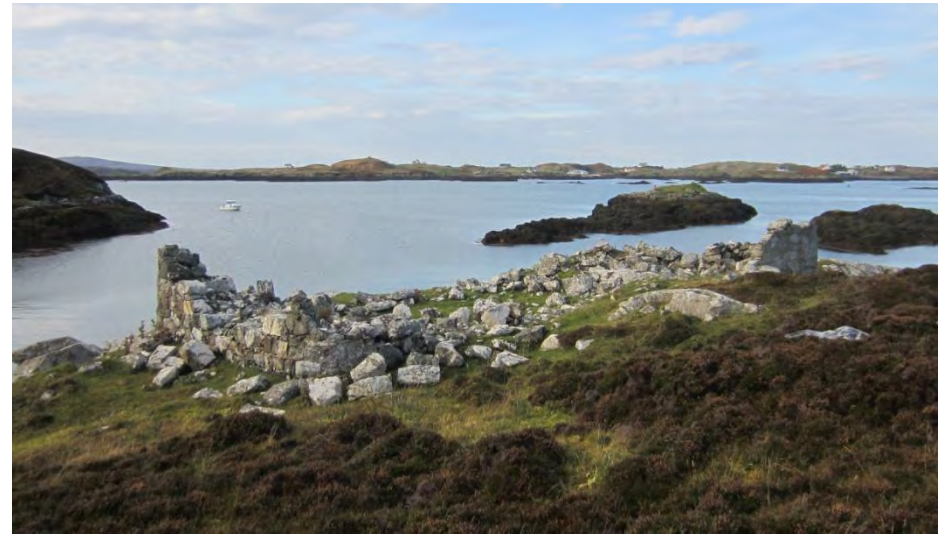
However a roofed building does appear on this site on the Cdr. F. W. L. Thomas Admiralty survey of the Kyle of Ronay dated 1861 where it is labelled as a 'Store House', and it seems likely that this location, used as a trading point by the early 19thC kelping crofters, continued in a similar role for a period after they left. Without any other buildings nearby however, it seems that when the building became disused, the dressed stone was good enough to be dismantled and shipped to another location, possibly Bàgh Mòr on Grimsay, where local fisherman Eardsaidh Nicholson is known to have used stone from old buildings on Ronay to build a pier and other structures in the 1930s.

BR 9: view from E

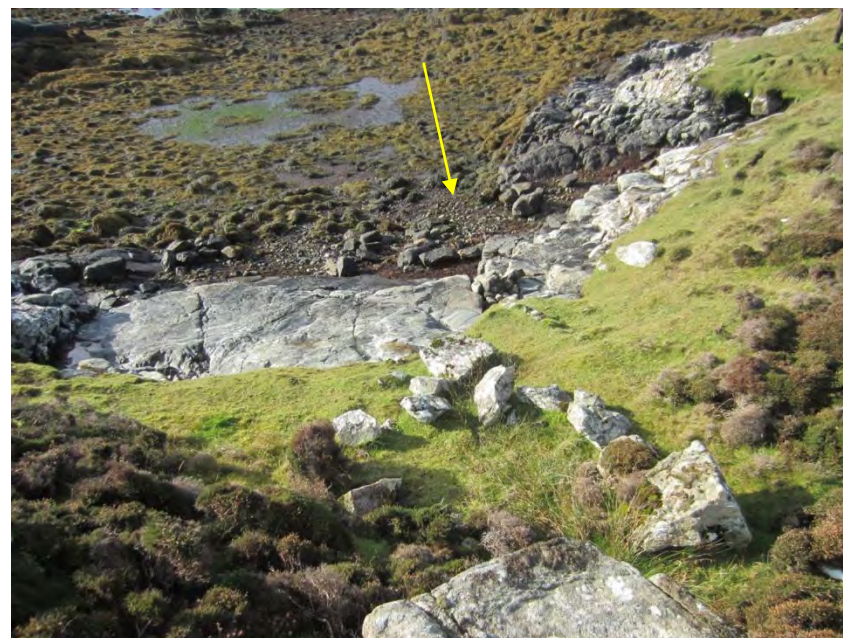
BR 11: view from NE

Along this coastline, often located a few metres inland from the shore and concealed in vegetation, are a number of small stone piles of which this is a typical example. Although their exact purpose is unclear, in this kind of location and away from areas of cultivation, they are most likely to be related to kelp processing.

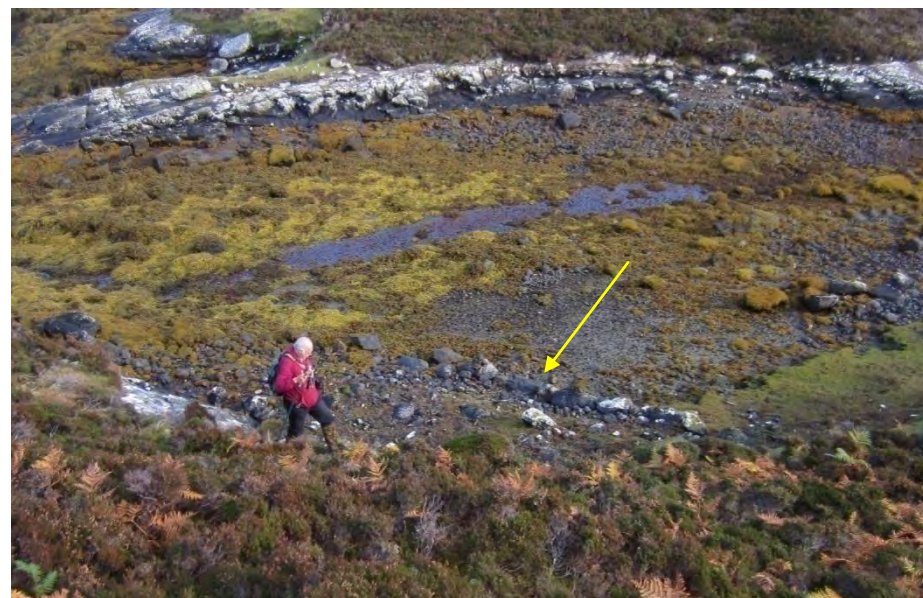
BR 13: view from W

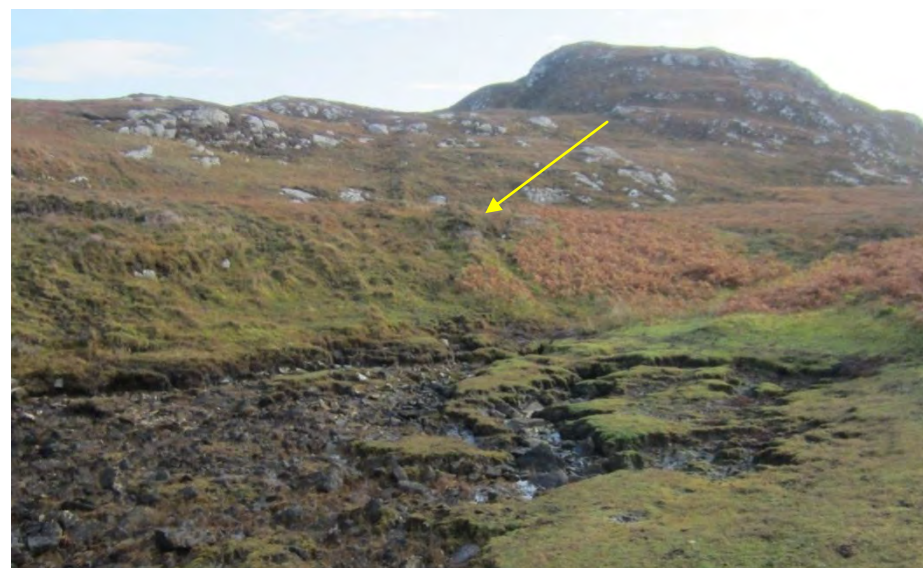
BR 14: view from W

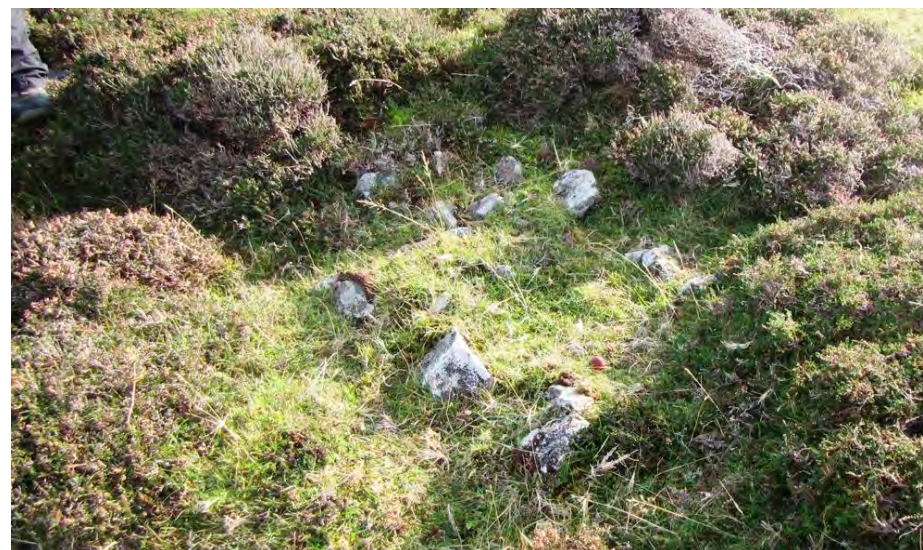
BR 15: view from W

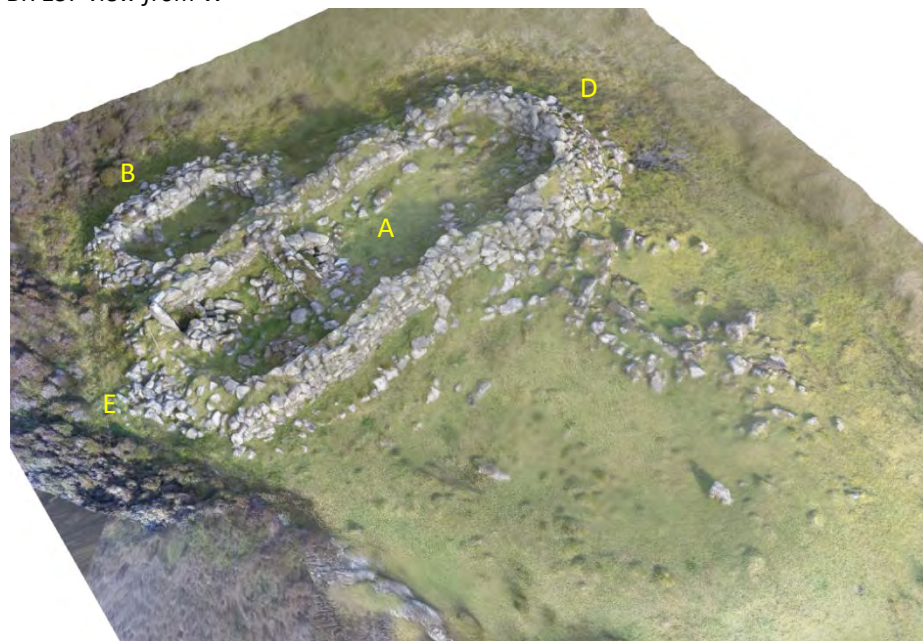
BR 16: aerial view from SW

This somewhat altered farmstead lies around 100 metres inland from the W shore of Ronay at an altitude of +30m AOD, near the centre of a dyke/seashore bounded area of croft land extending to nearly 6Ha. The main building (A) was probably originally constructed as a rectangular longhouse, measuring 13.5m from E to W by 4.2m transversely, together with a similarly shaped and orientated outbuilding (B) directly attached to the W end of its N facing long elevation, which measures 4.2m X 2.4m, both within drystone walls up to 1.7m thick and 1.2m high, of which both internal and external corners are generally rounded. All four entrance doorways (C) have been subsequently built up, but appear to have been located in the E elevation of the outbuilding, one on the house N side long elevation, and two on the S side - all towards their E ends. Different styles of walling point to other alterations at various points. These include what appears to be a gable extension at its E end (D), and in the W gable where a fireplace recess has been built near its centre (E).

A number of other structures are visible within the main house. These include a small cellular stone structure 1m across in the NW corner (F) which is probably a lamb pen, a 0.8m thick stone dividing wall (G) which bisects the main house around 3.6m from its W end, attached to the E side of which is a second D shaped pen around 0.8m across (H), and finally at the E end two raised floor areas (J) separated by what is probably a drain, which probably passed through the gable to connect to a field drain outside.

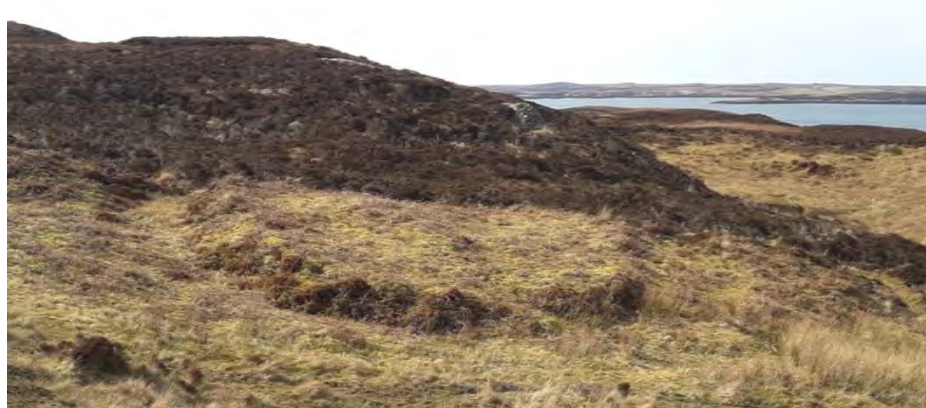
(Left) BR 16: view of stack stand or kale yard from N
