**Ronay Field Survey
2015-18**

**David Newman
June 2018**

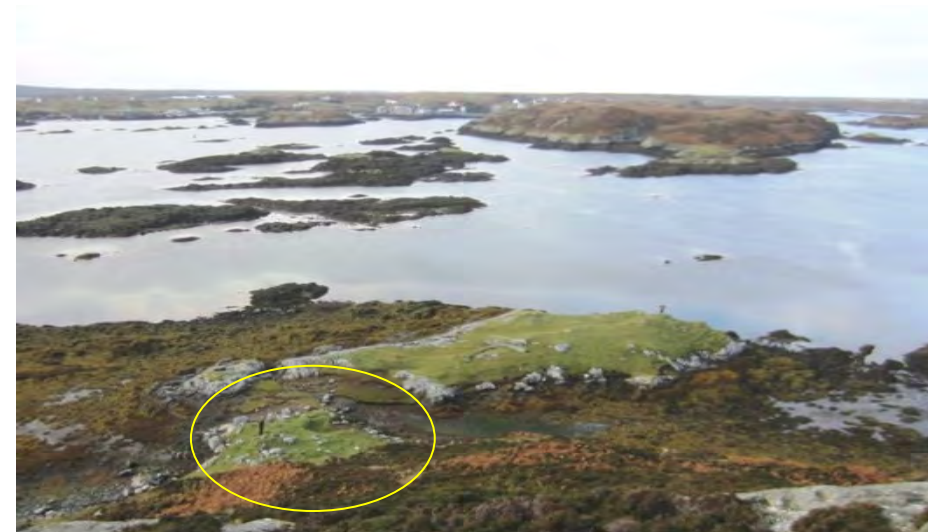
BR 17: view from E with Kallin Harbour in distance

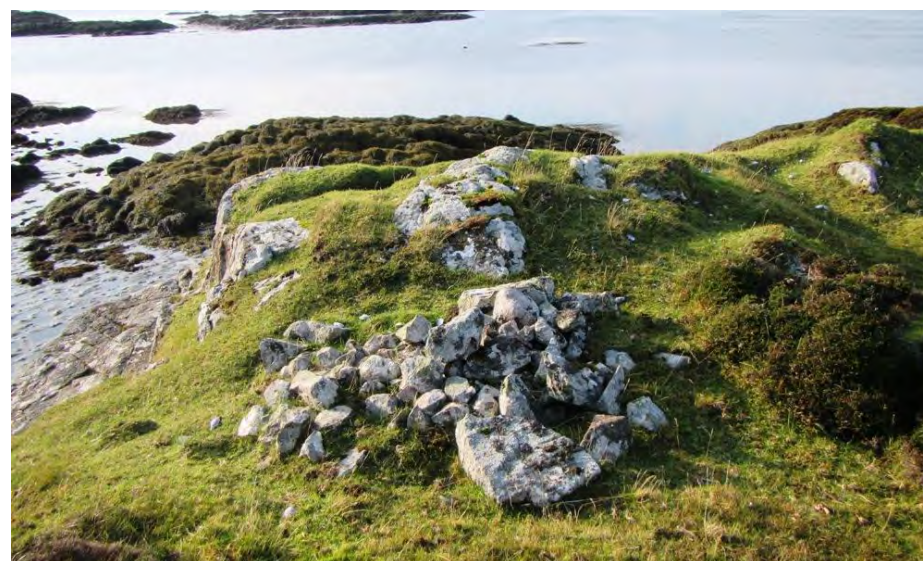
(See also BR 15) A small stone pile or cairn lies a few metres from the W shore of Ronay. Its exact purpose is unclear, but in this kind of location it could either be related to kelp processing or clearance from an area of cultivation nearby.

BR 19: view from E

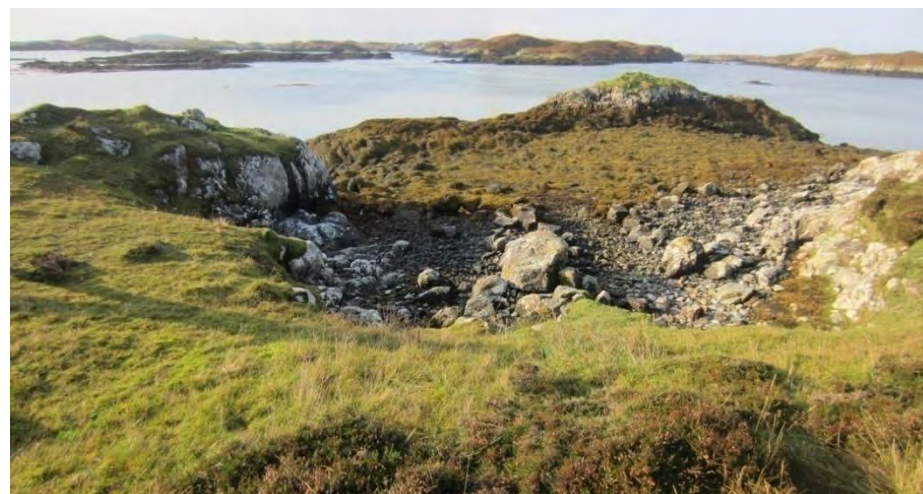
This farmstead lies around 85m inland from the W shore of Ronay at an altitude of around 25m AOD, towards the N end of a dyke bounded area of croft land extending to around 4.5Ha. It consists of a rectangular building measuring 9.2m from WNW to ESE by 3.7m transversely, within drystone walls no more than 0.8m high and of very varying thickness and condition, perhaps suggesting it was never completed. There is an entrance towards the W end of the S facing elevation. Around 6m to its NW lies a smaller, second building of similar construction and condition which measures 4.5m N - S and 1.8m transversely. This has an entrance towards the S end of its E facing elevation. Parts of the N facing elevation of the larger building may have been rebuilt which could suggest possible adaptation for stock rearing purposes.

BR 20: view from E

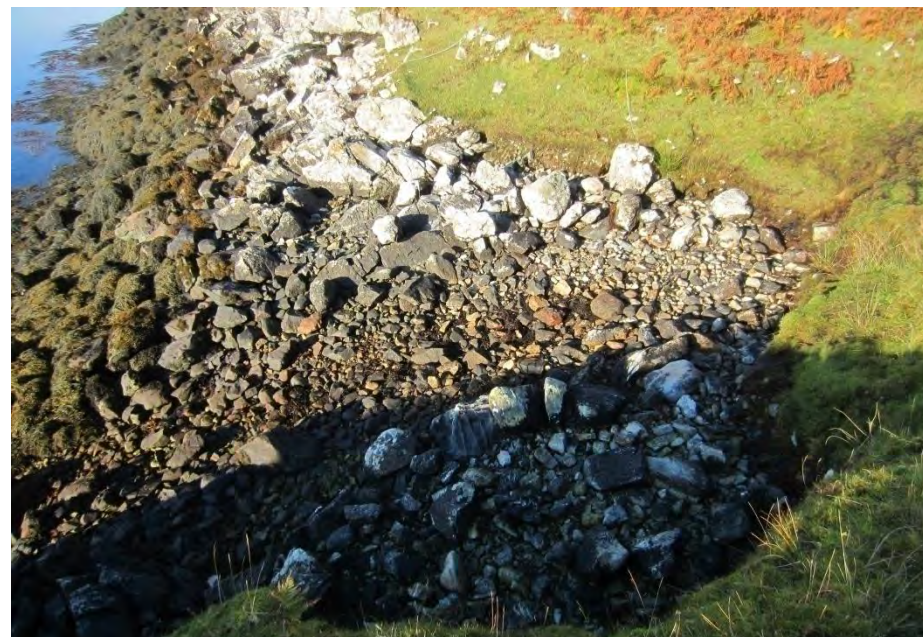
A dyke runs for a distance of around 450m in a WNW - ESE direction between the W shore of Ronay at NF 89180 55370 and Loch na Sruthan Beag at NF 89600 55250, intersecting the termination of the head dyke BR 24 near its mid point at NF 89395 55310. Constructed mostly as a turf bank and ditch it changes to drystone construction as it nears the sea and loch shores. As well as defining the N extent of the croft land related to the farmstead BR 21 it probably also represents the N boundary of the common grazing at the S end of Ronay related to the five farmsteads BR 1, 3, 4, 9, 16 and 21 and their related crofts.

BR 22: view from SE

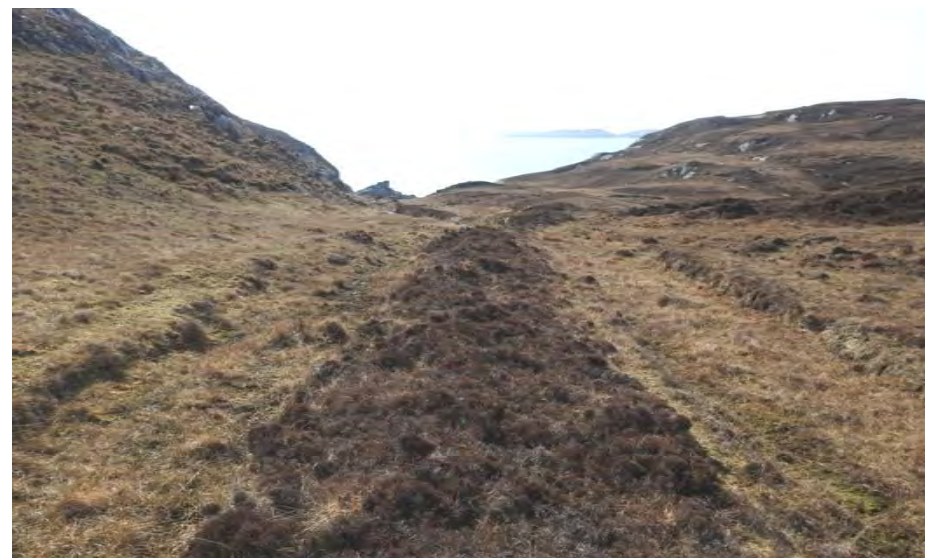
A head dyke runs in a generally S - N direction for a distance of around 1km between the SW shore of Ronay at Camas Mòr at NF 89250 54400 and its intersection with a second dyke running W - E between the W shore of Ronay and Loch na Sruthan Beag at NF 89395 55310. Construction alternates between drystone, stone and turf, and turf bank and ditch. The total area of land enclosed is around 28Ha and the remains of 4 further dykes which subdivide it, and a number of farmstead type buildings within, suggest that this area was formerly subdivided into 5 crofts.

BR 24: view of turf bank section towards S end looking S into Camas Mòr

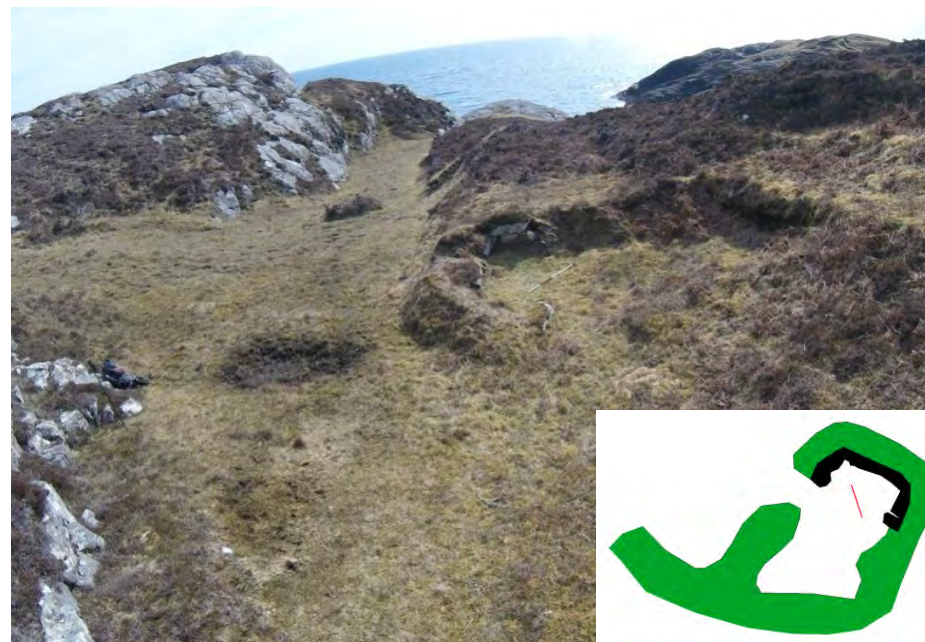
The remains of a rectangular hut lie near the top of a gully leading up from Geodha na Rodagraich/Muice near the S tip of Ronay. Formed in part by an excavation in a turf bank, it measures around 4m SW - NE and 2m transversely within mainly turf walls, partly lined inside with stones at its NE end. The entrance seems to have been on its NW facing elevation. At this location - away from the main settlement areas, by the coast, and in an area of slightly better grazing, its use was probably related to either kelping or sheep herding, though any relationship to traditional shieling activity seems unlikely.

BR 25: view from NW and thumbnail plan

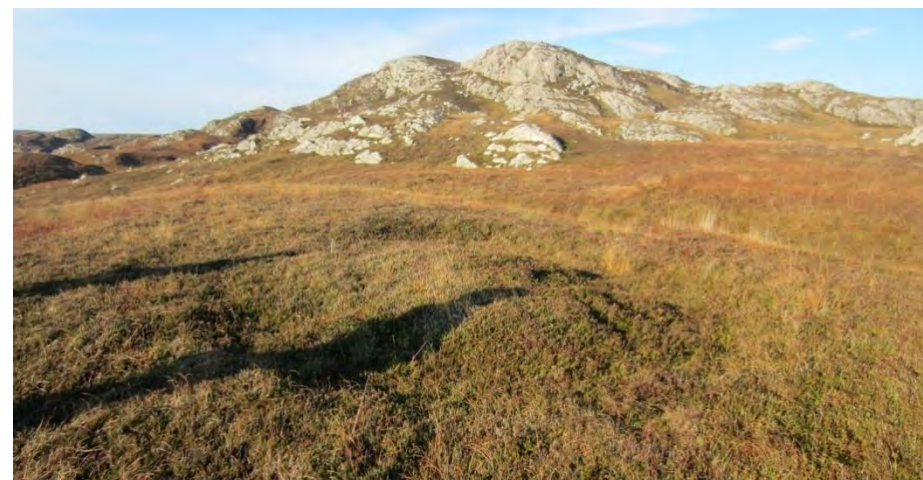
A sub-circular stack stand or clamp base, most likely used for peat or root crops lies amongst areas of peat cutting and small pockets of cultivation. The slightly raised central base measures around 3m NW - SE and 2m transversely and is surrounded by a ditch around 0.7m wide and 0.3m deep.

BD 2: view from SE

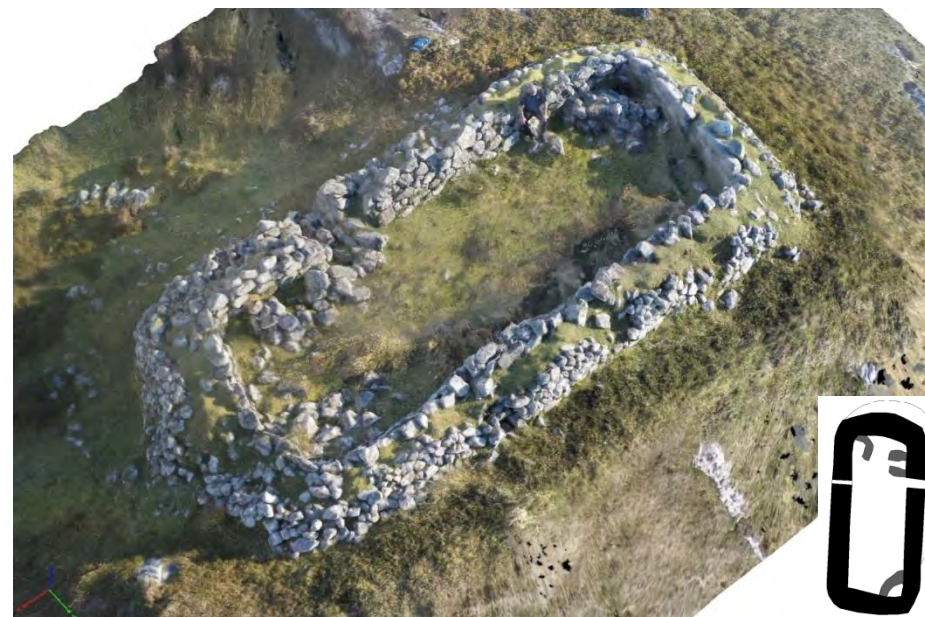
Within the building are a number of cellular drystone walled structures which point to its later use for animal husbandry purposes. These include four lamb pens typically no more than 1m across internally, with a single one in each of the SE and NW corners, and two in the NE. The entrance shows signs of having been temporarily walled up at one time too.

There are some unusual features about this building which set it apart in some respects from the many others on Ronay, particularly its isolated location at altitude away from the shore, the lack of any kind of byre or outbuilding, and the absence of any obvious keeping activity on the shore nearby. It is also noteworthy that the place-name 'Buaille nan Druidhneach' or 'Druid's Fold' is placed exactly by this structure on the 1st and 2nd edition OS 6" maps, and there is a good possibility therefore that this former building has been given that name relatively recently.

BD3: aerial view from NW and thumbnail plan

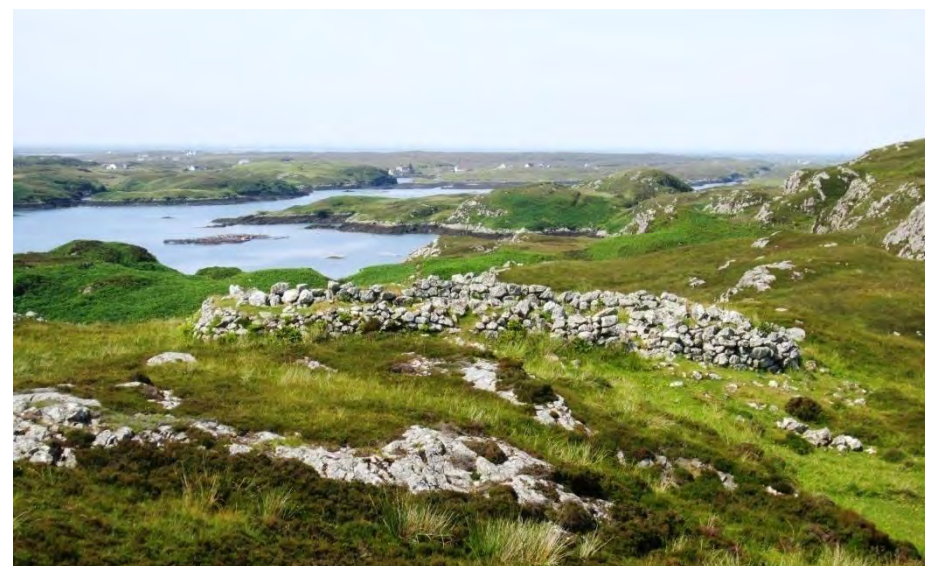
BD 3: view from E with Grimsay in background

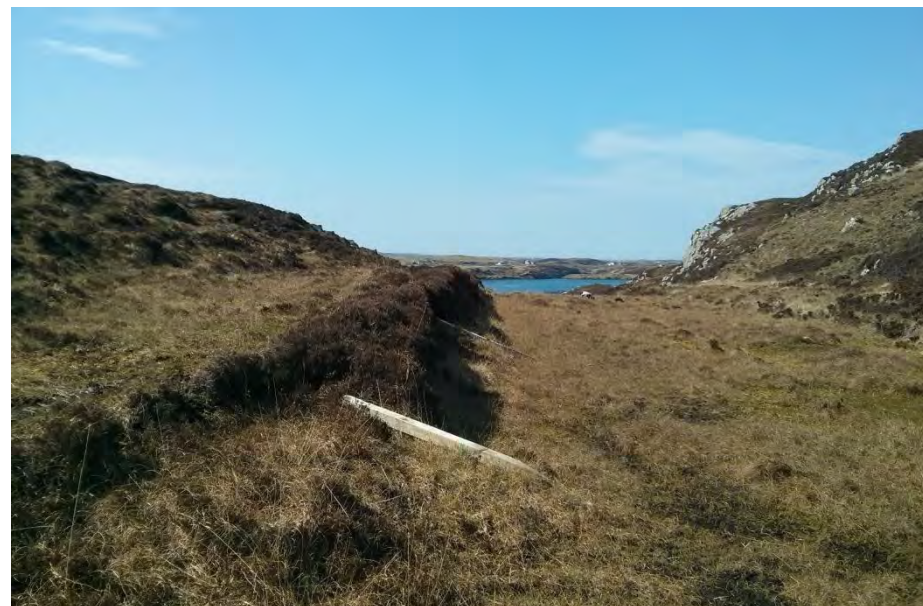
A dyke bisects Ronay from W to E between the head of Bàgh an Tighe Fhraoich, and the E shore of Bàgh na Caiplich where the outflow from Loch na Leig meets the sea (see BNC 4 and 5). This westernmost section up to the W shore of Loch nan Druidhneach is around 460m long, running from NF 89035 55780 in an NE direction for around 80m before heading ENE for a further 380m to NF 89480 35875. The dyke is constructed mainly as a turf bank with quarry ditch alongside in places and its straightness and relatively good condition suggest this is of mid 19thC date and is probably related to Ronay's re-organisation as a sheep farm around this date. Towards its W end it is interrupted by the construction of a modern house (BD 5), beyond which the final 10m to the shore were of drystone construction.

BD 4: View looking W taken near the intersection with BD 1

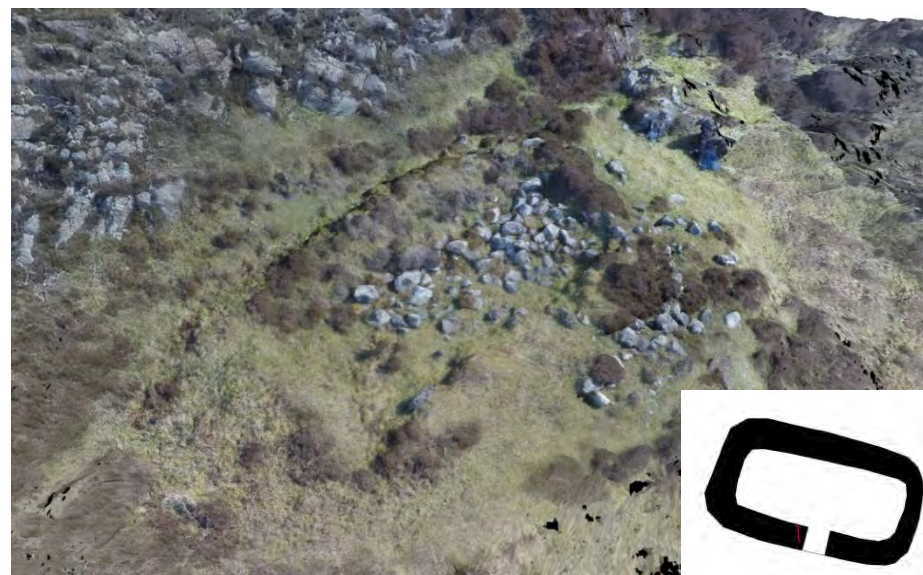
A rectangular building lies at the foot of a cliff some 70m N of the head of shore of Bàgh an Tighe Fhraoich at an altitude of around +25m AOD. It measures 8m WNW - ESE and 3.2m transversely between turf walls up to 1.4m thick, but degraded to barely 0.5m in height, which in places are lined internally with a single leaf of drystone walling. There is an entrance in the S facing elevation a little to the E of centre. Shown roofed in Commander F. W. L. Thomas's Admiralty survey of the Kyle of Ronay in 1861 it may be connected with Ronay's use as a sheep farm at that time.

BD 5: aerial view from SW and thumbnail plan

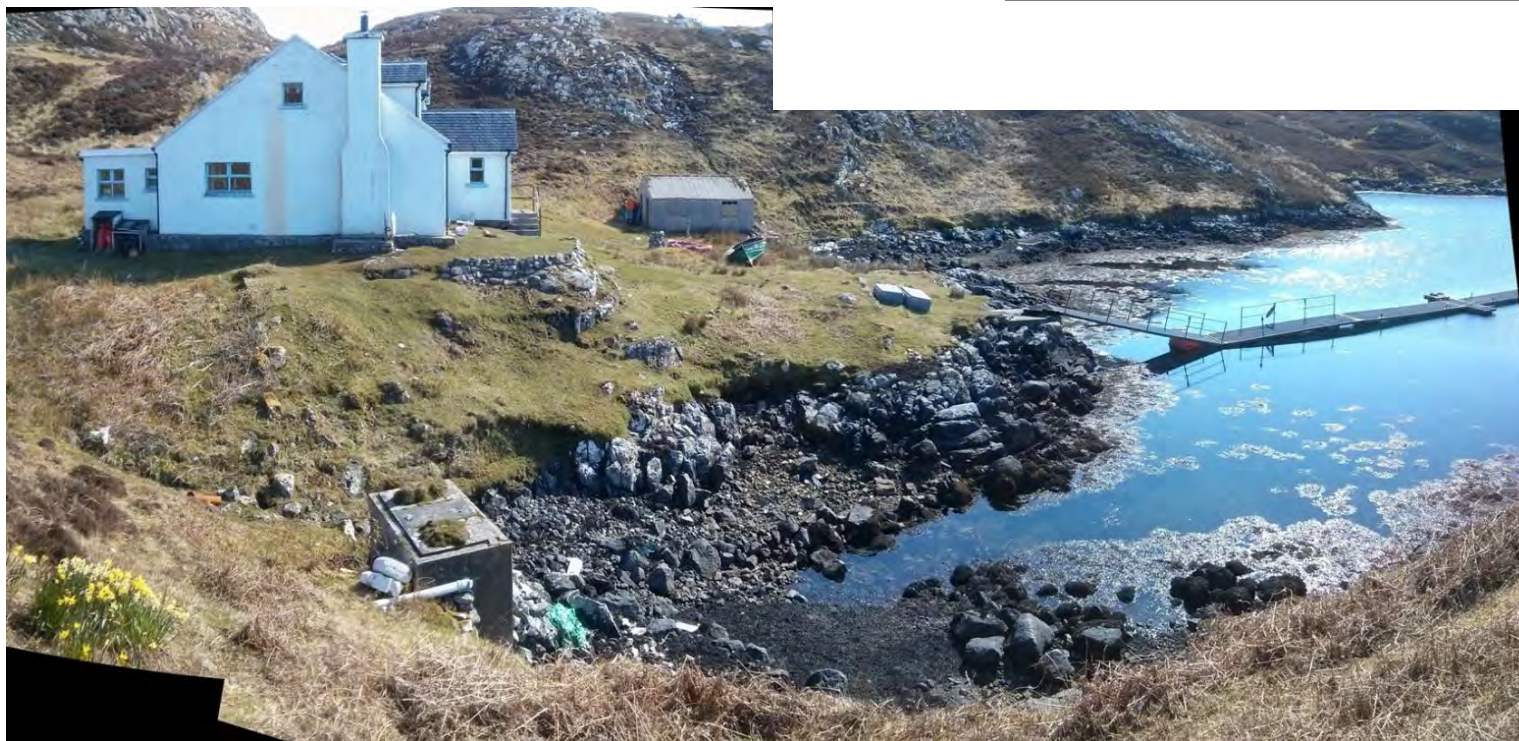
BD 6 & BD 7: view from W

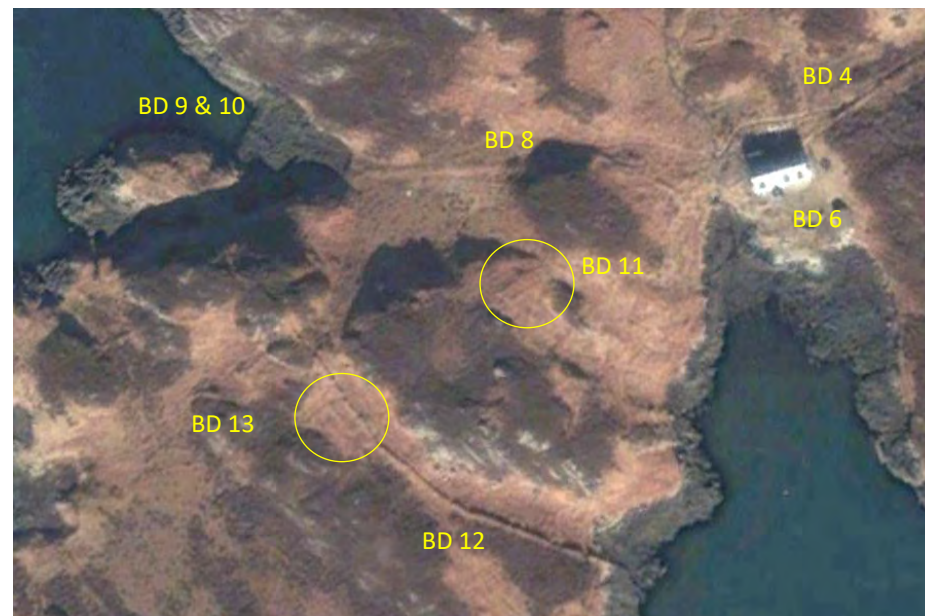
A landing point lies at the W end of a narrow isthmus that separates the peninsula Rubha Clann Nèill from Buaile nan Druidhneach. It comprises an area of beach measuring around 30m WNW - ESE and between 2 and 3m transversely which has been cleared of larger stones, and defined on either side by intermittent lines of larger stones and boulders.

BD 8: Google Earth view (2004). BD 4, 6 and 9 - 13 also shown.

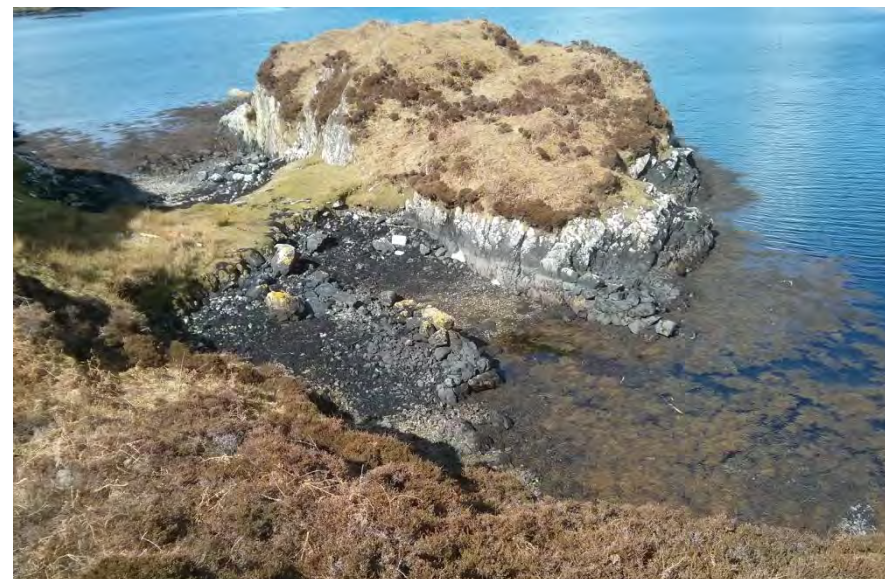
A second landing point lies at the W end of a narrow isthmus that separates the peninsula Rubha Clann Nèill from Buaille nan Druidhneach. It comprises an area of beach measuring around 12m WSW - ENE and 4m transversely which has been cleared of larger stones. It is defined on its N side by a low cliff and on its S by a roughly made drystone breakwater or jetty which is around 1m thick and up to 0.8m high.

BD 10: view from SE

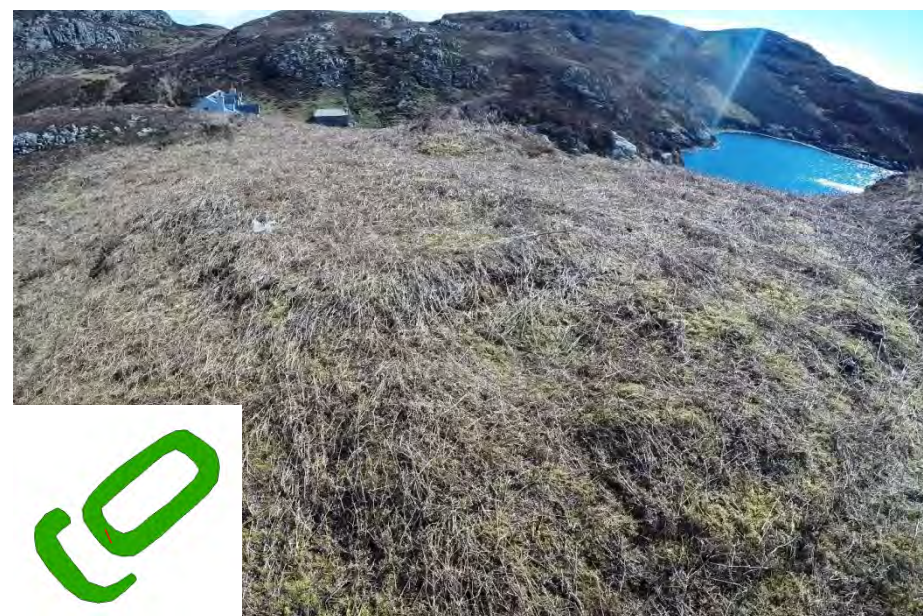
A rectangular turf walled building lies towards the N end of Rubha Clann Nèill at an altitude of around +15m AOD. It measures 7m SW - NE and 2.7m transversely between slumped turf walls up to 1.5m thick, but degraded to barely 0.5m in height. No entrance identifiable. Just outside the SW gable is the faint outline of another turf wall which may represent the remains of an earlier, underlying structure, or perhaps an attached secondary building. This building is located almost exactly where three buildings, at the same orientation, are shown on Robert Reid's *Plan of the Island of North Uist* published in 1799. Faint traces of other turf walls lie immediately to the E of this building and may represent remains of the other two.

BD11: aerial view from W and thumbnail plan

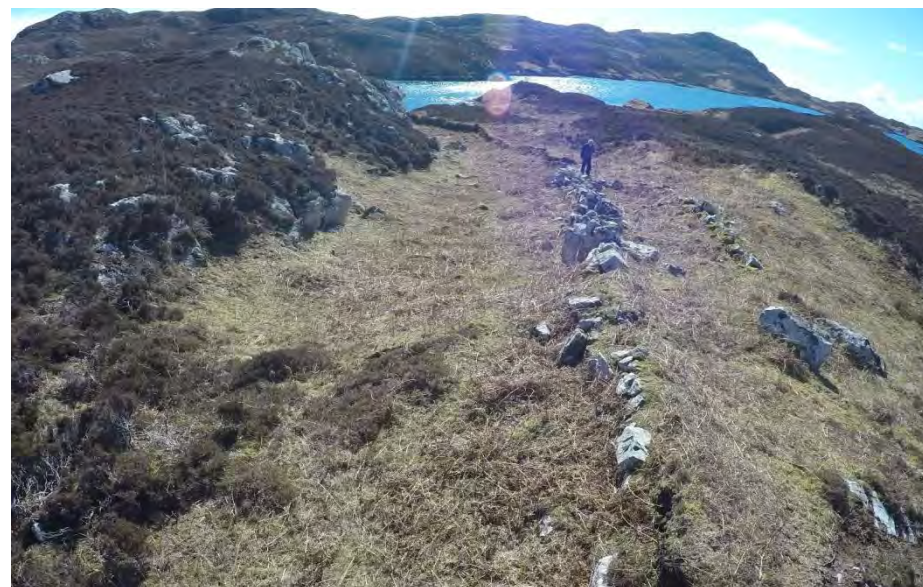
A rectangular building lies just N of the centre of Rubha Clann Nèill attached to the SW side of a head dyke (BD 12) which isolates the peninsula. It measures 12.3m NW - SE and 3.2m transversely within drystone walls up to 1.3m thick, and between 0.8 and 1.4m high. No clear entrance identifiable, but there is an 0.7m wide opening in the dyke shared elevation on its NE side just NW of centre. A partition located just SE of this opening subdivides the interior. Although rather unusual in form and position, the best interpretation for this structure is that it is the remains of one of the early 19th C kelping croft farmsteads.

BD 12: view from NW with BD 13 visible centre left

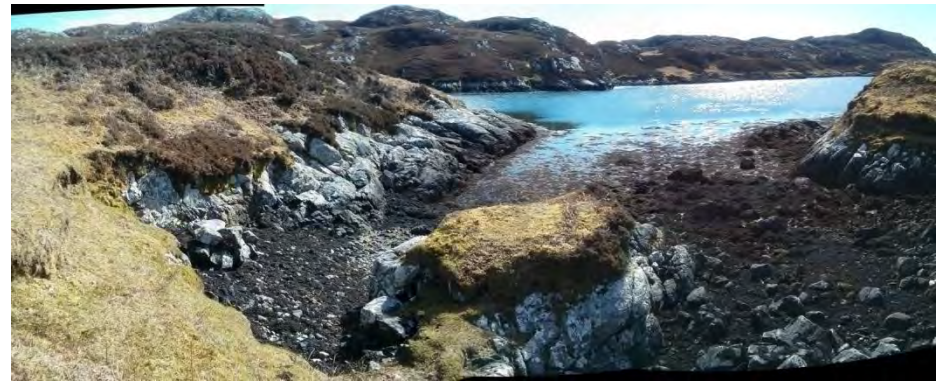
A possible landing point lies on the SE shore of Rubha Clann Nèill. An area of beach measuring around 30m NW - SE and between 3 and 4m transversely has the appearance of having been cleared of larger stones and boulders.

BD 14: view from W

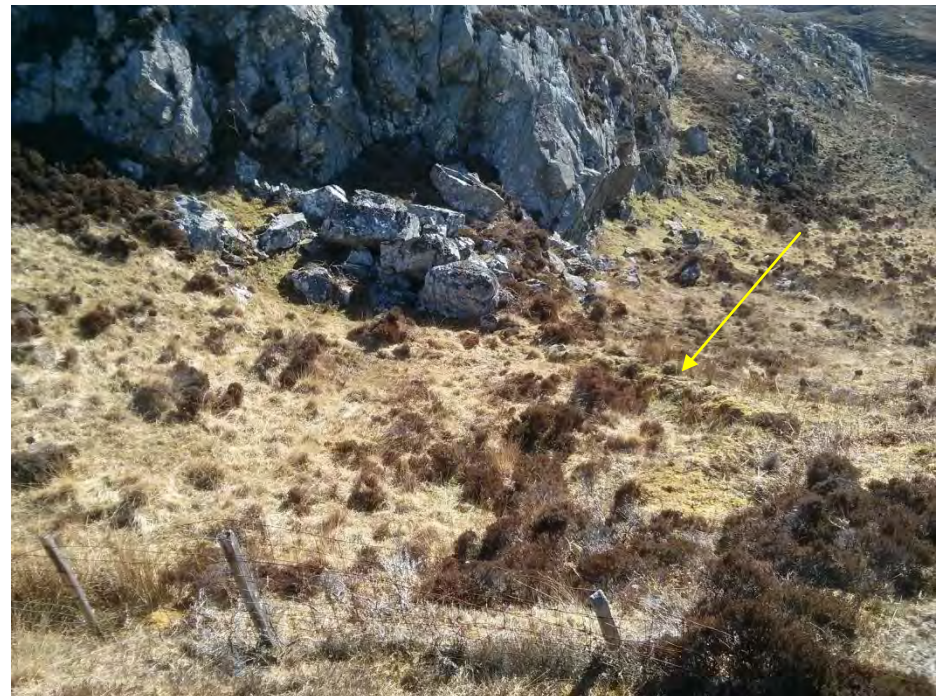
The remains of a drystone dyke cross the foot of a narrow gully and terminate at an area of rock fall at the base of a cliff at NF 88985 55910. This point appears to be the joint termination of three separate boundary dykes:

- a 750m long head dyke which enclosed the cultivated land around the township on the shore of Bàgh Clann Nèill which lies some 350m to the NW;
- an 850m long head dyke which enclosed the township of Buaile nan Druidhneach to the E and S, which at this point is formed by a rock outcrop;
- and a dyke which connected this point to the shore of Bàgh an Tighe Fhraoich and shown on Robert Reid's *Plan of the Island of North Uist* dated 1799, but is no longer visible.

BD 15: view from NW

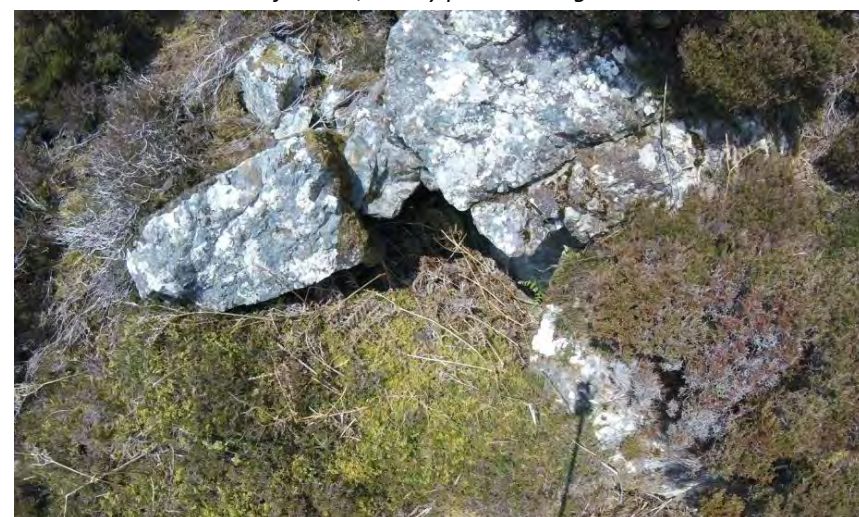
BD 17A: entrance to W shelter

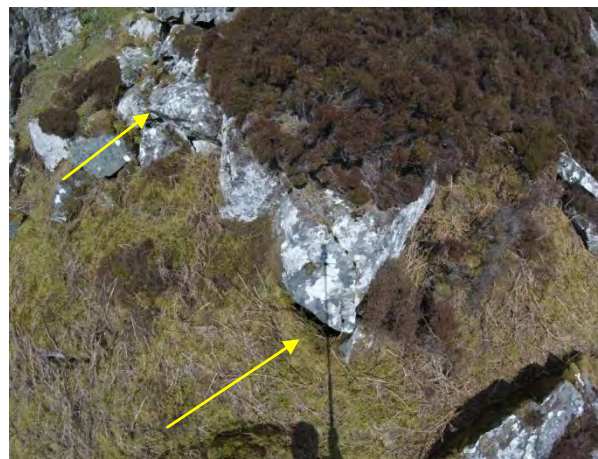
BD 17C: entrance and stone packing on E rock shelter

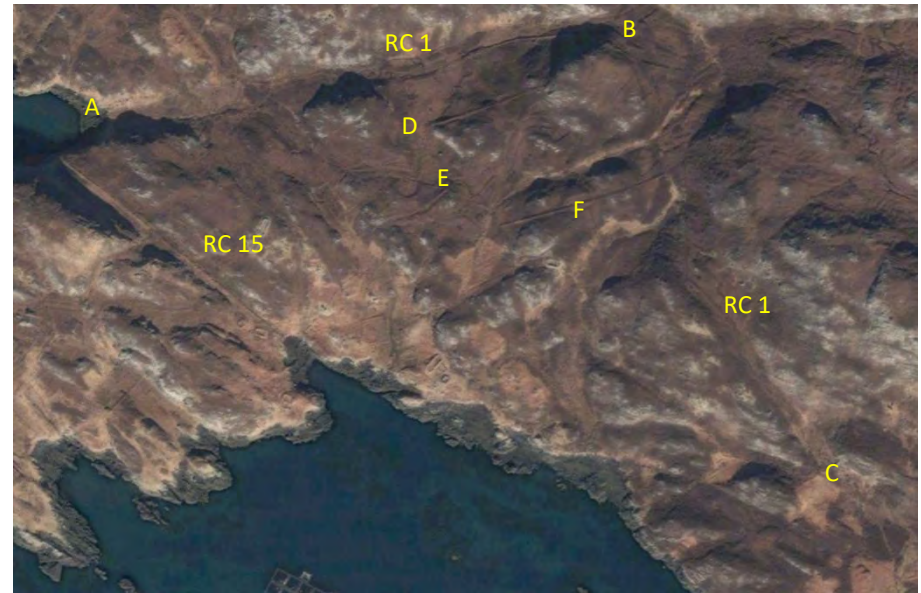
The remains of a head dyke enclose an area of partly cultivated land extending to around 16Ha, and which may, in part, represent the township boundary marked in this area of Ronay on Robert Reid's 'Plan of the Island of North Uist' published in 1799. Intermittent, and often difficult to see in the landscape, the dyke is formed mostly as a turf bank and ditch with some sections defined by drystone walls or natural features. The dyke starts at the shore of Bàgh Rubha Chnaip at NF 88450 56210 (A) and runs in a generally W - E direction for a distance of around 375m before gradually curving round to follow a SSE direction near NF 88850 56235 (B) and running for a further 360m before terminating at an intersection (C) with a second dyke (see BD 15) at NF 88970 55900. Three further lengths of dyke (D, E and F) can be seen on satellite imagery and traced on the ground just S of B and these may represent the remains of an uncompleted attempt at further sub-division.

RC 1: Google Earth view (2004)

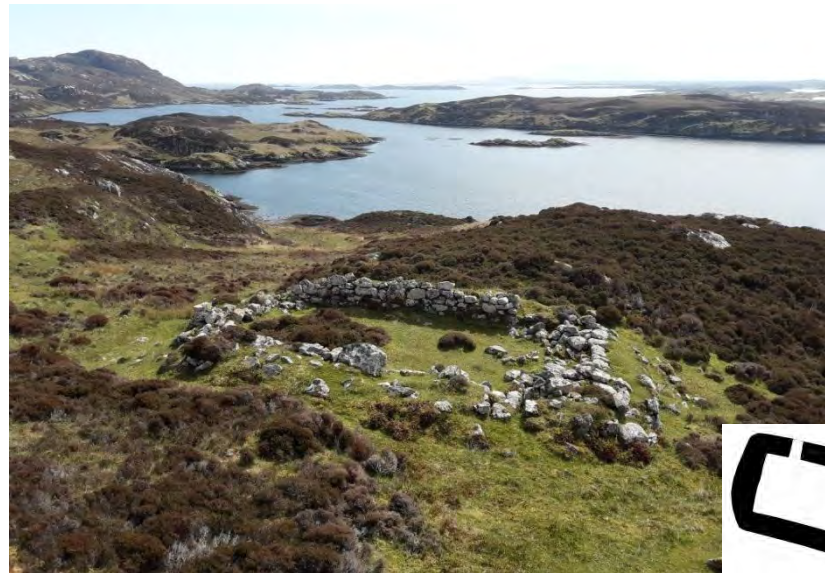
A rectangular building lies at an altitude of around +30m AOD some 120m from the Bàgh Clann Nèill shore. Measuring 8.2m W - E and 3.6m transversely within squarely built drystone walls, the fireplace recess in the centre of the E gable marks this out as probably being a small house dating from the later part of the 19th or early 20thC. A 0.6m wide doorway is positioned towards the W end of the N facing elevation.

RC 2: View from N and thumbnail plan

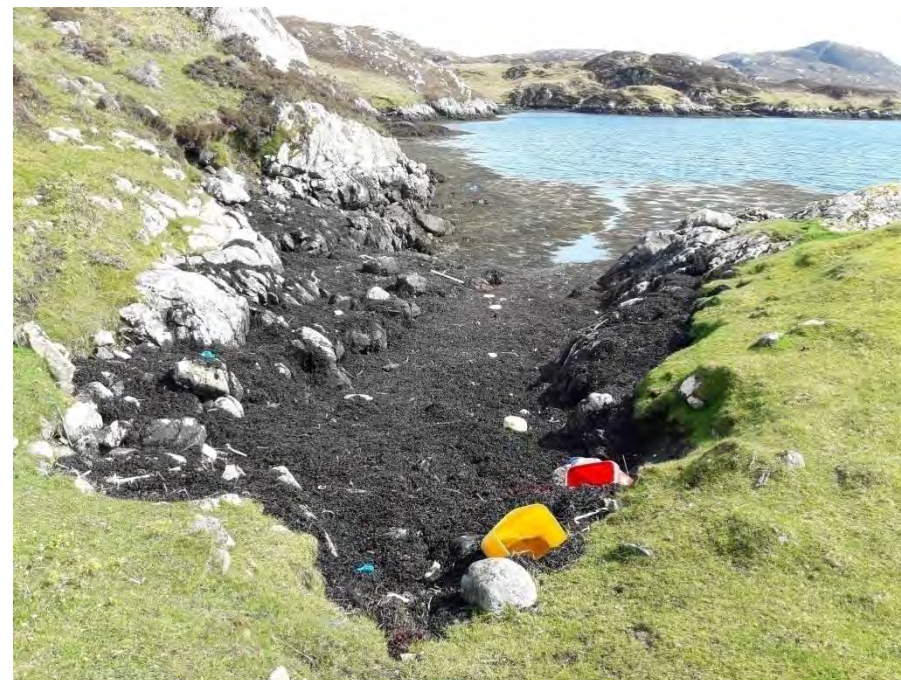
One of two landing points lying on the shore of Bàgh Clann Nèill immediately in front of the farmstead RC 5. It comprises a narrow inlet within which an area of beach measuring around 30m E - W and between 2 and 4m transversely has been cleared of larger stones, and defined on both sides by lines of larger stones and boulders. Above the HWM at its head, a naust has been formed. This measures around 10 X 4m and is defined on its N side by a low rock outcrop and its S and E by a low boulder wall.

RC 3: View from W

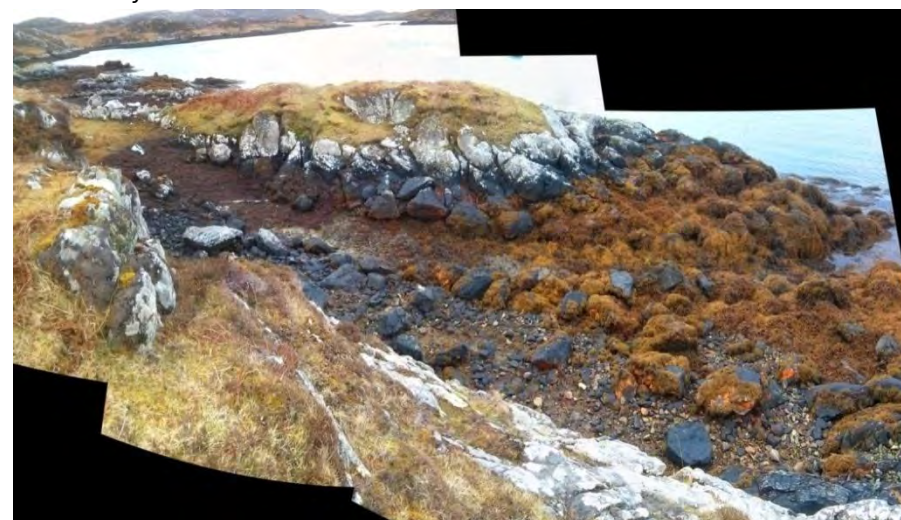
RC 4: View from W

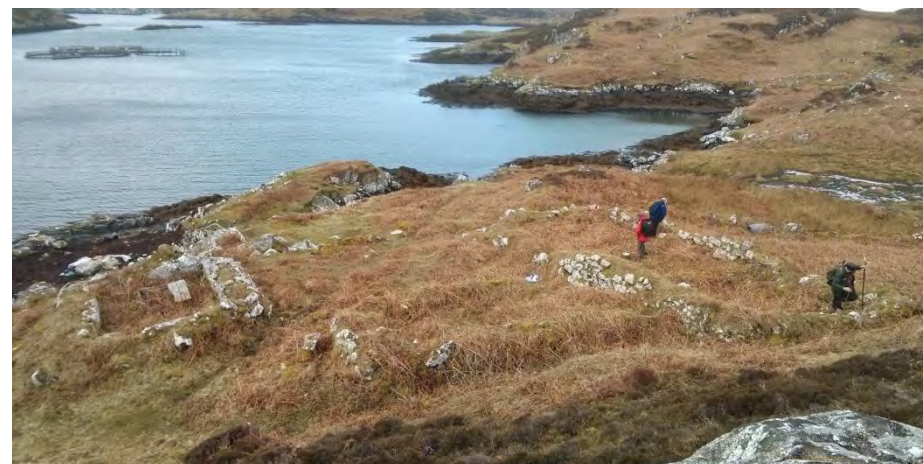
1.5m to the S of B lies a separate byre (C), also of drystone wall construction. This measures 4.2m NNE - SSW and 2.9m transversely internally and has a narrow entrance barely 0.4m wide at the S end of its WNW facing elevation. A large boulder over 1.5m across has been incorporated into the SSW gable and a number of large (possibly dressed?) rectangular stone blocks used in the other walls.

A drainage ditch (D) has been dug around the NE side of the buildings to separate them from the higher ground beyond, and an intermittent line of larger stones connecting the SW facing gables of the two buildings (E) may represent the remains of an enclosure wall.

RC 5: General view from NE

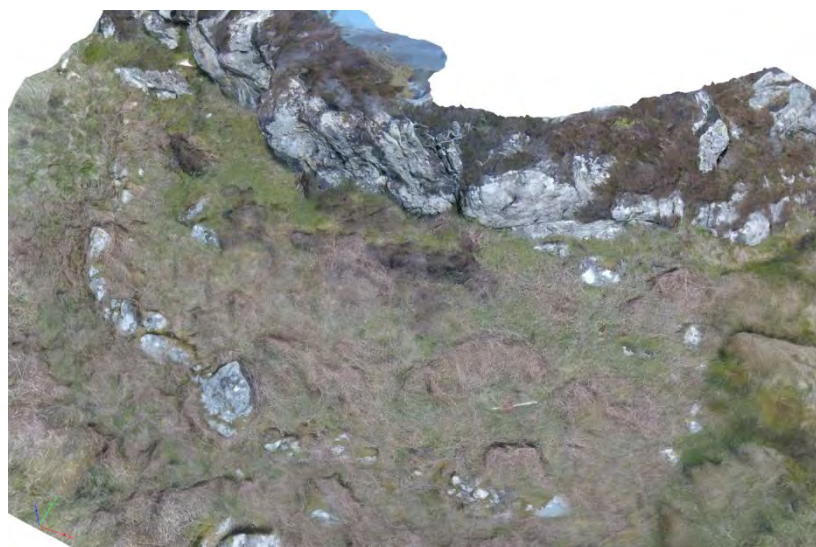
RC 7: aerial view from W

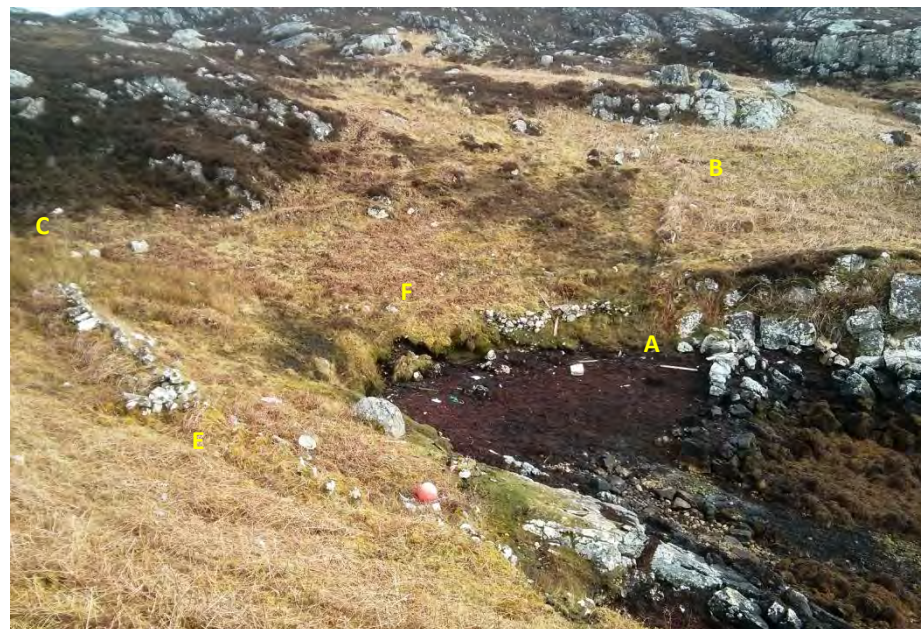
RC 10: view from SW

Site name: **Rubha Chnaip**
 RFS no: **RC 10**
 NGR: NF 88625 56010 (centre)
 Site type(s): Dyke(s)
 Condition: Poor - fair

A series of interconnected dykes lie around the inlet at the NW head of Bàgh Clann Nèill. Constructed mostly in drystone, the longest extends from the shore at NF 88600 56020 (marked A in photo) for around 75m in a NE direction before turning NW at NF 88655 56080 and joining with RC 1. This may have acted as part of the boundary between the two farmsteads RC 5 and RC 16. Extending WNW from point A, another section of drystone dyke around 30m long runs along the top of the shore towards farmstead RC 14 before petering out near NF 88575 56030 (C). Around 20m NE of point A at NF 88610 56040 (B) another 40m length of dyke runs WSW before also terminating at point C. Finally, two further lengths of dyke (E and F) extend from point C around the N and S inlet shores.

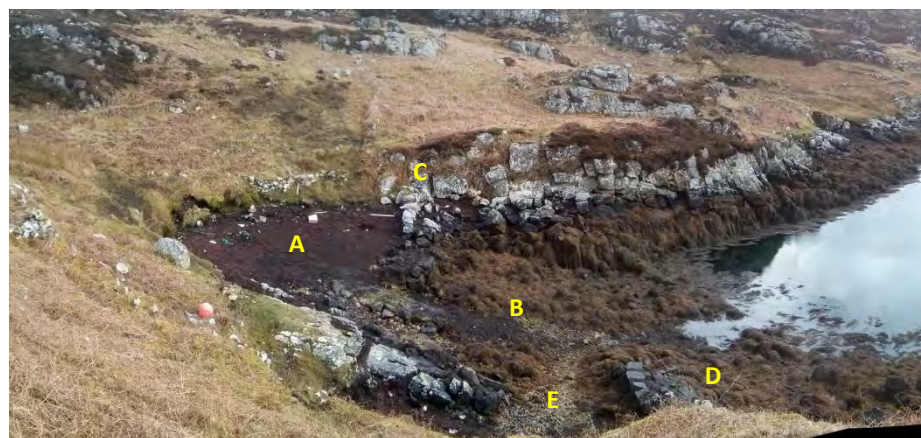
RC 11: view from N

Site name: **Rubha Chnaip**
 RFS no: **RC 11**
 NGR: NF 88595 56010 (centre)
 Site type(s): Landing point, breakwater(s), jetty(s)
 Condition: Poor - fair

A landing point lies in the inlet at the NW head of Bàgh Clann Nèill. An area of beach just below the HWM (marked A in photo) measuring around 10 X 8m has been cleared of larger stones and boulders, and is connected to the LWM by a similarly cleared channel 17m long and 2 - 3m wide (B). The landing area is protected on its NE side by a roughly constructed drystone breakwater (C) around 6m long, and on its SW side by a second (D), similarly constructed, around 8m long. This structure has another area of cleared beach on its NW side (E).

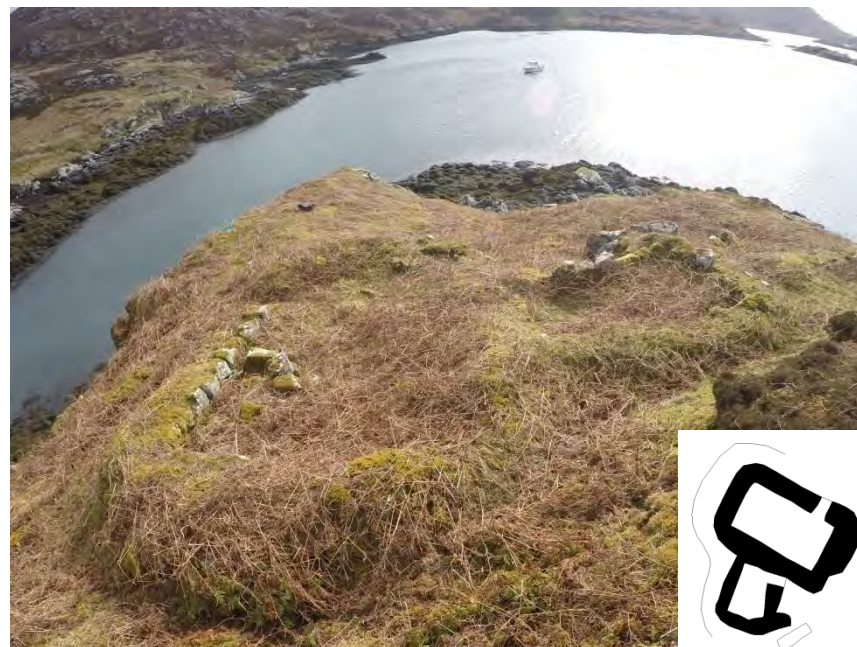
RC 12: view from N with Bàgh Clann Nèill in background and thumbnail plan

Site name: **Rubha Chnaip**
 RFS no: **RC 12**
 NGR: NF 88585 55975
 Site type(s): Farmstead
 Condition: Fair

A farmstead comprising a dwelling and an attached byre lies a few m from the shore of Bàgh Clann Nèill. The main building measures 6.8m WNW - ESE by 3.6m transversely within drystone walls varying in thickness between 1 and 2m, and typically 0.8m high. There is an entrance door at the E end of the NE elevation. Attached centrally to its SW elevation is a small byre of similar construction measuring around 3.7m NNE -SSW and 2.4m transversely. An entrance doorway lies where the SE elevation meets the SW wall of the main building, and adjacent to its SE corner is a large stone slab 2.5m long and 0.8 X 1.1m in cross section. A drainage ditch has been dug around the NE side of the buildings to separate them from the higher ground beyond, and a stone/turf dyke which extends to the shore is attached to the byre gable.

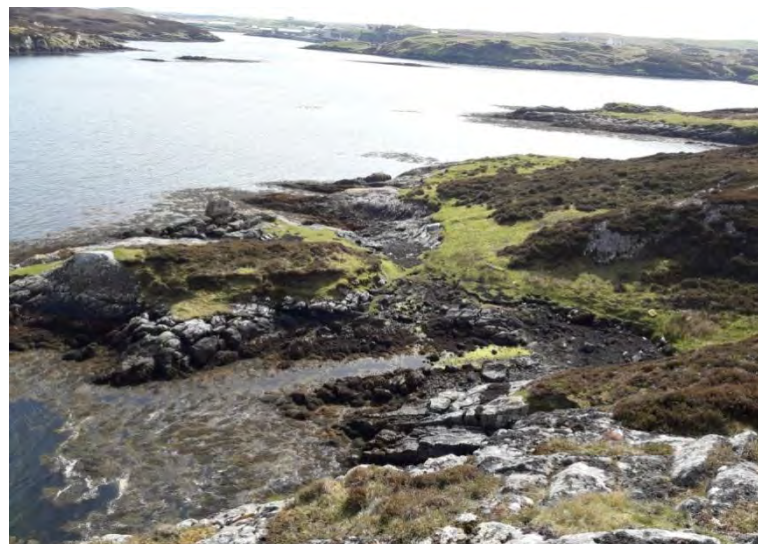
RC 13: view from NE

Site name: **Rubha Chnaip**
 RFS no: **RC 13**
 NGR: NF 88515 55945
 Site type(s): Landing point, jetty
 Condition: Poor

A landing point and a jetty lie in a narrow inlet on the SE shore of Rubha Chnaip. The landing point comprises an area of beach measuring around 30m NW - SE and between 3 and 4m transversely which has been cleared of larger stones, and defined on its NE side by a low breakwater of larger stones and boulders. Around 10m N of the landing point a low drystone wall around 8m long has been backfilled behind with beach material to form a basic jetty.

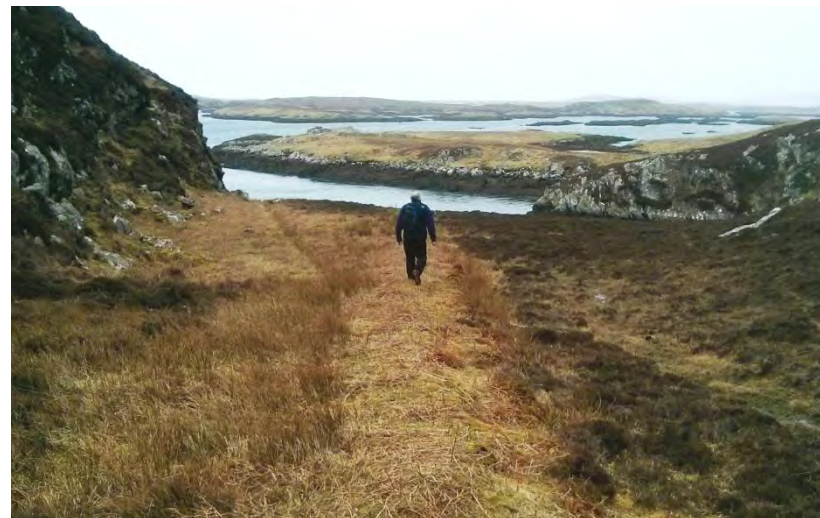
RC 15: view of NW end from SE with Bàgh Rubha Chnaip in background

Site name: **Rubha Chnaip**
 RFS no: **RC 15**
 NGR: NF 88510 55690 (centre)
 Site type(s): Head dyke
 Condition: Fair

A turf head dyke isolates the headland Rubha Chnaip from Ronay. Starting on the shore of Bàgh Rubha Chnaip at NF 88415 56175, it extends SE in a straight line for around 230m to the shore of Bàgh Clann Nèill at NF 88585 56025. The turf bank has now slumped to a width of 2-3m and around 1m high. The enclosed headland has a total area of around 6Ha and has been extensively cultivated and used for peat cutting in the past, and the isolated landing point on its SE shore (RC 13), suggests this may have included crofters from other communities. Likely to be 19thC in date, it was either built as part of the establishment of kelping crofts in around 1810 or the reorganisation of Ronay as a sheep farm after the island was cleared in the 1830s.

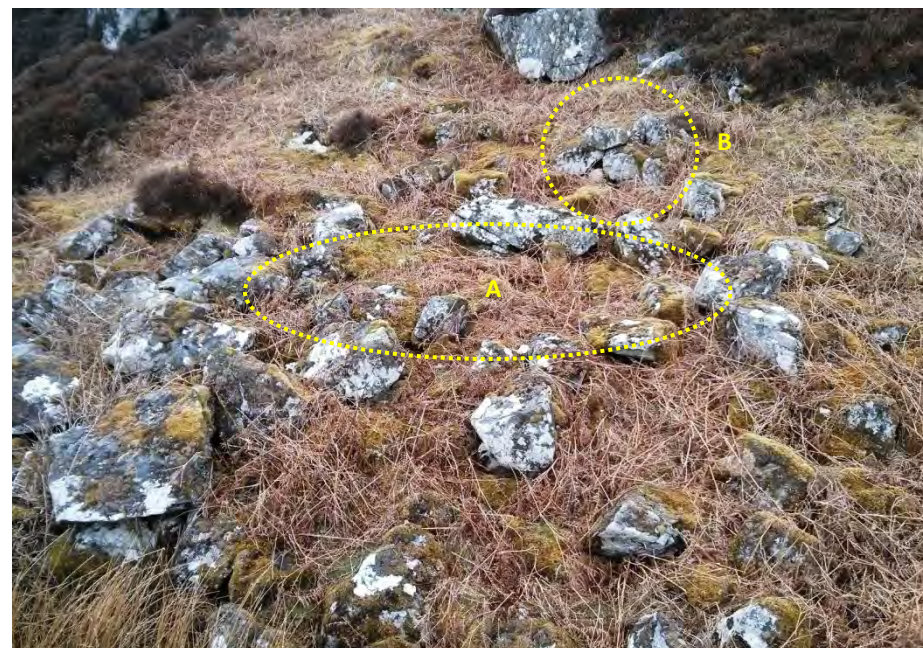
A sub-circular shaped hollow and associated drystone wall fragment lie in an area of scree on the NW side of a narrow glen extending E from Bàgh Rubha Chnaip some 250m from the shore. The hollow (marked A on photo) is around 2.5m dia and up to 0.5m deep in its centre and is partly surrounded on its circumference by a line of roughly arranged larger stone blocks. The wall fragment (B) lies immediately to the N of the hollow and is around 1m long and up to 3 courses high. It is not possible to be precise about the function of these structures, but the vestiges of a hut or pen are two possibilities.

RC 17: view from SE

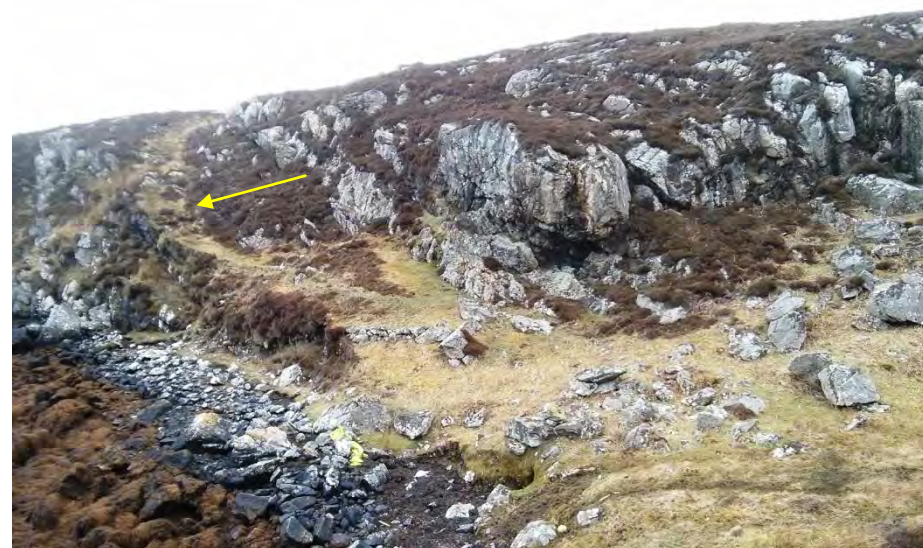
RC 18: view from S

Site name: **Rubha Chnaip**
 RFS no: **RC 18**
 NGR: NF 88430 56230 (centre)
 Site type(s): Path
 Condition: Fair

A short length of path has been constructed to bypass a low cliff which lies between the Rubha Chnaip and Buaille-mhòr communities at the head of Bàgh Rubha Chnaip. The path is around 70m long and between 1 and 2m wide and appears to have been levelled and paved in places. A number of sections of drystone revetment have been built on the steep shore side to provide support.

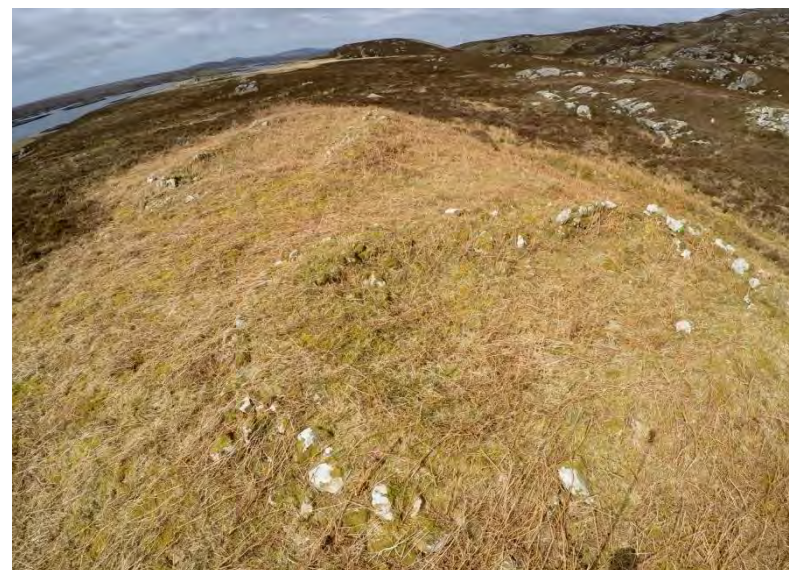
BM 1: view from S and thumbnail plan

A farmstead comprising a dwelling and a separate byre lies on a knoll 80m ENE of the inlet on the NW side of Rubha Chnaip. The dwelling measures 13.0m N - S by 4.4m transversely within low drystone walls averaging 1m thick and 0.5m high. Entrance doorways are located on both E and W facing elevations towards the N end. The byre lies 4m to the SE of the house and measures 7m NE - SW by 3.5m transversely within similarly constructed walls. It has an entrance doorway towards the NE end of the NW facing elevation. All the evidence points to this structure being one of the original early 19thC kelping crofts, but it is not possible to define its land boundaries with any certainty.
