**Ronay Field Survey
2015-18**

**David Newman
June 2018**

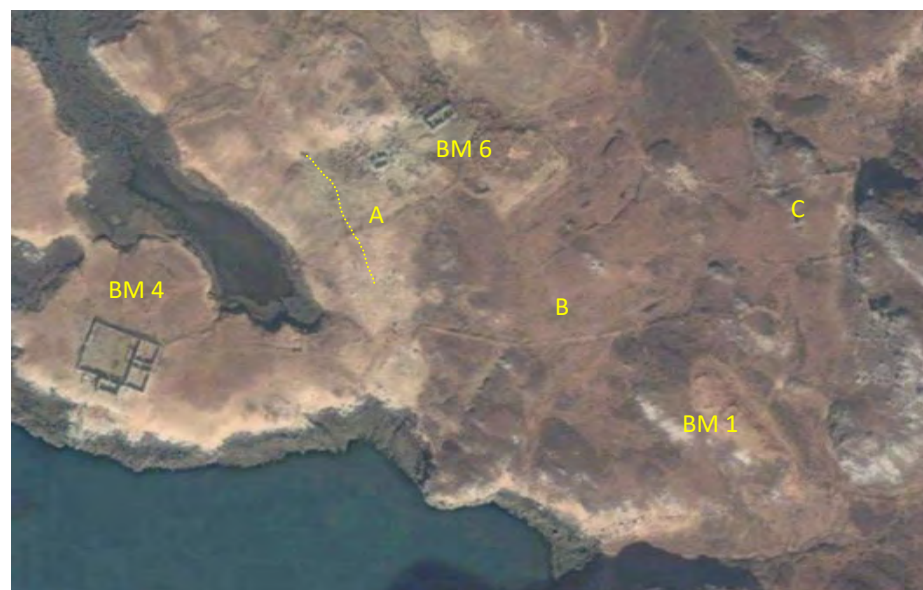
BM 2: Google Earth view (2004)

A series of dyke remains lie in the area between the two farmsteads BM 1 and BM 6 and the 19thC sheepfold BM 4. Section A (see photo) is centred at NF 88340 56360, is around 100m long and constructed in drystone and acts in part as a revetment for what appears to be a former track on its NE side. Section B is centred at NF 88440 56300, is constructed as a turf bank and is around 250m long and may have acted as a boundary between the two farmsteads. Sections C are centred at NF 88550 56340, are also constructed as turf banks, and start at a low rock outcrop. Each is around 50m long and that to the S may have connected with section B.

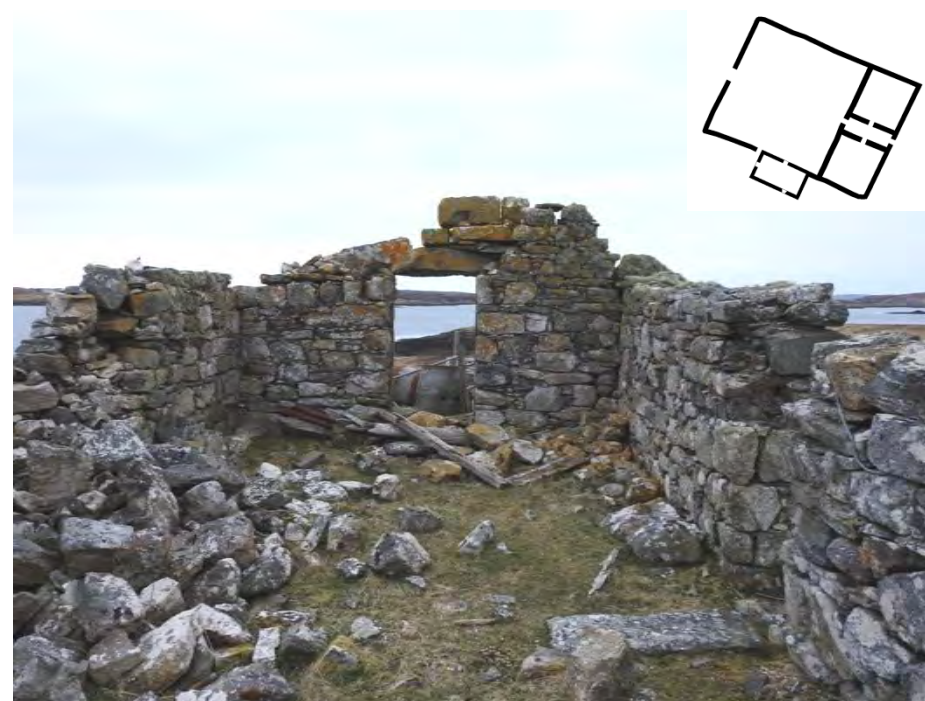
BM 4: building interior looking NW and thumbnail plan

Site name: Rubh' an Aisig
RFS no: BM 4
NGR: NF 88240 56300
Site type(s): Sheepfold, building
Condition: Good

A four compartment sheepfold and a rectangular building lie on a narrow peninsula extending out into the sound between Ronay and Grimsay named Rubh' an Aisig (Ferry Point). Most likely constructed after the island was cleared as a sheep farm around the mid 19thC, the fold measures around 30m NW - SE and 22m transversely within drystone walls up to 1.5m high and 0.8m thick. Attached to its SW side is a rectangular building measuring around 9.4m NW - SE and 4.3m transversely within well built coursed and part dressed masonry walls bound with lime mortar. Doors are located centrally in the SW and NW elevations, and the remains of a single window jamb can be seen in the part demolished SE facing elevation. The contrast in construction method and quality between the building and fold are noteworthy, suggesting different builders were probably involved.

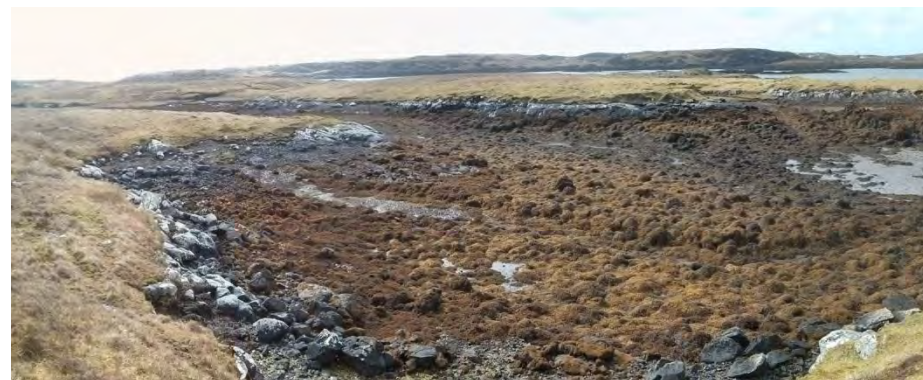
BM 7: view from N

Site name: **Buaile-mhòr**
 RFS no: **BM 7**
 NGR: NF 88245 56455
 Site type(s): Landing point
 Condition: Fair

A landing point lies on the E side of a sheltered bay protected by the peninsula Rubh' an Aisig upon which the sheepfold BM 4 is located. It comprises an area of beach cleared of larger stones, and measures around 45m SE - NW and between 2 and 7m transversely. Near the shore the cleared area has been widened to provide space for beaching boats and this is defined on its N side by a row of larger stones.

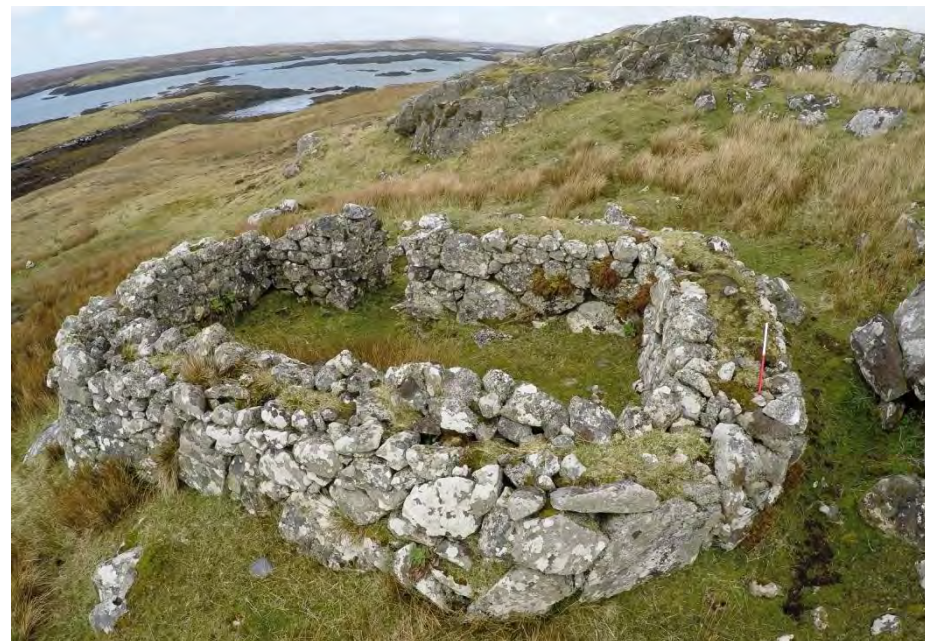
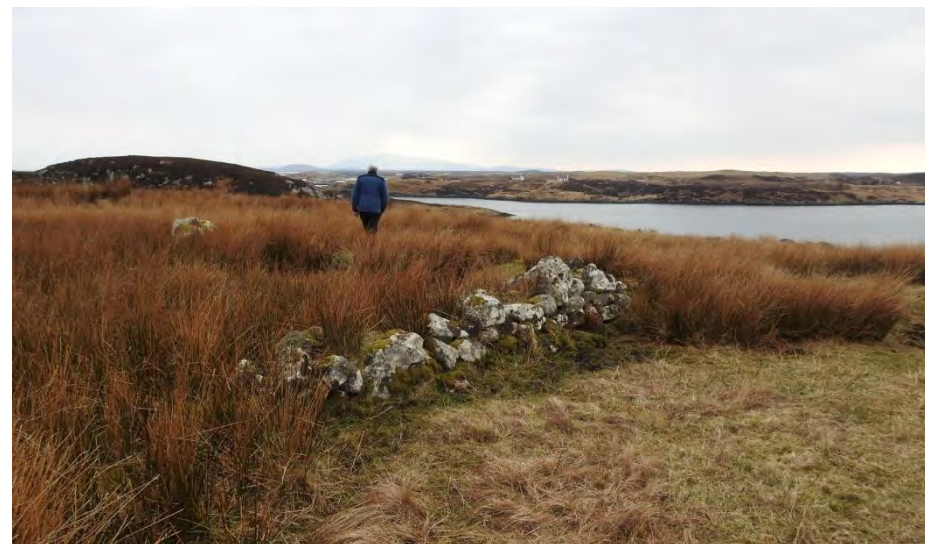
Around 15m SE of the house lies a large sub-rectangular enclosure around 1100m² in area. Slightly raised above the surrounding ground, it is enclosed mostly by a now much reduced turf bank, but there are also sections of drystone walling on its N and W sides suggesting it may have been altered or extended over time. Possible functions include a sheepfold, stack yard or garden ground, and it is possible that this is the original *Buaile-mhòr* or 'Big fold' referred to in the local place-name. However, as the name doesn't appear on any mapping until 30 years after the new fold BM 4 was built, it may relate to that later structure instead.

Evidence from both OS 6" 1st and 2nd edition mapping, and the design and construction of the main house, indicate this was built sometime between 1878 and 1901 on the site of a smaller building, which may have been one of the original early 19thC kelping crofts. Local oral history indicates the house was built for the head shepherd on Ronay, and it was occupied up until the 1950s.

BM 8 lower outbuilding: view from SE

BM 8 enclosure: NW wall remains

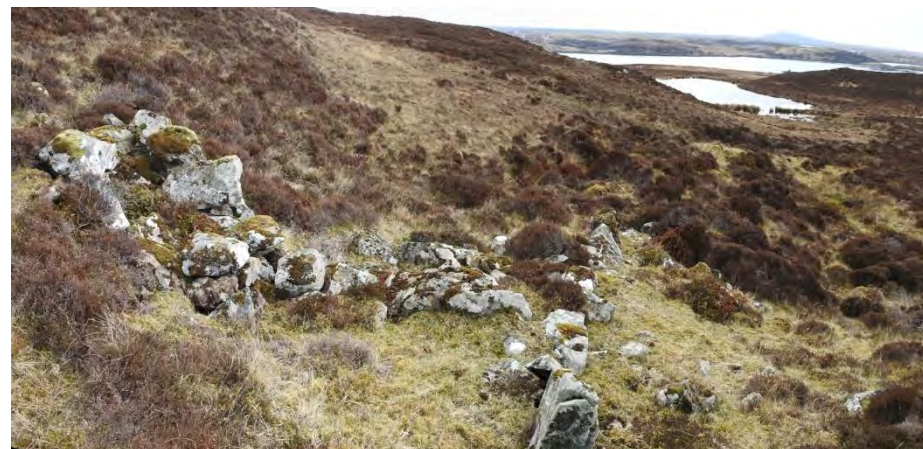
BM 9: view looking S at the junction with the E end of BM 10

Site name: **Buaile-mhòr**
 RFS no: **BM 9**
 NGR: NF 88600 56750 (centre)
 Site type(s): Head dyke
 Condition: Fair - poor

The township of Buaile-mhòr is enclosed by a head dyke which runs for a distance of some 750m in a generally S - N direction, roughly parallel with, and typically 250m inland of, the W shore of Ronay. It starts on the N shore of a small lochan lying just to the NE of the farmstead BM 8 at NF 88495 56450 and can be traced continuously as far as a point near the S shore of Bàgh nan Uamh around NF 88700 56900. It part encloses an area of land extending to some 25ha which is subdivided into 6, possibly 7 crofts. Constructed in a variety of methods and materials - drystone, stone/turf and turf bank - as well as making use of natural features, the dyke is best preserved near its junction with dyke BM10, and also towards its N end near where it is connected to a second head dyke (BM 33) enclosing land related to farmstead BM 34.

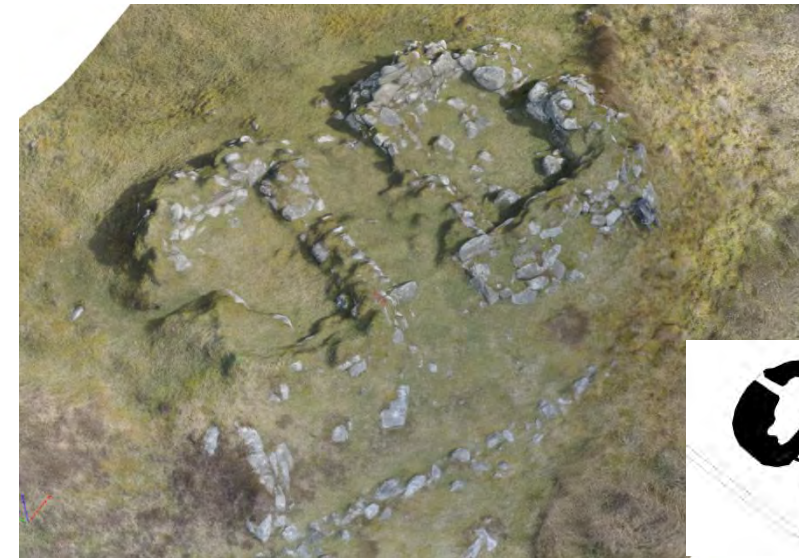
BM 12: aerial view from W and thumbnail plan

Site name: **Buaile-mhòr**
 RFS no: **BM 12**
 NGR: NF 88285 56605
 Site type(s): Building, pen(s)
 Condition: Fair

This altered building is in the centre of a group of three buildings lying on the W shore of Ronay. Rectangular in plan with notably curved and thickened gables, the original building measured 7.6m NW - SE by 3.7m transversely within drystone walls varying between 1.2m and 1.7m thick and up to 1.2m high. The position of the original entrance is not identifiable, but is likely to have been on the SW facing elevation. The building appears to have been subsequently altered for stock husbandry purposes by the insertion of two drystone cross partitions which has created 2 pens separated by a passage, each with an entrance in the original gables.

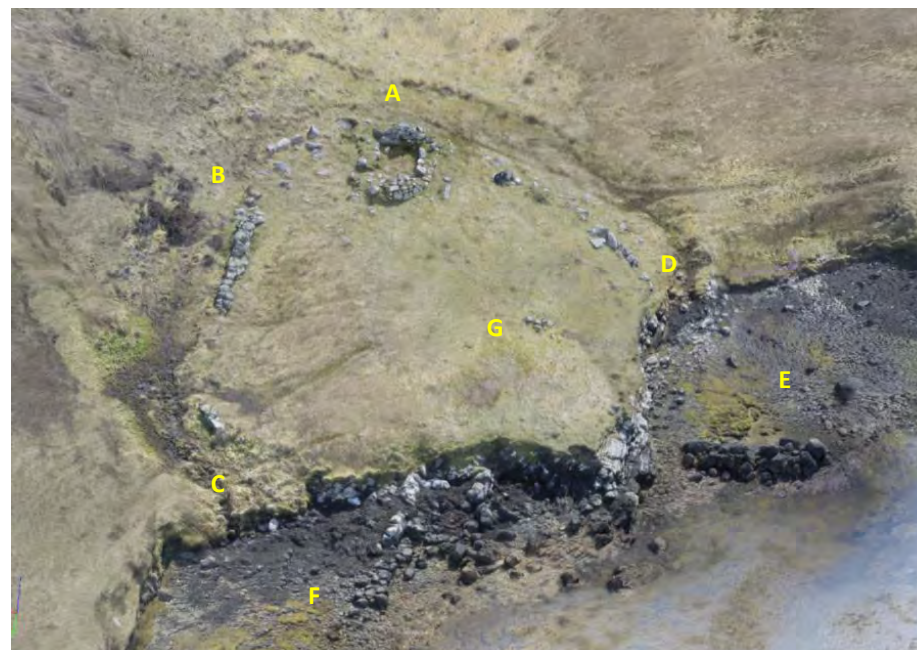
BM 13: aerial view from N

Site name: Buaille-mhòr
RFS no: BM 13
NGR: NF 88310 56630 (centre)
Site type(s): Building, enclosure, landing point(s)
Condition: Fair

The building is rectangular in plan with a distinctly curved gable to the N, and measures 3.2m N - S by 1.9m transversely within drystone walls between 0.8m and 1.1m thick and up to 1.2m high. There is a narrow entrance 0.4m wide towards the N end of the E facing elevation, and a possible second opening (a drain or vent?) opposite. The S gable is built squarely and appears to extend beyond the E and W elevation walls, and this feature, together with the remains of another wall foundation extending N beyond the N gable, suggest this building may overlie another earlier structure.

The building lies within a 350m² enclosure bounded in part by a drystone and turf wall and in part by the coast edge, although it is not possible to determine the full extent of the original enclosure because of coastal erosion. The wall is between 0.7 and 1.5m thick and is a maximum of 1m high. A ditch has been dug outside the E section and the faint remains of two outer dykes run around 2.5m outside and parallel with both E and W sections which appear to connect with dyke BM 14. A small stone heap (G), possibly a clearance cairn, lies within.

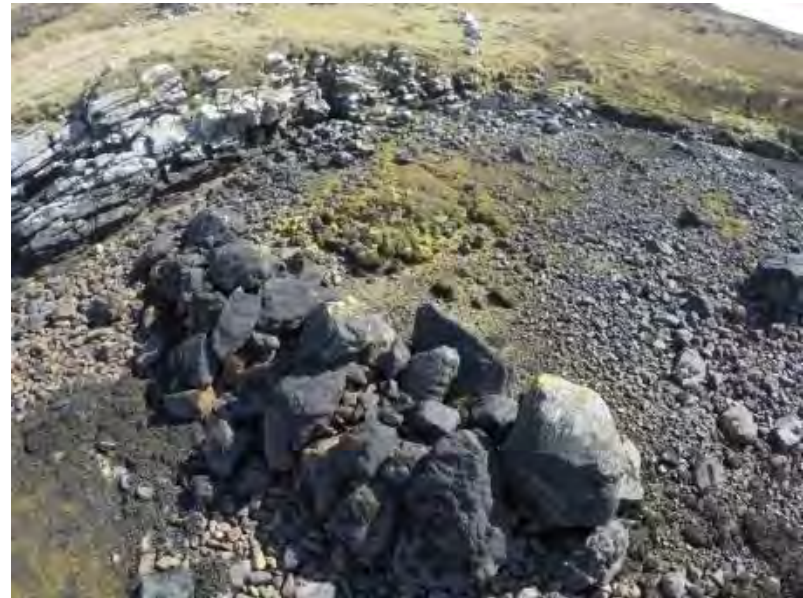
BM 13: view of W landing point from W

On the shore are the remains of two landing points. That to the W is marked by a drystone jetty or breakwater 7m long, 2m thick and up to 1m high. That to the E by the less well preserved remains of a similar structure around 8m long.

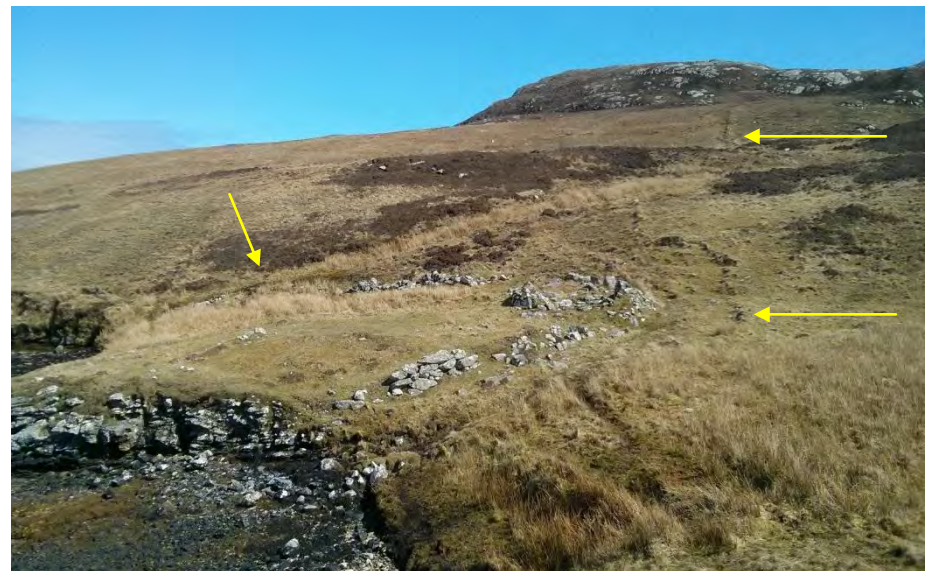
BM 13 & 14: View from W, with sections of BM 14 highlighted

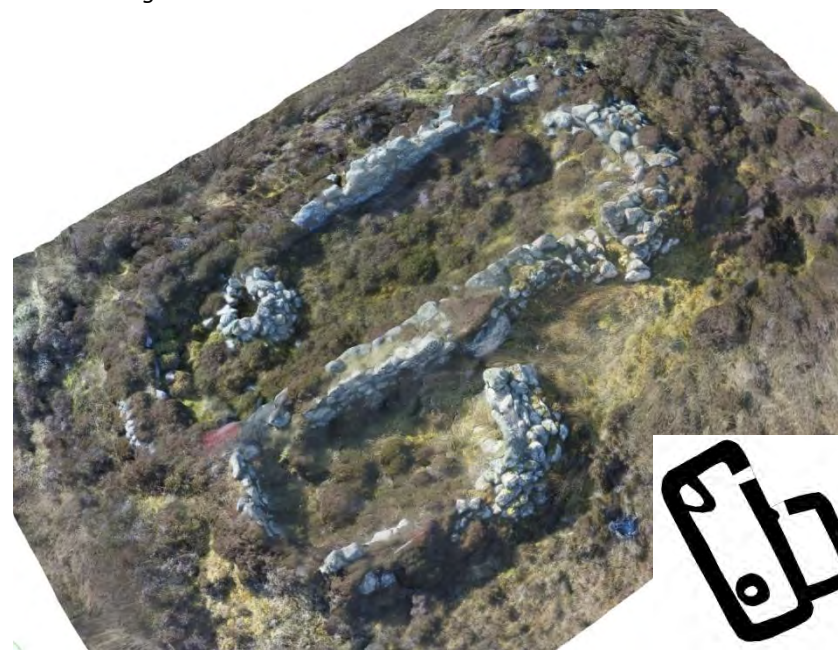
BM 16: aerial view from SE and thumbnail plan

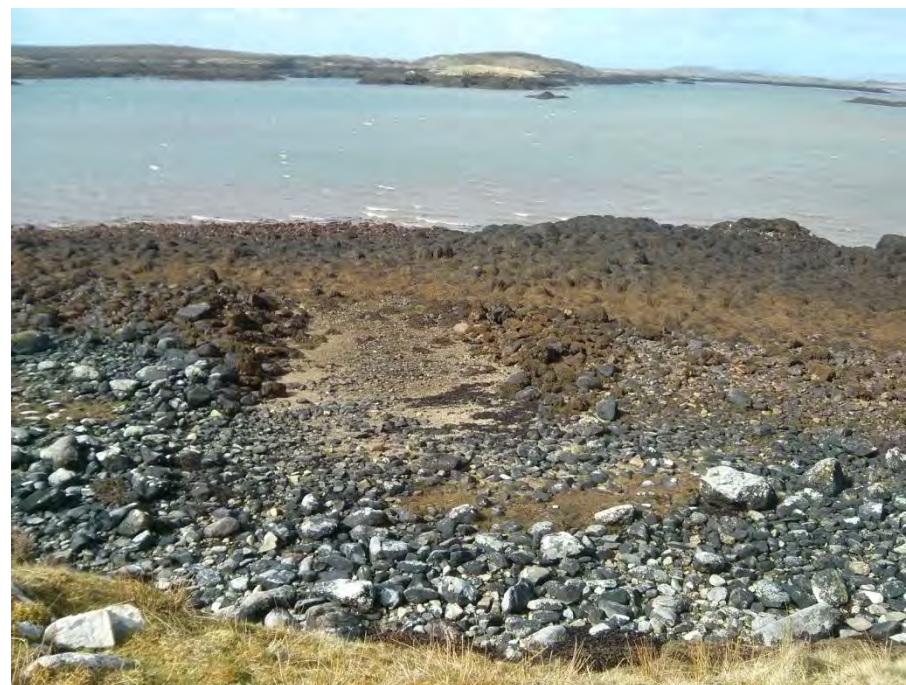
BM 17: view from E

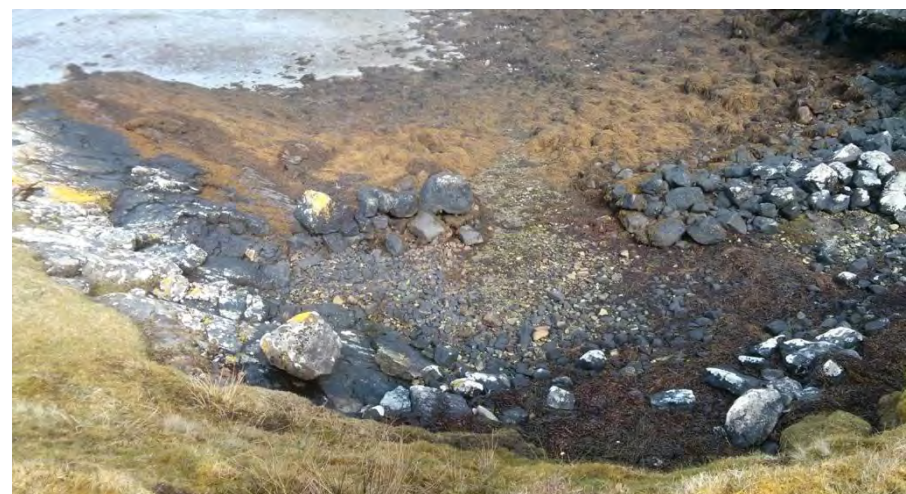
A landing point lies within a small N facing inlet on the W shore of Ronay some 130m NW of the farmstead BM 16. The head of the inlet measures around 13m E - W and 8m transversely and has been cleared of larger stones and boulders. On its seaward side two roughly assembled drystone breakwaters have been constructed separated by a narrow entrance around 2m wide. Between the entrance and the LWM, an area of beach of the same width has also been cleared of stones to give safe access. The E breakwater may also represent the W termination of dyke BM 19.

BM 18: view from S

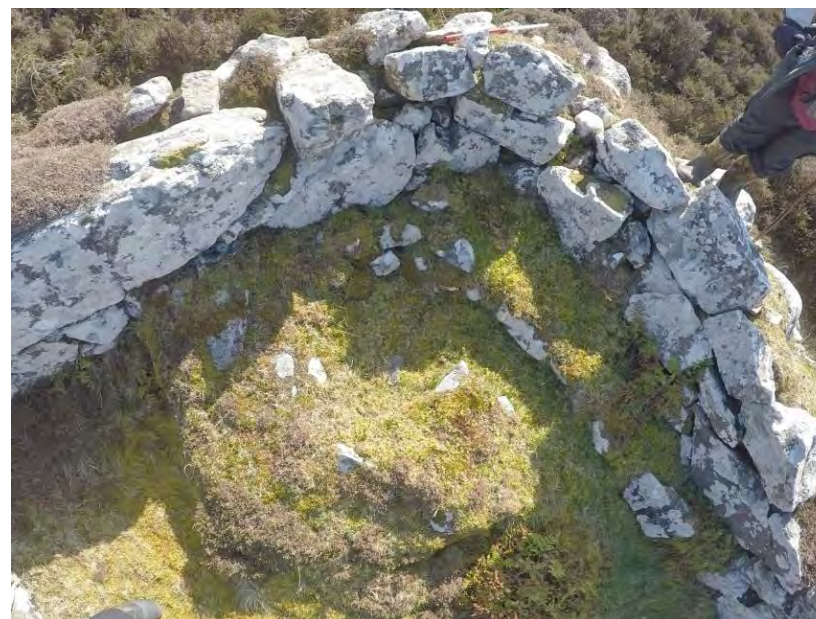
A farmstead comprising a dwelling house with an attached byre, and a kiln barn is located some 125m E of the W shore of Ronay at an altitude of +25m AOD. The dwelling measures 12.2m W - E X 4m transversely within drystone walls typically 1.4m thick and up to 1.5m high. There are two entrances slightly W of centre on each on the N and S facing elevations, and a small niche centrally located on the inside of the N wall. A byre is attached to the E end of the same wall and measures 4m W - E X 3m transversely within similarly constructed walls and has an entrance at the S end of the W facing elevation. The kiln barn is located 4.5m NE of the house and byre and measures 5m NW - SE by 3.3m transversely within similar walls and there is an entrance towards the NW end of the SW elevation. A corn drying kiln has been constructed in its SW corner and a pen in the NW. Lying within an enclosed area of land extending to around 4Ha this is likely to be one of the original 26 crofts established on Ronay in the early 19thC.

BM 20: view of corn drying kiln in kiln barn

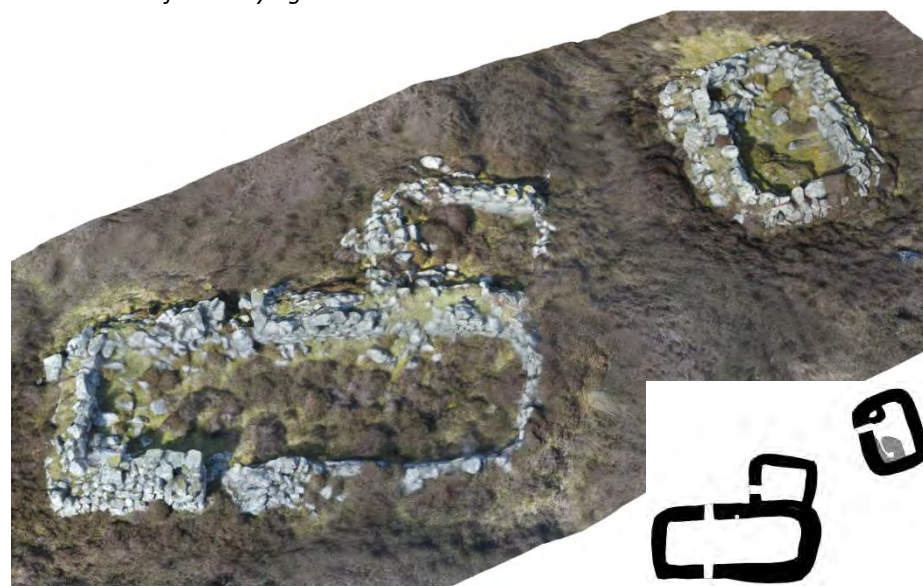
BM 20: aerial view from S and thumbnail plan

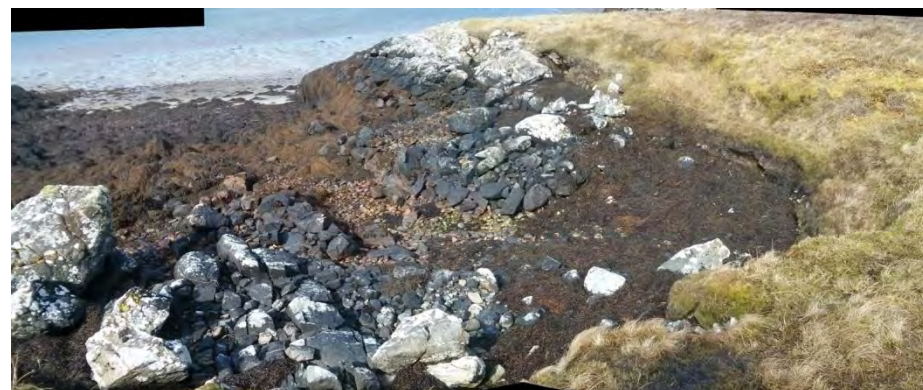
A landing point lies within a small W facing inlet on the W shore of Ronay some 150m WSW of the farmstead BM 25. The head of the inlet measures around 10m NE - SW and 5m transversely and has been cleared of larger stones and boulders. On its seaward side two roughly assembled drystone breakwaters have been constructed separated by a narrow entrance around 1.5m wide. Between the entrance and the LWM, an area of beach of a similar width has also been cleared of stones to give safe access.

BM 23: view from S

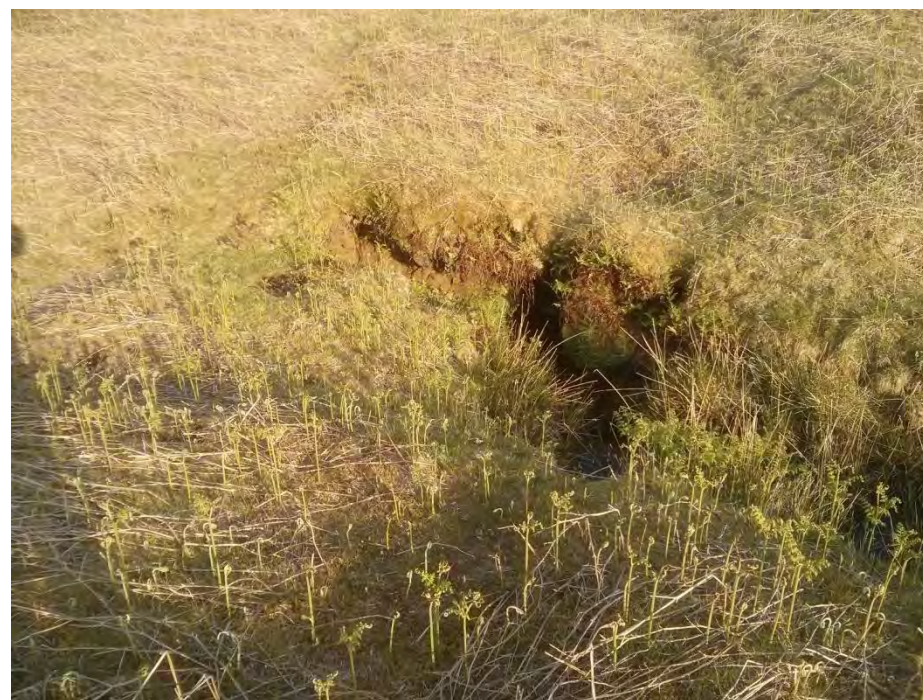
The source of a small burn lies in a depression in a natural valley surrounded by an area of former cultivation and within 125m of three farmsteads. In the absence of any other fresh water supply in the vicinity, there is a good possibility this acted as a well for this community.

BM 24 view from NW

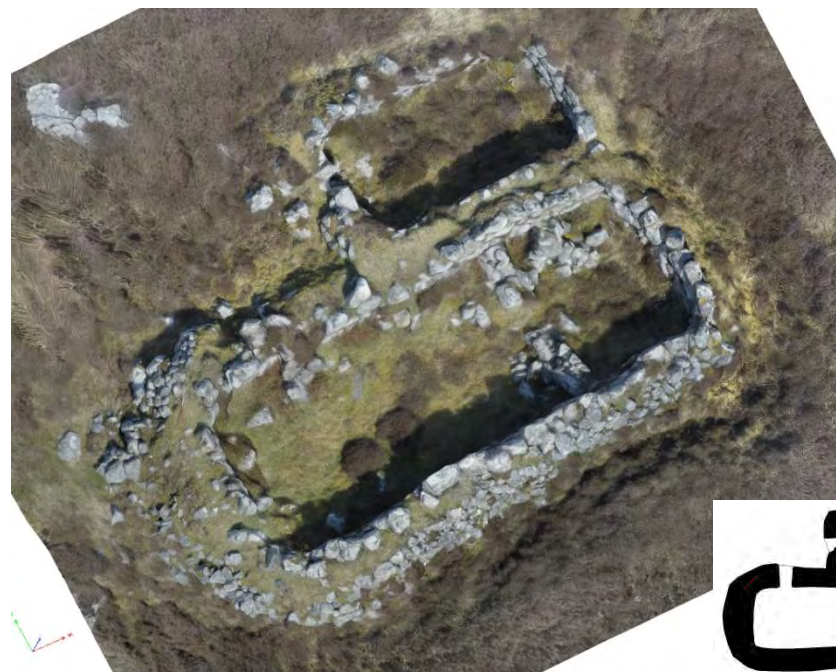
BM 25: aerial view from SW and thumbnail plan

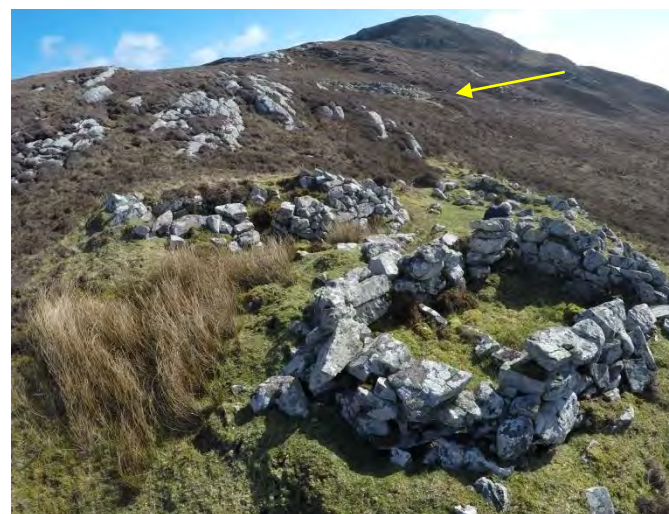
A farmstead comprising a dwelling house with an attached byre, located 25m NW of the almost identical building BM 25, has been significantly altered post-abandonment for stock rearing purposes. The dwelling measures 10.9m NNE - SSW by 3.8m transversely within much reduced drystone walls averaging 1.5m thick and up to 0.5m high. The original entrance is located near the S end of the W facing elevation. The S gable is less curved and less thick than the N and may have been rebuilt. Outside the building's SW corner the line of a supporting stone revetment can be seen. The byre is attached to the N end of the W facing elevation and

BM 26: view from NW with BM 25 in distance (highlighted)

measures 3.7m N - S by 2m transversely within re-constructed drystone walls that stand to 1.3m high. The original entrance would probably have been located in the S facing wall, but has been replaced by one located in the original house wall to the E. A single line of stones running W -E just N of centre marks the line of a former dividing partition.

A similarly sized and constructed drystone structure has been built within the NE corner of the original dwelling, making use of the original walls on the E and N sides. There is an entrance located centrally in the W facing wall. It isn't clear if either of these later structures were roofed and acted as byres, or even possibly huts, or whether they were open sheepfolds or pens.

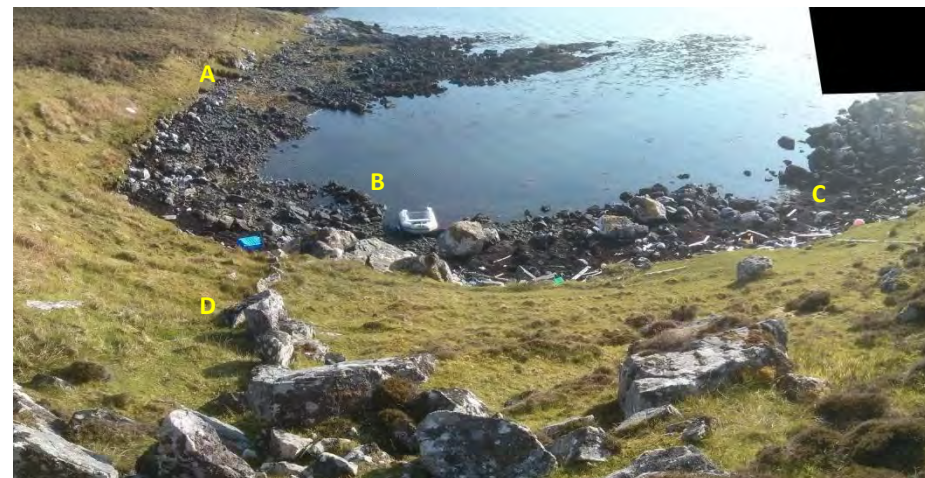
Three landing points lie within a W facing bay at the S end of Rubha an t-Sagairt some 75m NW of the farmstead BM 26. They are located at NF 88455 57090 (A), NF 88465 57105 (B) and NF 88455 57120 (C) respectively, and each comprises an area of beach typically around 40-50m² which has been cleared of larger stones and boulders, lines of which part define the sides of the cleared areas. Each also connects into a common channel running down to the LWM which gives clear passage to open water.

BM 28: view from N

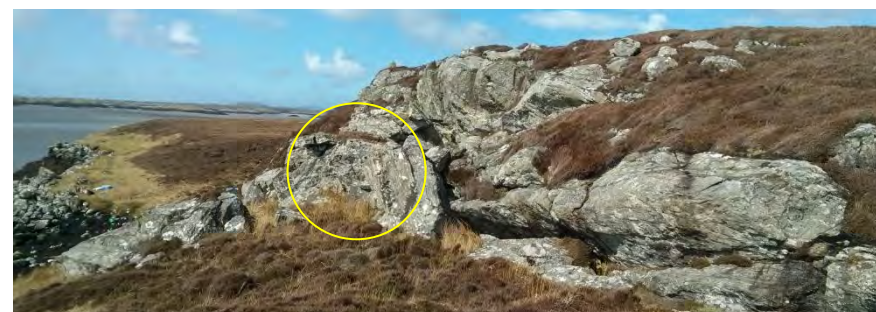
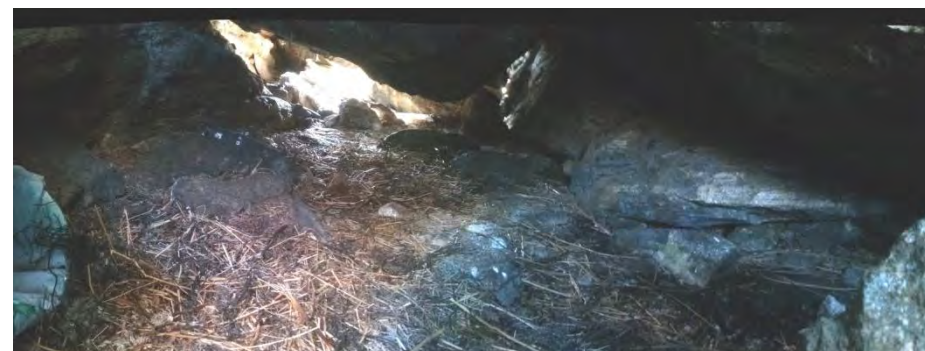
A natural cavity in an area of rock fall on the SW side of Rubha an t-Sagairt may have been used as a rock shelter. Mollusc shells lie on the floor within and there is evidence of stone packing of inter-boulder spaces. From a point near its entrance a line of natural rock fall extends SW towards the HWM for a distance of around 5m and this has been extended by a further 10m with a line of planted larger stones which may represent the core of a former dyke. (See D in photo above right).

BM 29: view from SE

BM 29: interior view

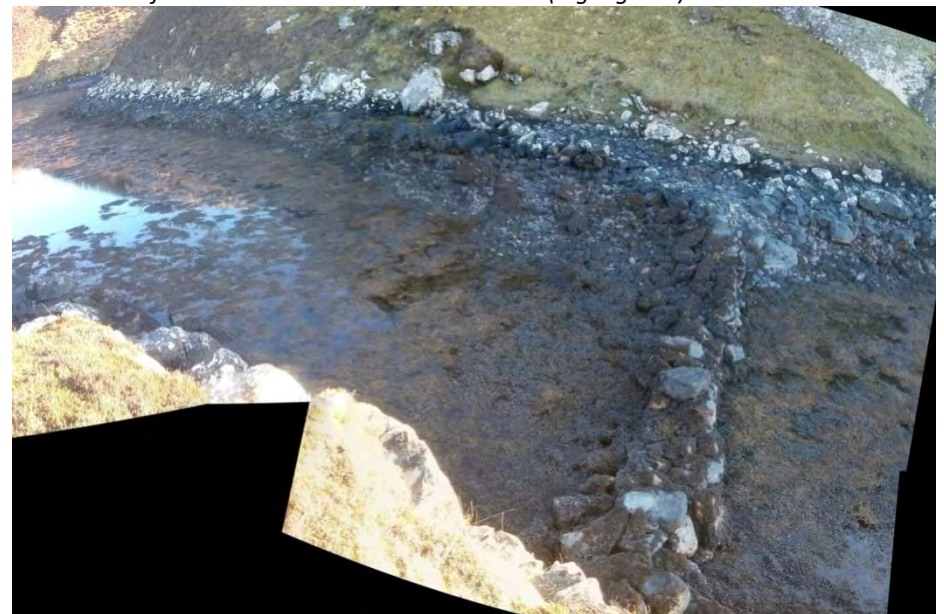
A well constructed drystone wall connects a small island to the S shore of Bàgh nan Uamh. 1m thick and up to 1.2m high the wall runs in a straight line NE - SW for a distance of 10m before curving in a SE direction for a further 10m along the shore at or near the HWM. Its purpose is not certain, but two possibilities are that either it is a breakwater to shelter the landing place to the SE (BM 32), or, it represents the end of an incomplete boundary dyke separating the crofts relating to farmsteads BM 25 and 26 and BM 34.

BM 31: view from NE

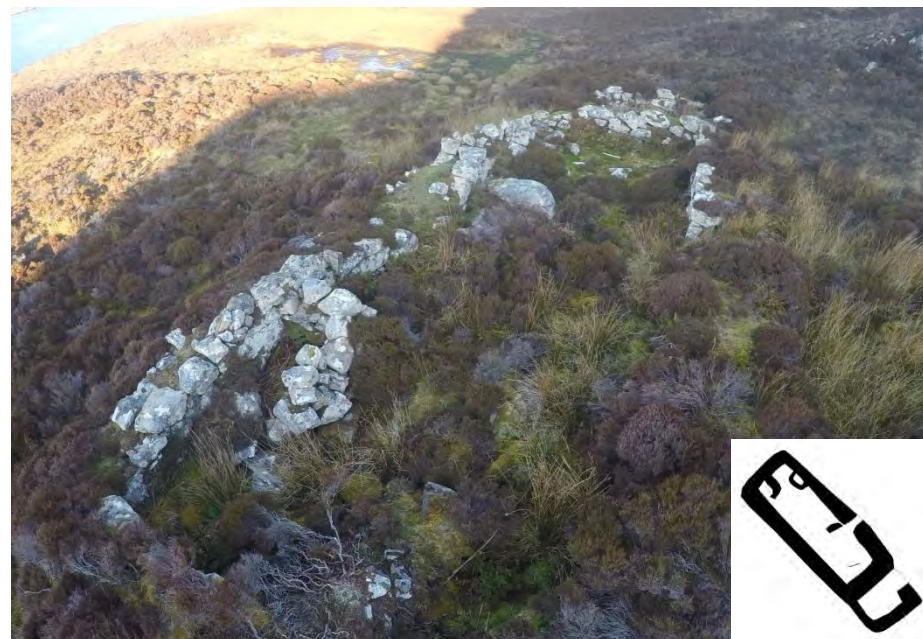
A farmstead comprising a dwelling house with an attached byre is located some 150m SW of the S shore of Bàgh nan Uamh at an altitude of +27m AOD. The dwelling measures 12.3m NW - SE by 3.6m transversely within relatively squarely built drystone walls between 1 and 1.3m thick and up to 1.6m high. There is an entrance door located near the SE end of the NE facing elevation. Two small drystone walled pens at the NW end are likely to be post-abandonment adaptations for stock rearing purposes, and a large slab, possibly a former lintol, lies just inside the entrance. The byre is attached to the SE gable and measures 2.8m NW - SE by 3.5m transversely within similarly constructed walls and has an entrance located at the NW end of the NE facing elevation. The possible remains of a turf walled enclosure lie 15m to the SE. Although this is likely to be one of the original 26 crofts established on Ronay in the early 19thC, its isolation and different layout and construction compared to other farmsteads in this area of Ronay are noteworthy.

BM 34: view from NW with thumbnail plan

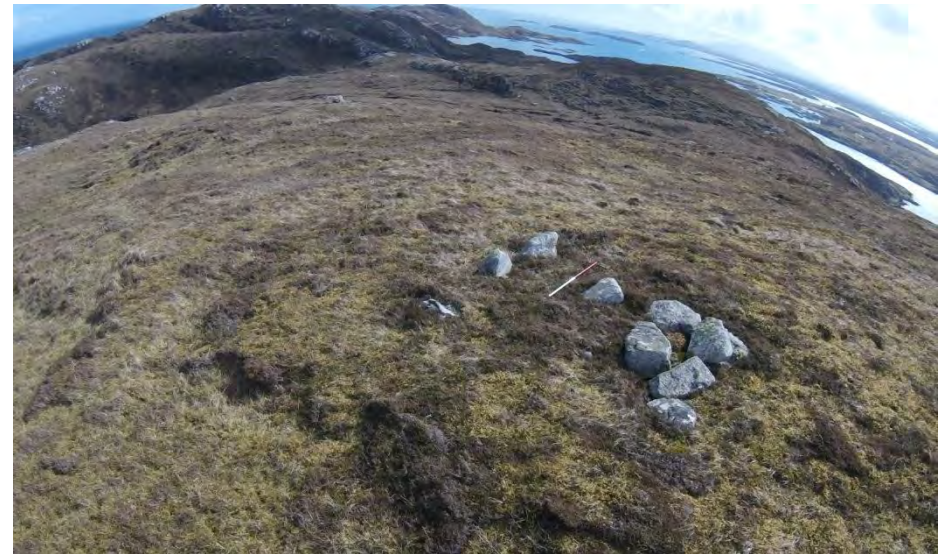
The outline of a rectangular structure lies on the summit of Beinn an t-Sagairt. Measuring around 3.5m NW - SE and 2.5m transversely, the interior is part delineated with single stones and is outlined by a slightly raised area of turf, but it is not possible to determine if this might be the remains of turf walls. Given its elevated position it is possible this is the site of a beacon, perhaps one commemorating VE Day in 1944 when it is known from local oral tradition that many beacons were lit on North Uist.

BM 36: view from N

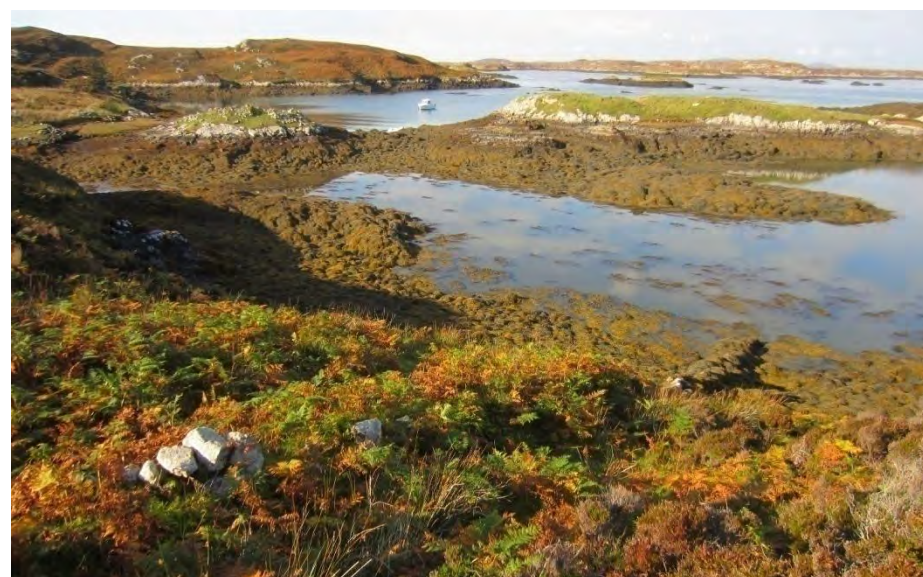
The township of Ronay Beag is enclosed by a head dyke which can be traced for a distance of some 700m in a generally SE - NW direction between a point 100m inland from the N shore of Bàgh nan Uamh at NF 89760 57050 to the N coastline of Ronay Beag at NF 89325 57460. It part encloses an area of land extending to some 23ha which is subdivided into 3, possibly 4 crofts. Constructed in a variety of methods and materials - drystone, stone/turf and turf bank - as well as making use of natural features, the dyke is best preserved towards its NW end near where it changes to drystone construction as it crosses the HWM and heads down to the LWM. It isn't possible to identify the route of the 100m or so section which connected it to the Bàgh nan Uamh shore, and this may never have been completed.

RB 2: NW termination view from E with RB 21 in background

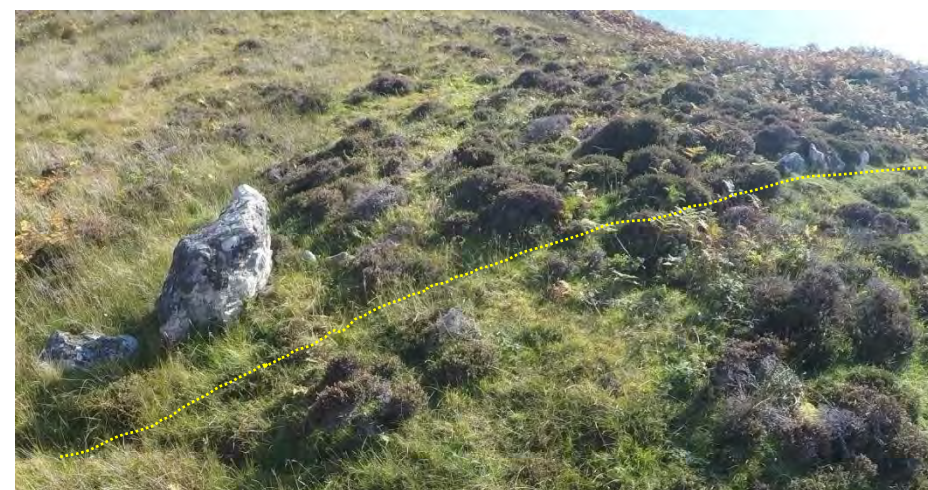
A rectangular enclosure lies a few m SE of the farmstead RB 5. Measuring 26m SW - NE by 22m transversely within walls constructed of a combination of drystone and turf there is no identifiable entrance, although this may have been adjacent to a single orthostat near the centre point of its NW side. The SE side continues in a SW direction as a turf bank to the line of the HWM and seems to have functioned as a further sub-division of in-bye land.

RB 4: view of NW side from N with orthostat in foreground

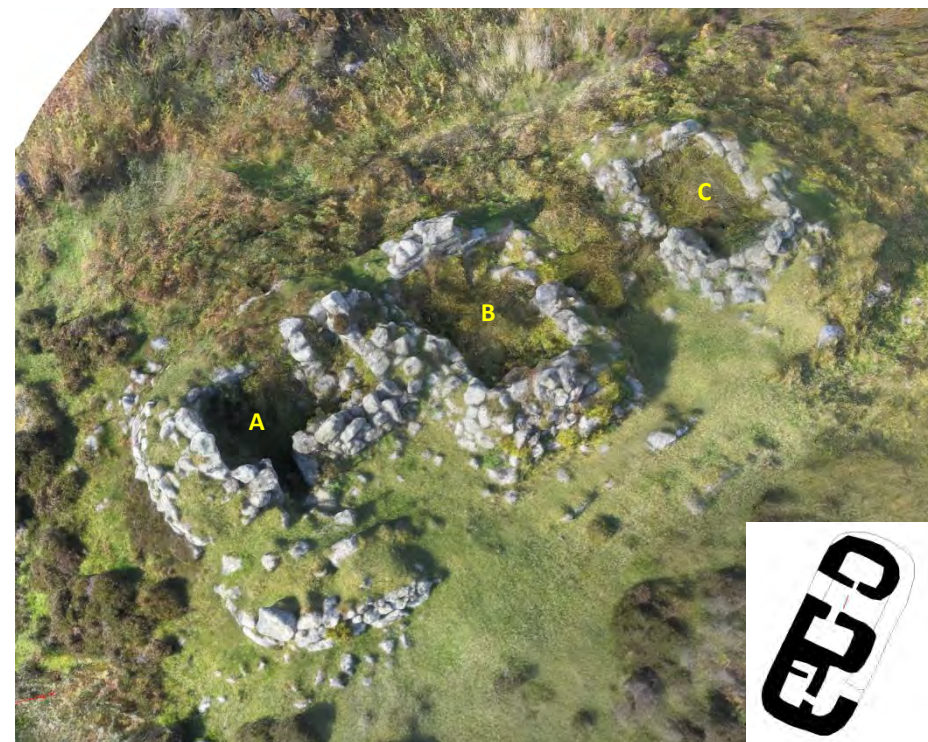
A farmstead, comprising a dwelling house with a detached byre (see RB 6), and an enclosure (see RB 4), is located 20m NE of the N shore of Bàgh nan Uamh, and has been significantly altered post-abandonment, probably for stock rearing purposes. The original dwelling measures 12.2m NNE - SSW by 4.4m transversely within drystone walls averaging 1.4m thick and up to 1.5m high, although almost reduced to ground level along parts of the SE facing elevation. The original entrance was probably located near the SW end of the SE facing elevation. The original interior has been completely remodelled to form three separate rectangular drystone walled structures which were probably either huts or pens (A, B and C). Structure A is inserted into the SW corner of the original house and measures 3.3m NNE - SSW by 1.8m internally. A narrow entrance is located on its SE facing wall and the interior is divided by a drystone partition. B is located centrally within the original house, has internal dimensions of 3.4m by 2m, and has an entrance in its NE facing wall. C occupies the NE gable end and is of similar dimensions to B with an entrance in its SW facing wall. Lying within an enclosed area of land extending to around 5ha the original house is likely to be one of the original 26 crofts established on Ronay in the early 19thC. The re-modelling is most likely related to the change of Ronay's use to a sheep farm in the mid 19thC when this former farmstead may have been set up as a base for stock rearing operations at the N end of the island.

RB 5: aerial view from SE and thumbnail plan

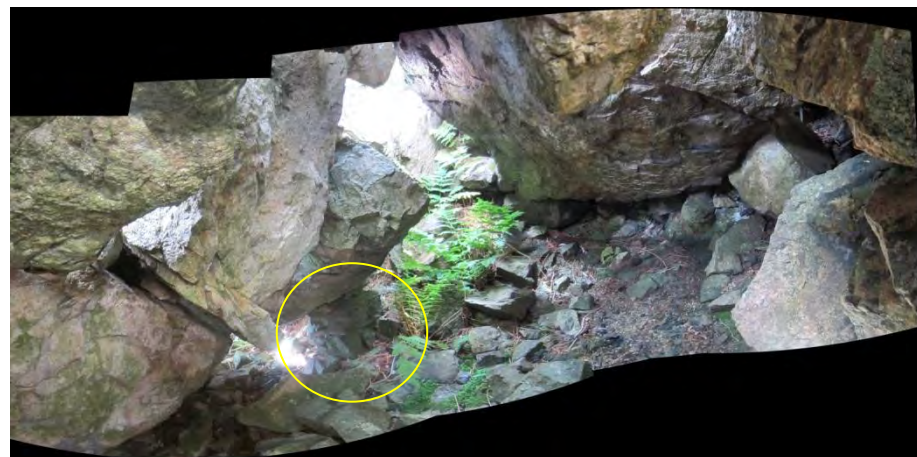
Two rock shelters lie in an area of rock fall and scree at the base of a cliff 40m NE of the farmstead BM 5 (see plan on page 125). RB 7A is accessed through a vertical chimney (outlined in red) which leads down to a naturally formed, irregularly shaped cavity roofed over by several large boulders, one of which is supported by a drystone pier (highlighted). The cavity floor measures around 6m by 2m at its greatest extents and the space within up to 1.2m high. RB 7B lies under a single stone slab which is over 6m long and a small cavity under its E facing side acts as an entrance (also outlined in red). This cavity floor measures around 2.5m by 1.5m at its greatest extents and the space within up to 1.2m high. The floors of both structures contain a scattering of mollusc shells and a number of inter-boulder spaces have been blocked up with stones and small sections of drystone wall. The remains of a number of other structures lie within the rock fall and scree. Between RB 7A and the SE gable of RB 6 is a space around 1.5m across and this is backed by a curved section of drystone wall (C) which appears to extend under both RB 6 and RB 7A. This may be the remains of an earlier building which has been destroyed by a rock fall from the cliff above. Further SW is an extensive area of scree (D) amongst which are a number of features which could be the remains of man-made interventions, but it is not possible to identify their complete form or purpose. There is a good possibility

RB 7A: interior view looking SW with the drystone support pier highlighted

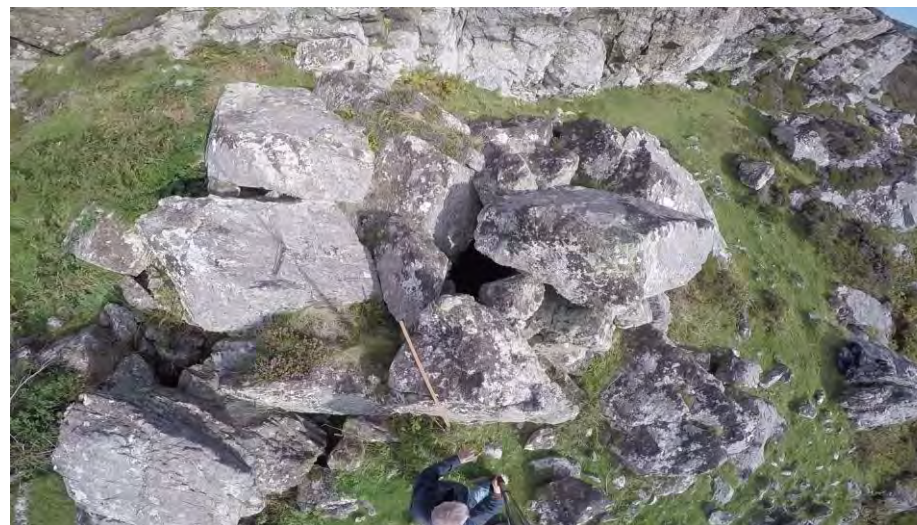
RB 7A: aerial view looking down into entrance chimney

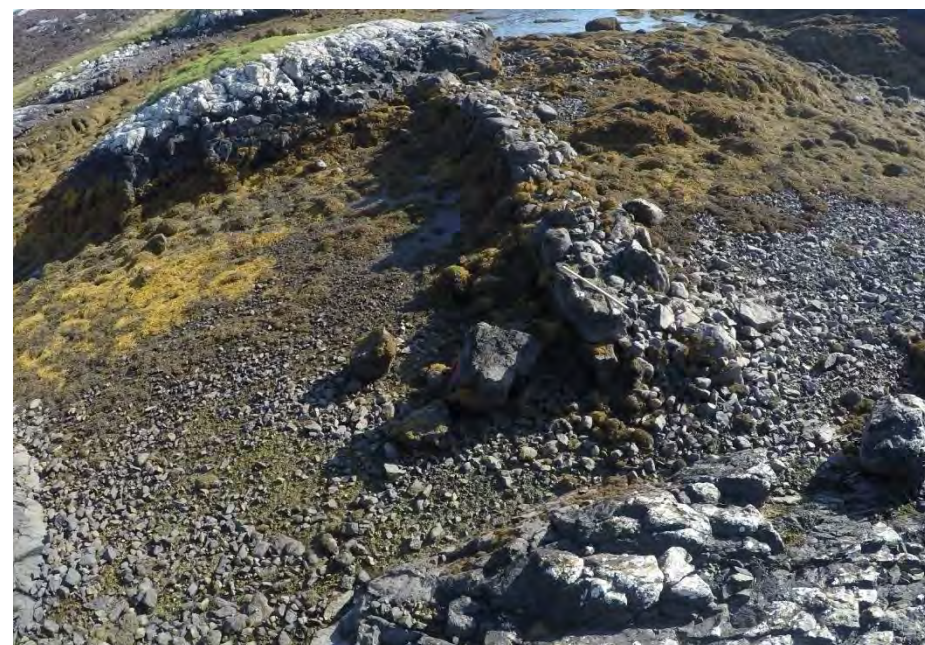
RB 9: view from NW

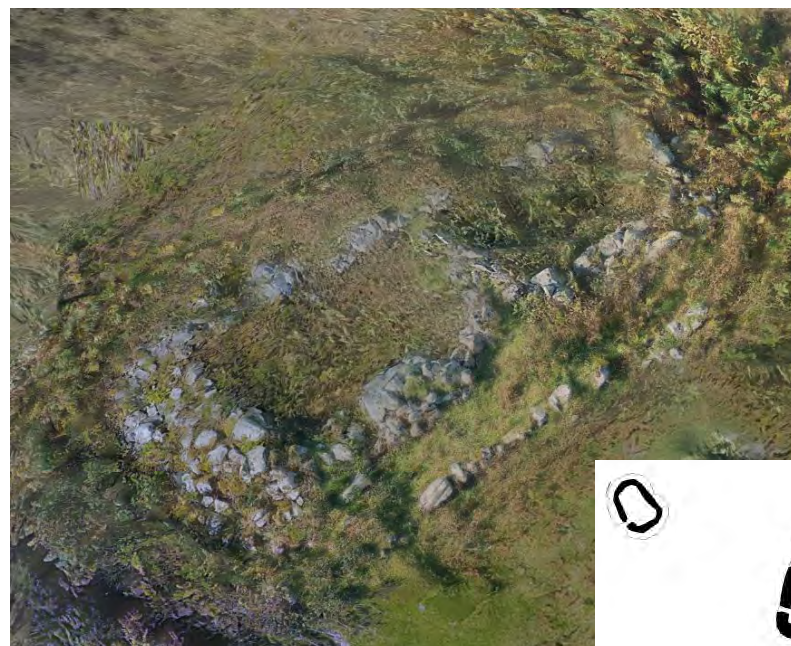
A farmstead, comprising a dwelling house with a detached byre, and an enclosure, is located 25m NW of an inlet on the N shore of Bàgh nan Uamh. The original dwelling measures 8m NNE - SSW by 2.4m transversely within roughly constructed drystone walls averaging 1.1m thick and up to 0.8m high. The original entrance was probably located near the S end of the E facing elevation, 1m outside which runs a low stone revetment supporting what is probably a narrow path. The original interior has been subsequently divided by a drystone partition near its midpoint to form two separate rectangular spaces, which were probably either byres or pens, each with an entrance on the W facing elevation. 3m E of the dwelling are the remains of a second small drystone walled structure measuring around 3m ENE by 2.7m transversely internally. This has no identifiable entrance and a small lamb pen has been built within its NE corner. The walls are so poorly constructed that it may never have been roofed and therefore functioned as a pen rather than a byre. 12m NW of the dwelling lies a third rectangular structure. This measures around 3.8m NW - SE by 2.3m transversely within turf walls lined within with a leaf of drystone rubble. These are up to 1.5m thick at their base and 0.6m high. There is no clear entrance although this may be represented by a gap in the stonework near the SE end of the SW facing elevation. As with the previous structure this may never have been roofed so it is not possible to be certain whether this functioned as a byre or small enclosure or pen. Lying within an enclosed area of land extending to around 7ha the original buildings may be the farmstead for one of the original 26 crofts established on Ronay in the early 19thC, but their relatively small size and rough construction hint at a slightly different history to the two others nearby. The interior re-modelling is most likely related to the change of Ronay's use to a sheep farm in the mid 19thC.

RB 10: view of dwelling from SE and thumbnail plan

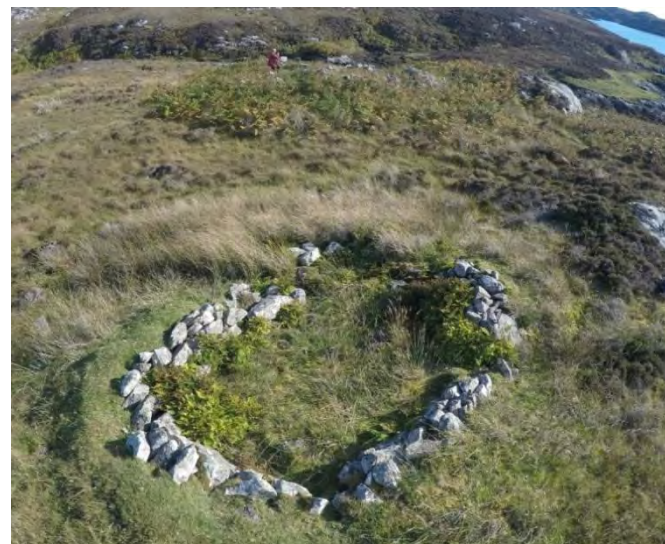
RB 10: view from NW with possible enclosure in foreground
