**Ronay Field Survey
2015-18**

**David Newman
June 2018**

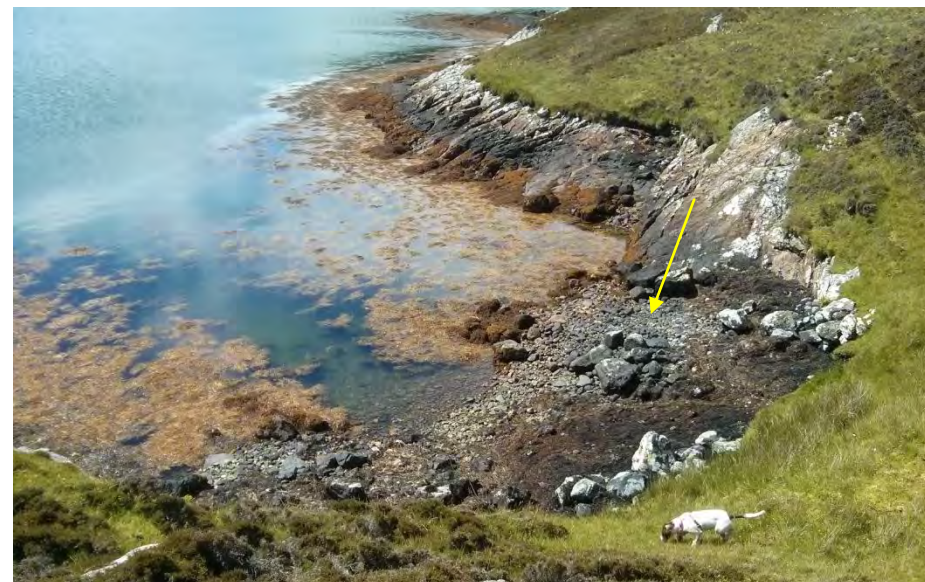
RB 11: view of S termination from NE

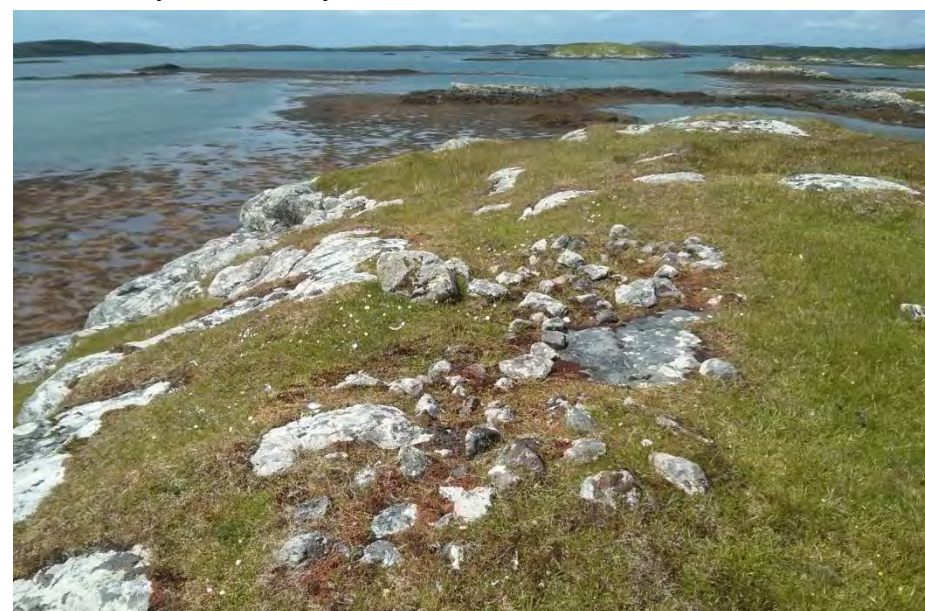
Along this coastline, often located a few metres inland from the shore or on tidal islands, are a number of stone piles of which that illustrated is a typical example. Although their exact purpose is unclear, in this kind of location and away from areas of cultivation, they are most likely to be related to kelp processing. The eight individual site locations recorded in this area are at - a): NF 89005 57250 b) NF 88925 57280 c) NF 88935 57290 d): NF 88875 57365 e): NF 88900 57440 f): NF 88870 57475 g): NF 88905 57615 h): NF 88865 57670.

RB 12b: view from E

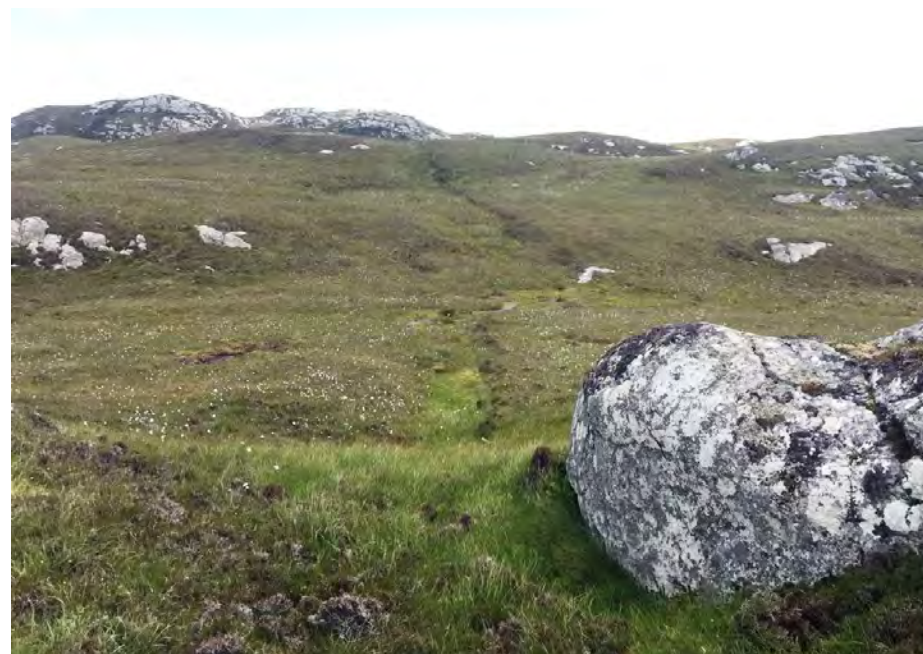
RB 13: view looking E at NF 89000 57390

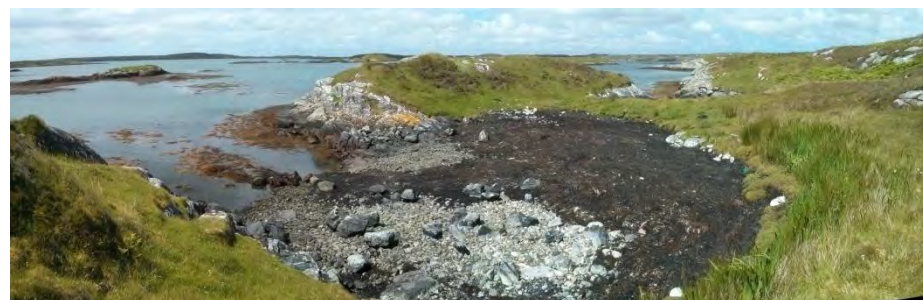
A landing point lies within a small W facing inlet on the W shore of Rubha nan Brisgein. An area of beach which runs between the HWM and LWM and is around 25m long and between 2 and 5m wide, has been cleared of larger stones and boulders. On its S side are the faint remains of what was possibly a roughly assembled drystone breakwater. Some distance from any settlement it is most likely this is related to kelp collection and processing.

RB 14: view looking W

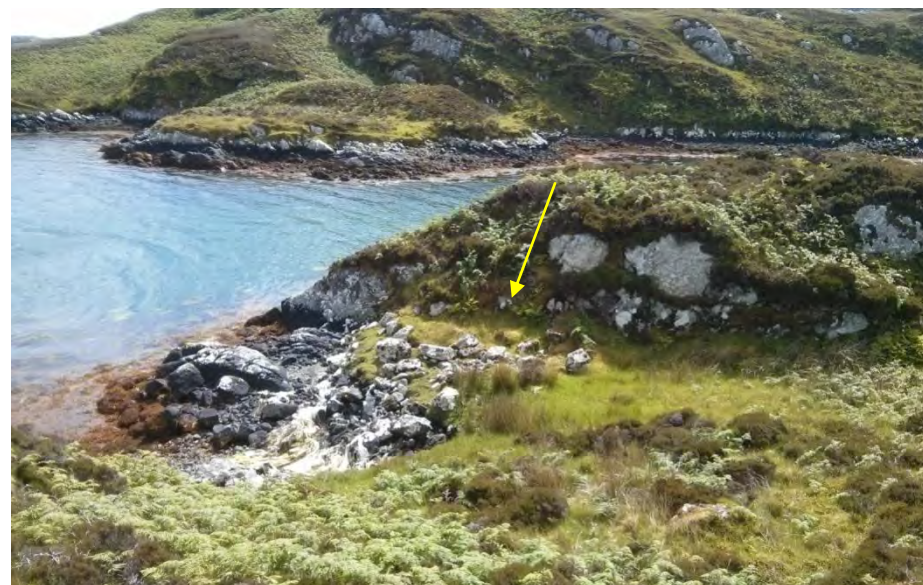
A rectangular pen or hut has been constructed against a low cliff close to the HWM on the shore of Bàgh Sealg on the E coast of Rubha nam Brisgein. The structure measures around 5.5m E - W by 3.5m transversely within a single line of small boulders. It lies within an area of better quality land, possibly cultivated in the past and, with the jetty RB 16 and dykes RB 13 and 18, it may be related to this use.

RB 15: view from NW

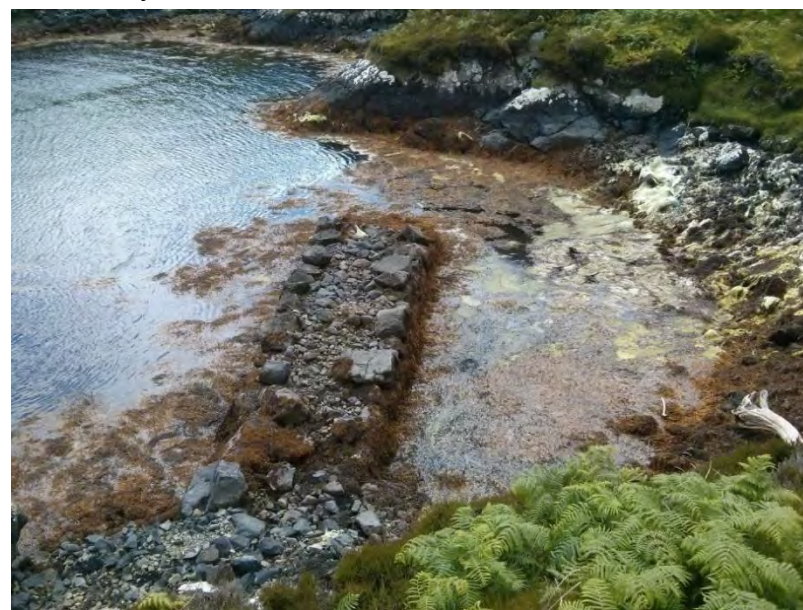
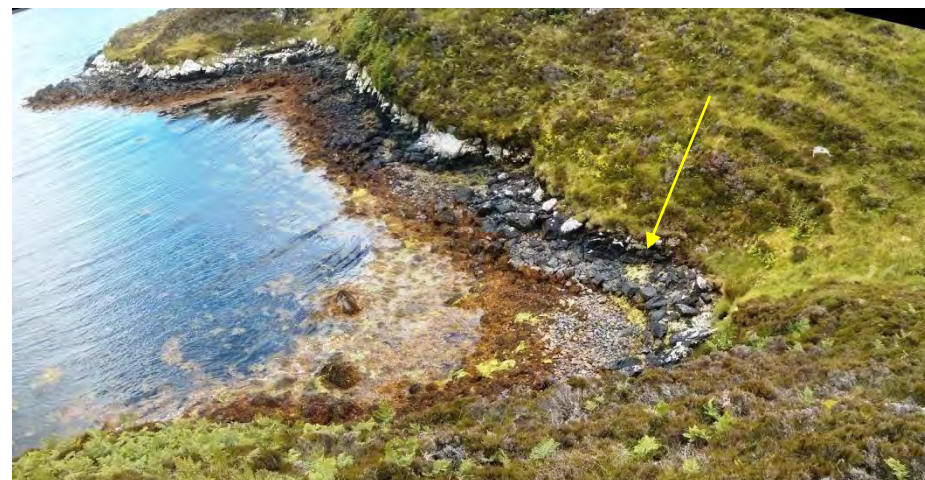
A jetty lies on the shore of Bàgh Sealg on the SE coast of Rubha nam Brisgein. Well constructed in drystone it measures around 10m N - S and 2m transversely and is between 0.7 and 1.5m high. Its good condition and form of construction suggest it may be of a later date than other structures in this area.

RB 16: view from N

RB 16: view from W

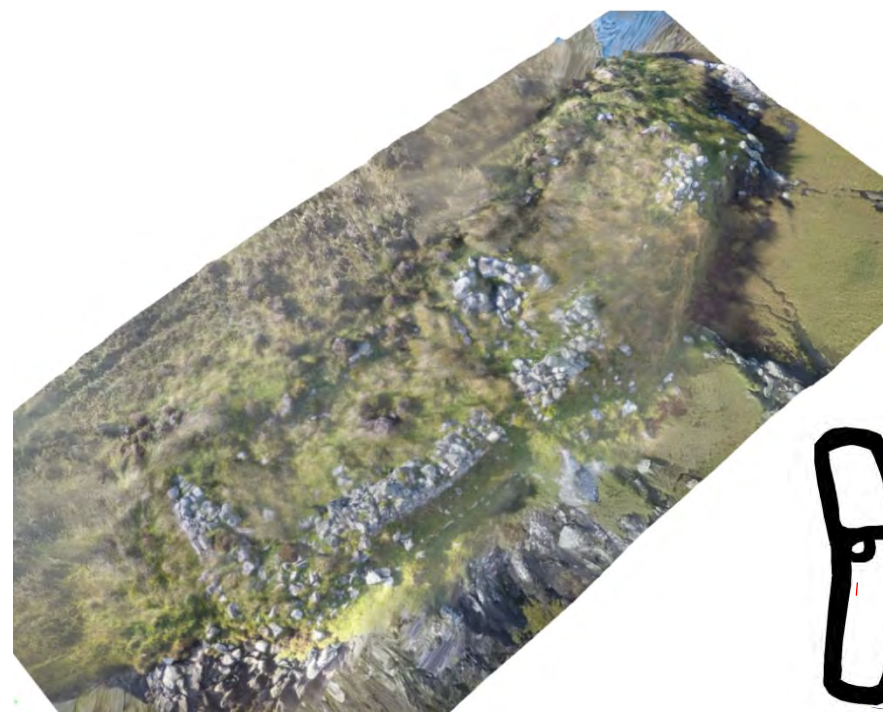
A farmstead, comprising a dwelling house with an attached byre or enclosure, is located right on the shore of a small bay on the E side of Rubha nam Brisgein named Bàgh Sealg. The dwelling measures 13.6m N - S by 4.1m transversely within roughly constructed and now quite dilapidated drystone walls averaging 1.7m thick and up to 0.8m high. The entrance is located towards the N end of the E facing elevation, 1m outside of which runs a low stone revetment supporting what is probably a narrow path. A drainage ditch has been dug around the outside of the S and W elevations. The ruined remains of a small pen lie in the NW corner of the interior. Attached to the N gable is a second rectangular drystone walled structure, aligned slightly differently to run parallel with the adjoining HWM. It is not possible to determine whether this was a roofed byre or an open enclosure of some kind. This measures 7.6m NNE - SSE within similarly constructed walls, although a good part of the E facing wall appears to have collapsed following coastal erosion. Lying within an enclosed area of land extending to around 5.5ha the original house may be one of the original 26 crofts established on Ronay in the early 19thC, but its unusual layout and rough construction hints at the possibility of a slightly different history to others on the island.

RB 19: aerial view from the SE and thumbnail plan

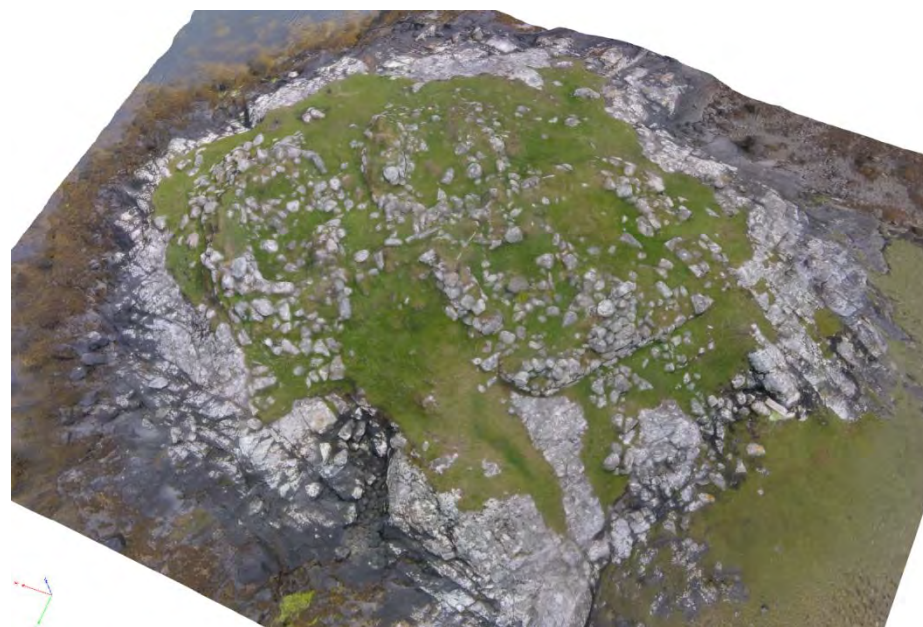
A rectangular building and two huts lie on a small tidal island barely 15m across at the SE side of Bàgh Sealg. The building measures 4.8m N - S by 3.4m transversely within much reduced drystone walls averaging 1m thick and between 0.4 and 0.8m high. Gaps in the walls suggest possible openings in each of the N, W and S walls, but none could be described as a definitive entrance point. The regularity of the curved external corners is noteworthy. The huts are located to the NE of the building. Both are rectangular in plan, orientated WNW - ESE, and are separated by a narrow passage no more than 1m wide onto which their centrally located entrances face. That to the S measures around 3.6 by 1.7m within stone rubble walls up to 1.2m thick at their base and 0.6m high with its SW corner partly embedded in the NE corner of the building. That to the N has almost identical internal dimensions within similarly constructed walls although these are thicker and more curved near the N corner which sits right on the island's edge. Clear interpretation of this group of structures is difficult. Unusually, it is not even possible to reliably state an order of construction where the rectangular building and one of the huts are joined. Both building types are unique in both the Ronay survey, and in the wider area of these parts of SE North Uist and NE Benbecula and it seems unlikely that they relate to either the 19thC crofting establishment or subsequent sheep farming period. This is perhaps reflected in the lack of tumble around the rectangular building, the stone from which may well have been used for the construction of the nearby farmstead RB 19.

RB 21: aerial view from NW

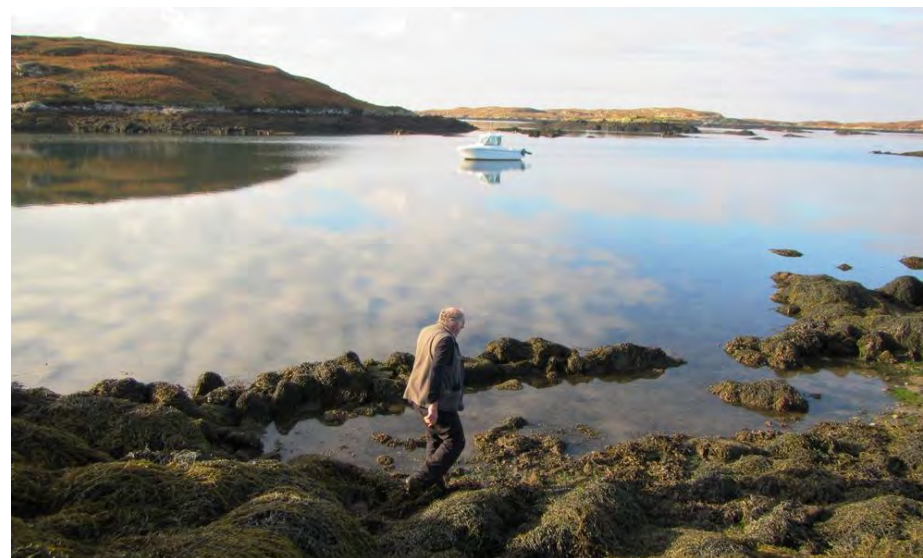
The remains of a length of rubble wall around 8m long in the intertidal zone on the SE side of Bàgh Sealg between Ronay Beag and Eilean Rainich may be a fish trap.

RB 22: view from SE

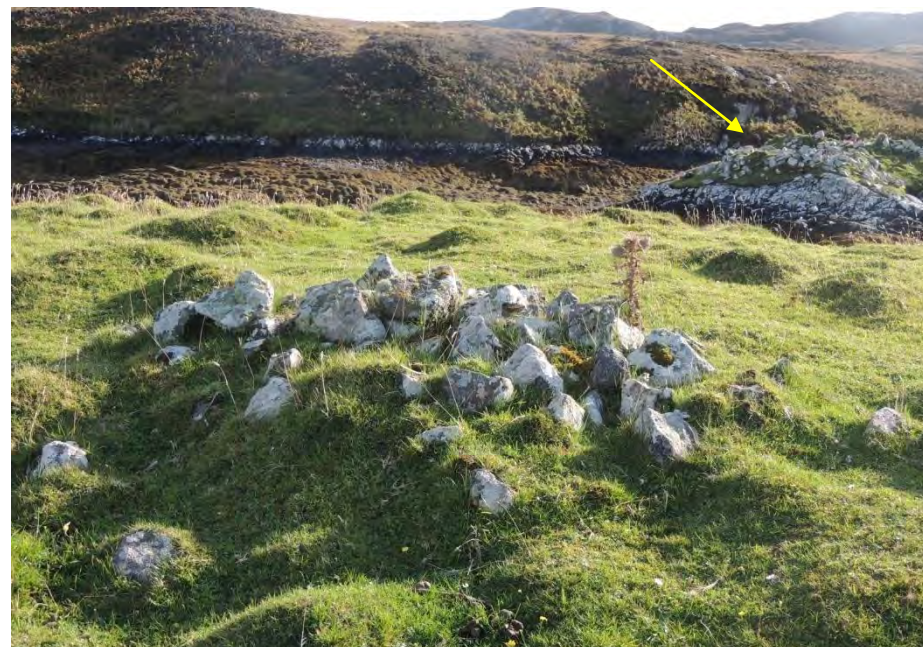
Two stone piles lie on the island Eilean Rainich at NF 89255 57530 and NF 89280 57550. Although there are no signs of cultivation on the island it might have been cleared of stones for grazing or haymaking. Alternatively they may represent the remains of kelp processing sites.

RB 23: S stone pile looking S with RB 21 behind (highlighted)

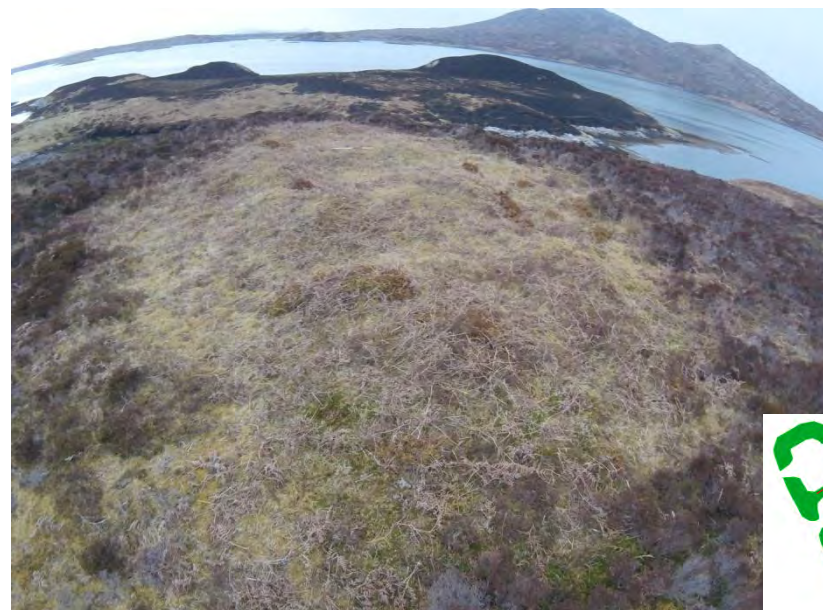
A three compartment turf walled structure lies on a low mound some 25m SE of the shore of the narrow tidal inlet which separates Ronay Beag from Eilean MhicNeill. Measuring around 11m SE - NW o/a, and between 3 and 2m transversely within slumped turf walls typically 1.3m thick at their base and 0.3m high, the structure is similar to others recorded on Flodaigh Beag (see site ROI 2), Garbh Eilean Mhòr (see site GEM 3), at Kallin on Grimsay, and on Eilean Flodaigh in Lochmaddy where a total of 8 with cell numbers varying from 2 to 6 exist. All five locations have common historic links with both fishing and kelping industries and it is presumed that these structures are related in some way to processing one of these products.

RB 24: view from S (with Eilean MhicNeill beyond) and thumbnail plan

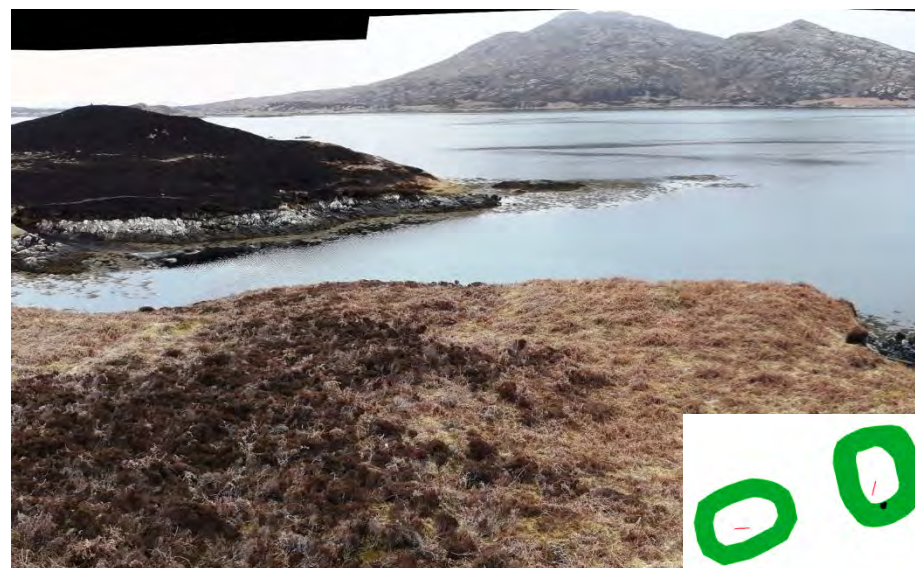
The faint remains of two sub-circular turf walled structures lie 8m S of the shore of the narrow tidal inlet which separates Ronay Beag from Eilean MhicNeill. That to the E measures around 4m NNW - SSE and 2.5m transversely within slumped turf walls around 1.5m thick and a maximum of 0.3m high. That to the W is similarly dimensioned and constructed but with its long axis orientated WSW - ENE. Most likely to be the remains of huts related to seasonal fishing or kelping activity.

RB 25: view from S and thumbnail plan

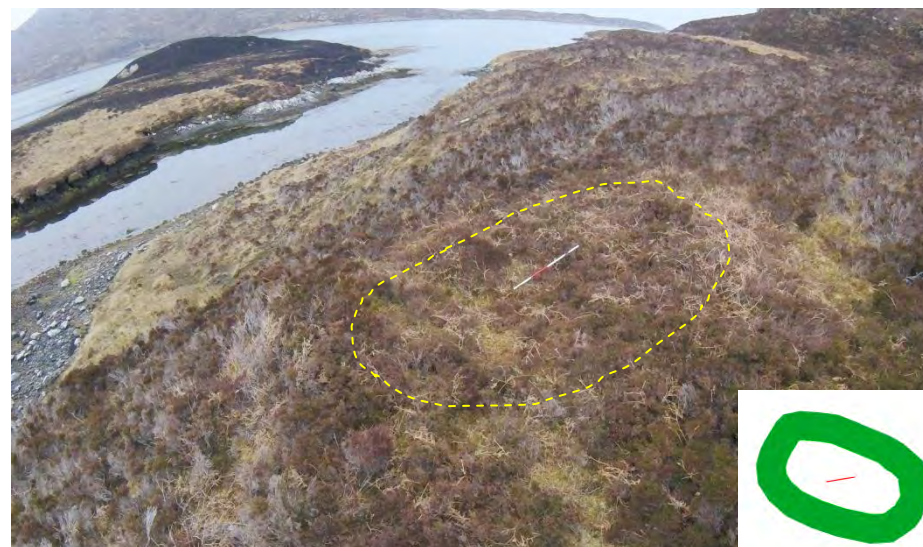
The faint remains of a sub-circular turf walled structure lies 10m S of the shore of the narrow tidal inlet which separates Ronay Beag from Eilean MhicNeill. It measures around 4m WNW - ESE and 2m transversely within slumped turf walls around 1.5m thick and a maximum of 0.5m high. Most like to be the remains of a hut related to seasonal fishing or helping activity.

RB 26: view from SW and thumbnail plan

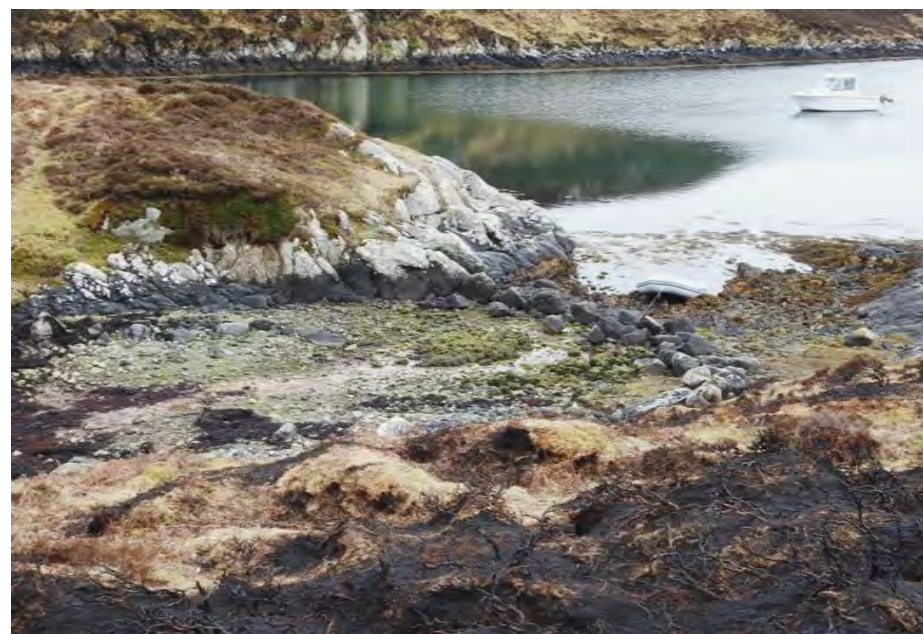
A curved line of small boulders and larger stones around 10m long runs across the entrance of a small coastal inlet on the W side of Eilean MhicNeill. Being located quite near the level of the HWM in an area where kelp processing took place, the most likely interpretation is that this was used to temporarily store seaweed after cutting and collection.

RB 27: view from N

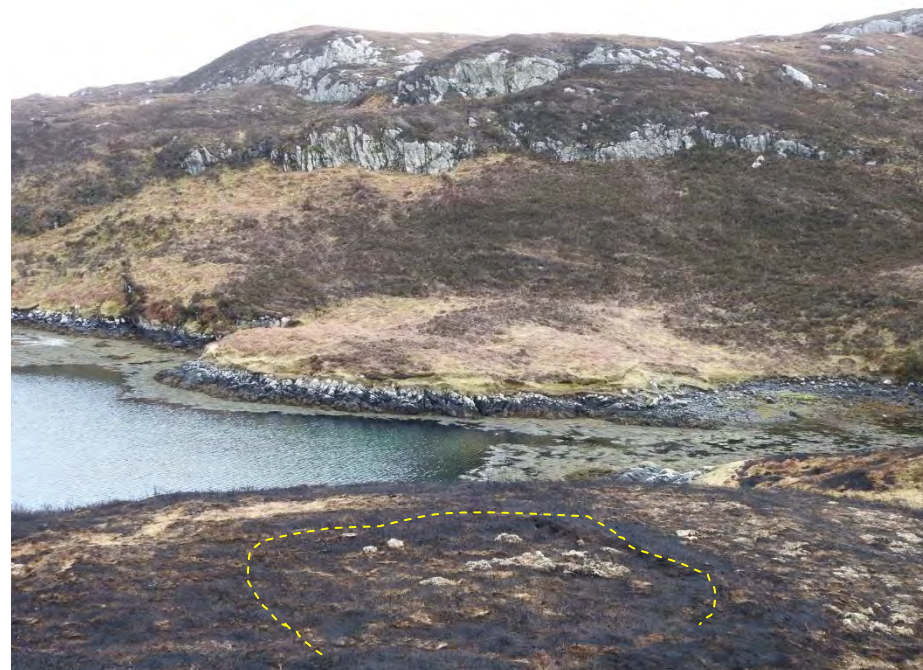
Recent muir-burning on Eilean MhicNeill has revealed the faint traces of a rectangular structure cut out of the peat towards its N end. It measures around 9m SW - NE and 6m transversely and it might represent the remains of an enclosure.

RB 28: view from N

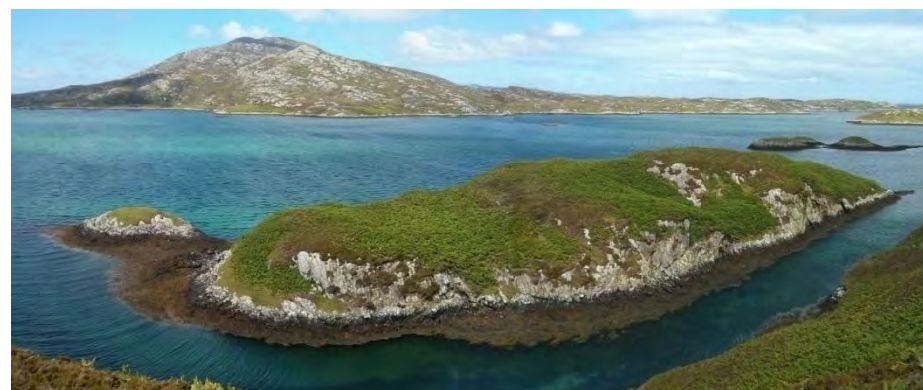
Beveridge reported that this island, called 'Old Castle', was traditionally the site of a fort, but if such a structure ever existed no traces remain. A systematic survey before summer bracken growth confirmed this - not even a platform or stone tumble in the sea below. Research has revealed significant confusion with place names around Ronay, especially with islands, and the possibility exists that this is wrongly identified by map makers. Alternatively it could be a descriptive name, as the island appears quite daunting from sea level, with its mostly sheer rock coastline being quite difficult to access.

RB 29: view from SW

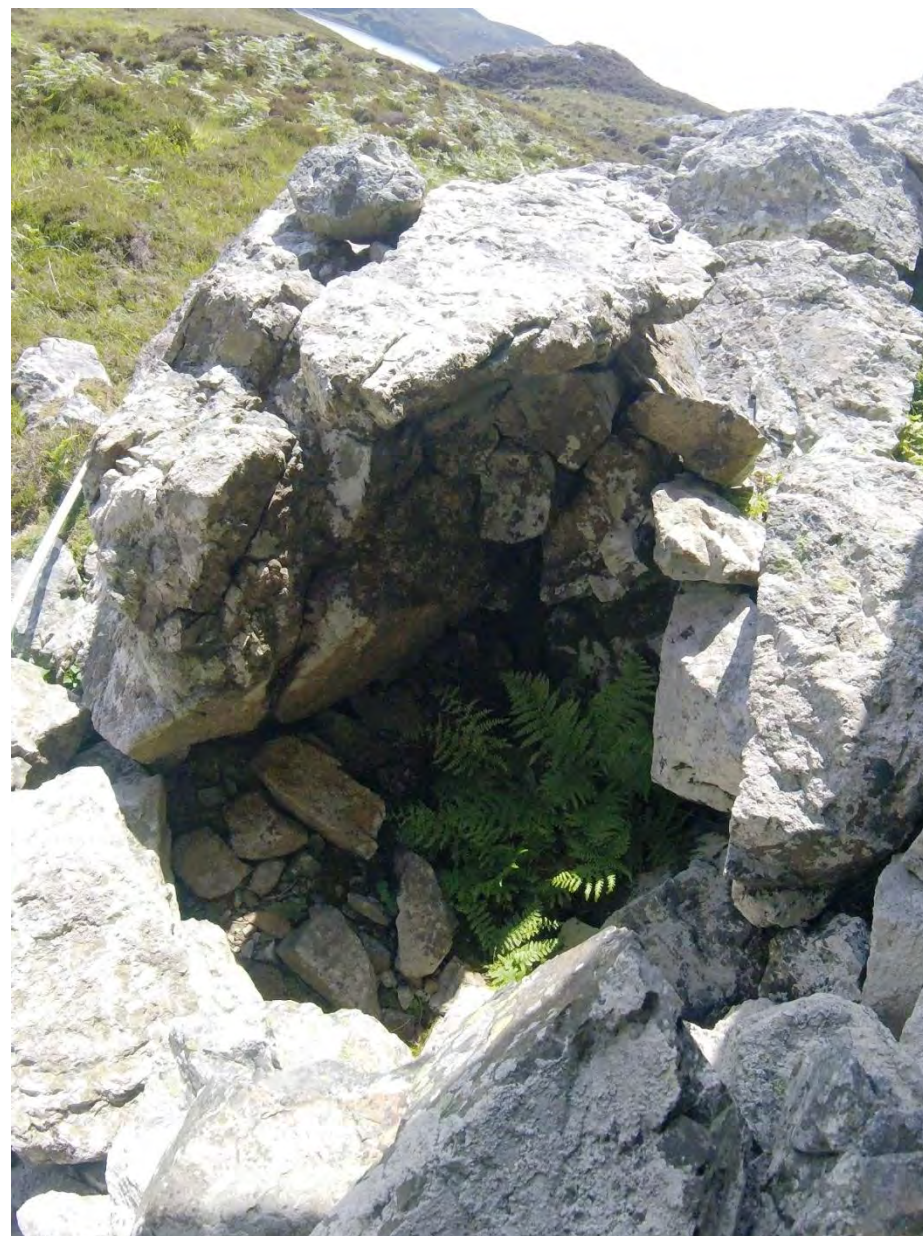
A pen has been constructed underneath a rock overhang at the foot of a cliff S of the plateau at the centre of Ronay Beag. Defined by a corbelled, sub-circular, single leaf drystone wall around 0.7m thick and 1.2m high and a single rock slab, it measures around 1m by 0.5m within. This is probably a lamb pen.

RB 26: view from SE, survey rod 1m long

RB 26: internal view from E side

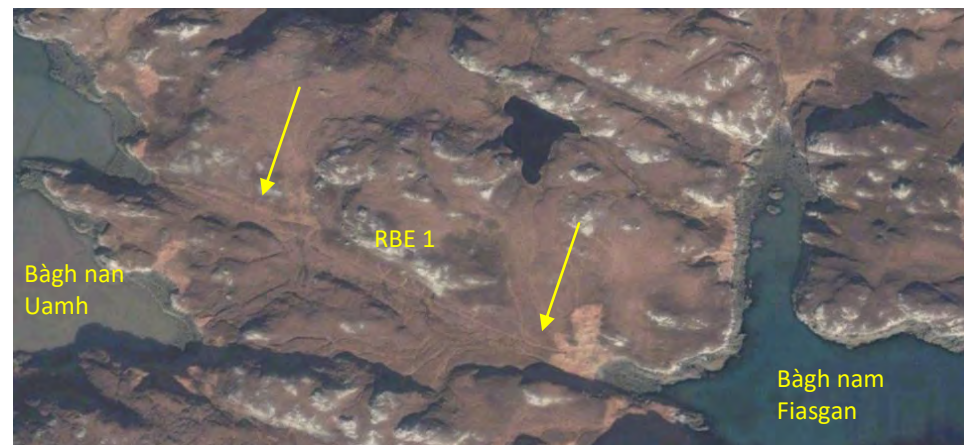
The peninsula of Ronay Beag was separated from the rest of Ronay by a ditch and turf bank dyke. This extended in a WNW - ESE direction for around 330m from a small inlet at the E end of Bàgh nam Uamh at NF 89900 56490 to the W end of Bàgh nam Fiasgan at NF 90210 56340. Since replaced by a modern post and wire fence on a slightly different alignment, the dyke was never recorded by the OS, but can be seen as a faint pencil line as a proposed boundary in Robert Reid's *Plan of the Island of North Uist* in 1799. Thus it was probably a subdivision of the island related to its use as a sheep farm in the mid 19thC.

BME 1: Google Earth view (2004)

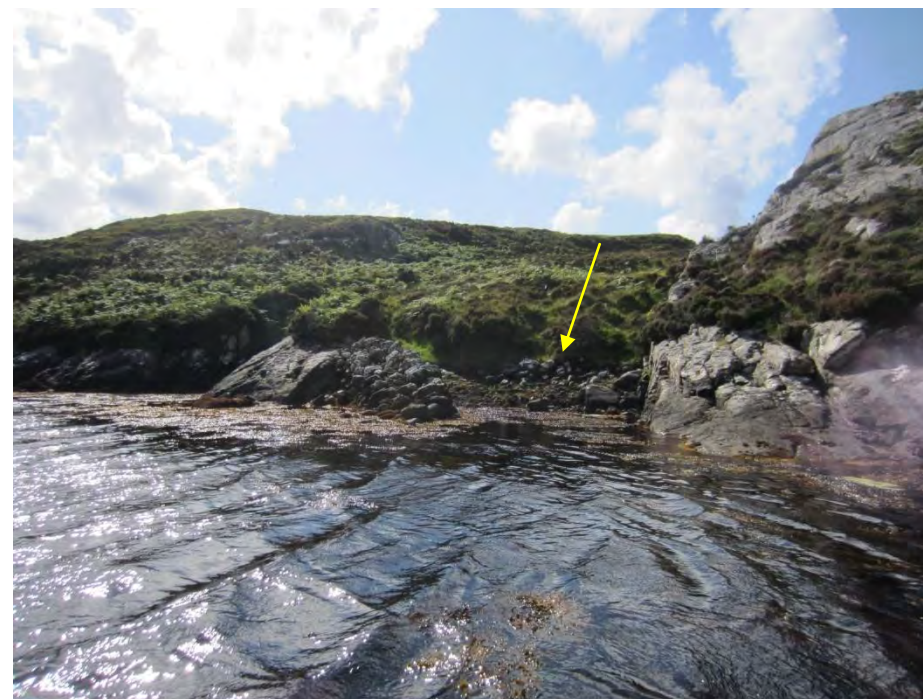
A landing point lies at the NW head of Bàgh nam Fiasgan. An area of beach around 10m long and 3m wide, has been cleared of larger stones and boulders. On its S side a roughly assembled drystone breakwater has been constructed.

RBE 2: view from E

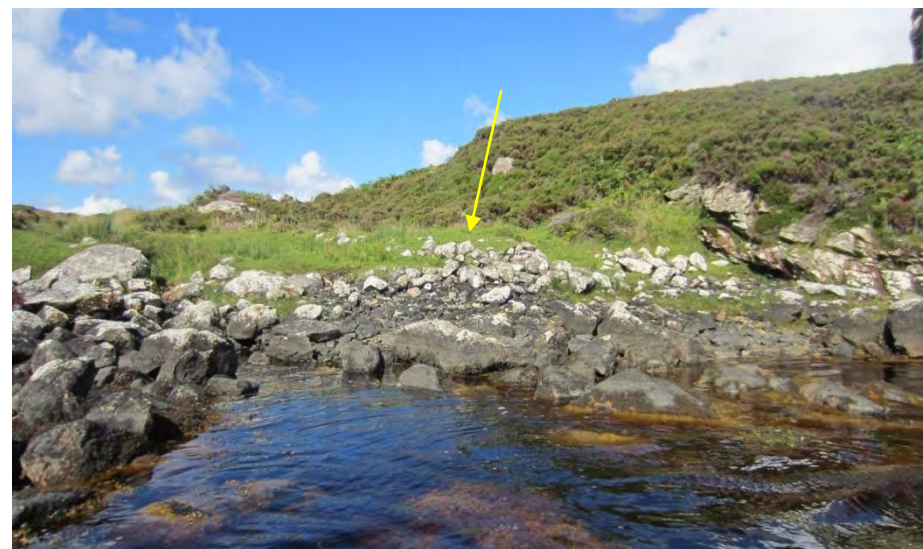
RBE 3: S termination, view from S

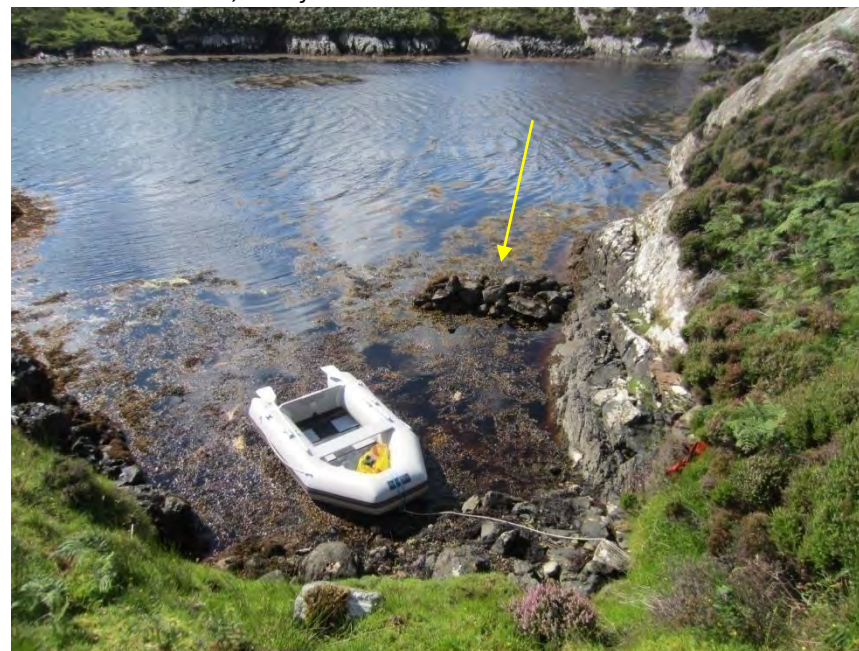
A landing point lies at the NE head of Bàgh nam Fiasgan some 75m W of the farmstead RB 5 to which it is presumably related. A small inlet measuring around 7m square is protected on its W side by a roughly built drystone breakwater 3.5m long, 1.5m thick and up to 1m high.

RBE 4: view from E

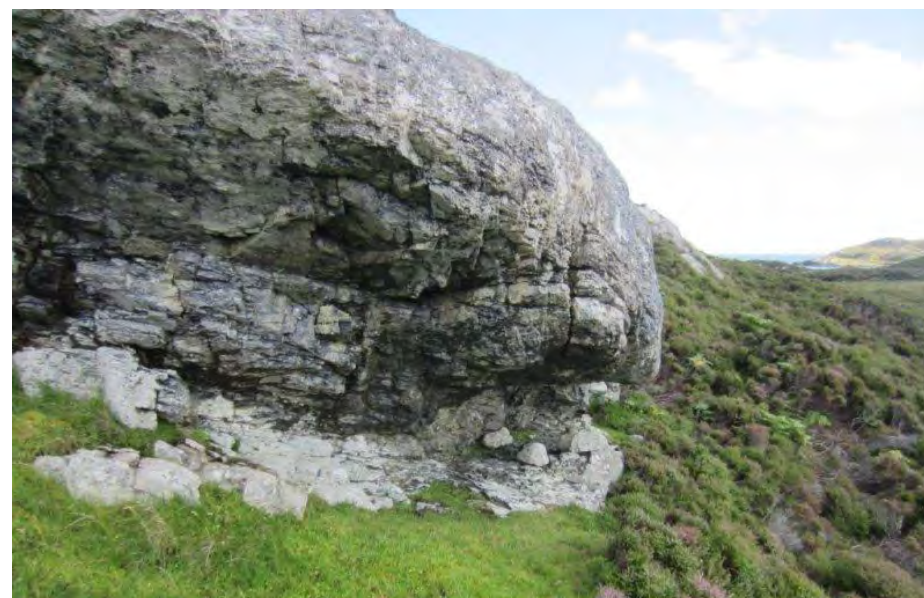
An outcrop of bedrock with a naturally formed overhang shelters an area around 4m X 2m X 1.5m high and a scattering of stones within and nearby may be the remains of a shelter wall on its outer side.

RBE 7: view from NW

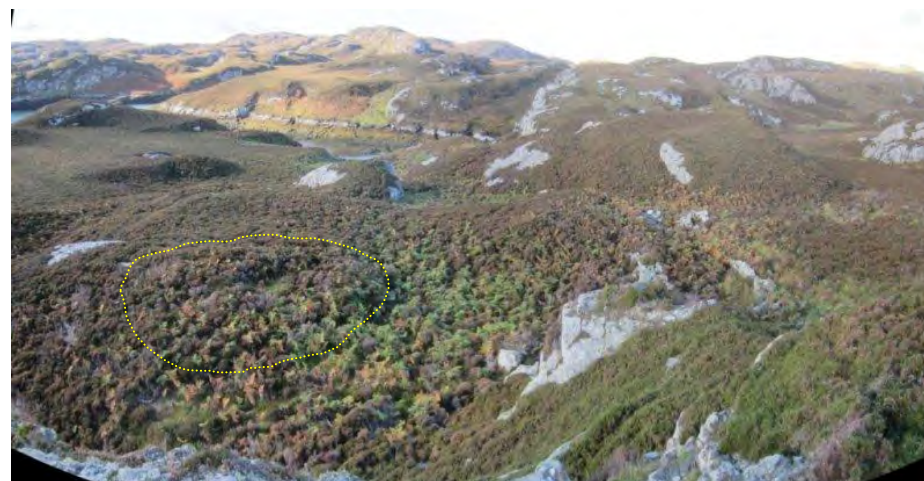
A roughly levelled sub-circular area of ground averaging 3m in dia is surrounded by a turf bank between 2.5 and 3.5m wide and up to 0.5m high. Its actual purpose is unknown, but it may be the remains of a turf walled building or perhaps a stack stand.

RBE 8: view from E

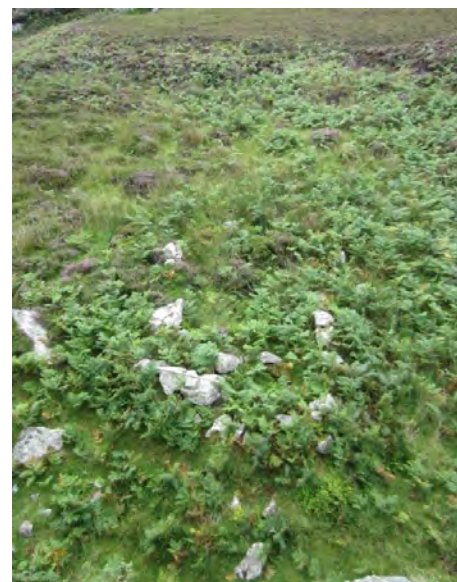
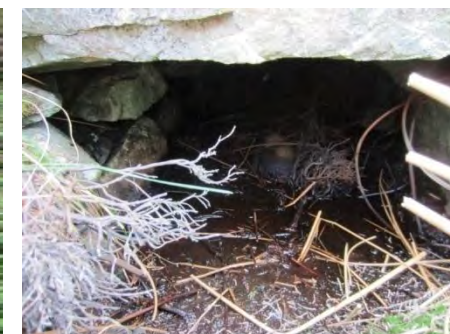
The much reduced remains of a rectangular building, possibly a byre, lie close to the base of a 12m high cliff which defines the S side of a *roche moutonnée*, and 30m SE of the farmstead RBE 5. It measures 5.3m N - S and 2.6m transversely within drystone walls averaging 0.6m thick and a maximum of 0.5m high. No clear entrance. A lintel slab near the centre of the E wall covers a small water filled niche at floor level. 2m E of the building's NE corner, a depression in the ground covered by a rock slab is filled with water and this may be a well.

RBE 9: left - view from N; right - view of niche from W and thumbnail plan

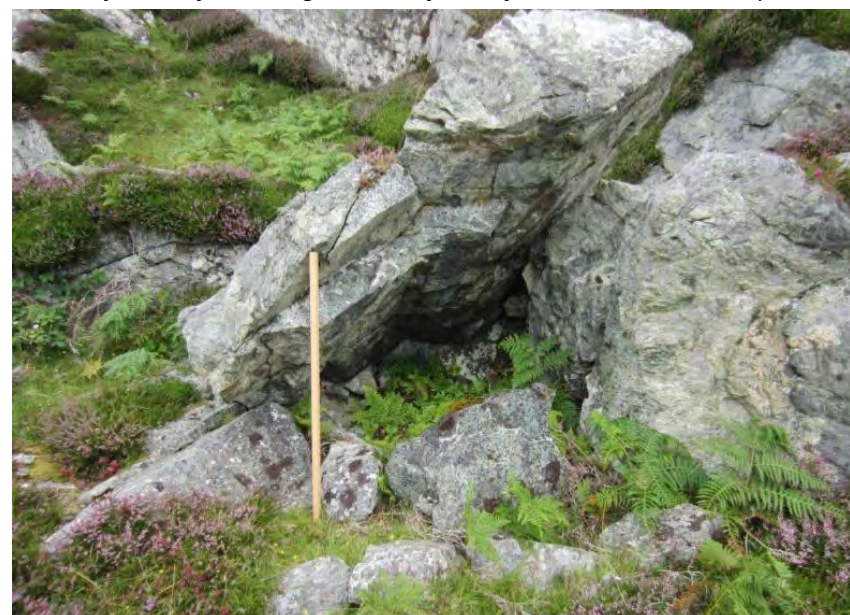
A triangular shaped rock slab around 2m across lies propped on a large boulder. The space thus formed has been partly enclosed at the open side with a line of stones which together, may represent the remains of a small pen.

RBE 10: view from S, survey pole 1m long

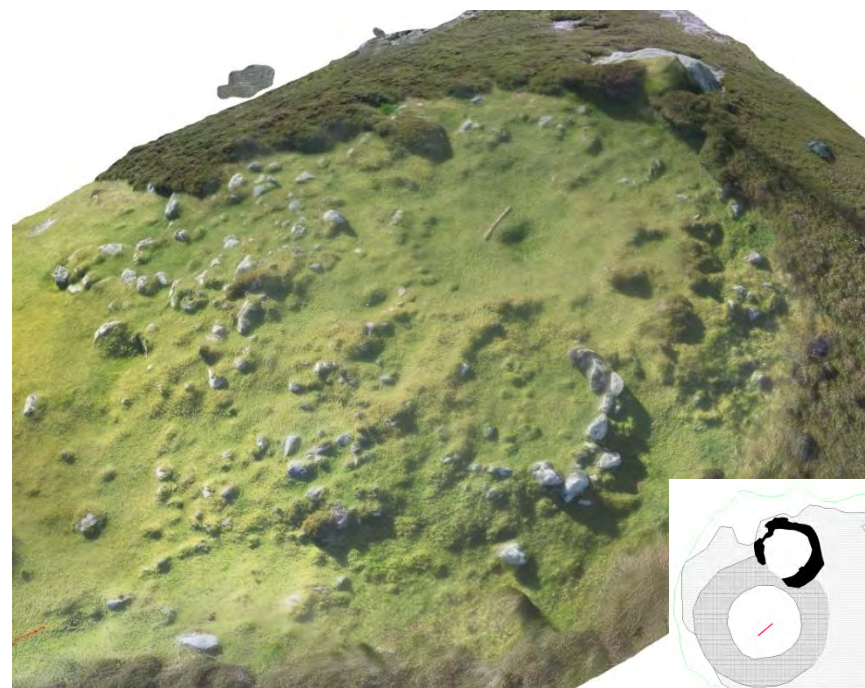
The remains of a stone structure lie on the summit of a 12m high *roche moutonnée*, 75m N of the shore of Bàgh nan Fiasgan on the E side of Ronay. Beveridge described the remains as '.....a knoll showing upon its flat summit the foundations of a circular erection about 34' in diameter. The rocky and almost precipitous west side of this hillock presents some appearance of steps leading downwards to a plateau adjoining its base'. Today the outline of the circular structure can still be seen with an internal diameter of around 4m and almost levelled enclosing walls averaging 1.7m thick and 0.4m high. A significant amount of loose stone is scattered outside, covering an area perhaps twice that of the main structure. Embedded within its N wall is a second circular structure with an internal diameter of around 2.3m in part defined by a line of embedded stones which may have been an entry point. The age and purpose of the structures can only be guessed at, but their defensible location and extensive views over the Minch to the E may well be related. The two 'steps' are located some 25m NW of the centre of the main structure at NF 90475 56475, immediately above site RBE 5, but may represent a fortuitous outcome of quarrying activity.

RBE 11: aerial view from NE and thumbnail plan

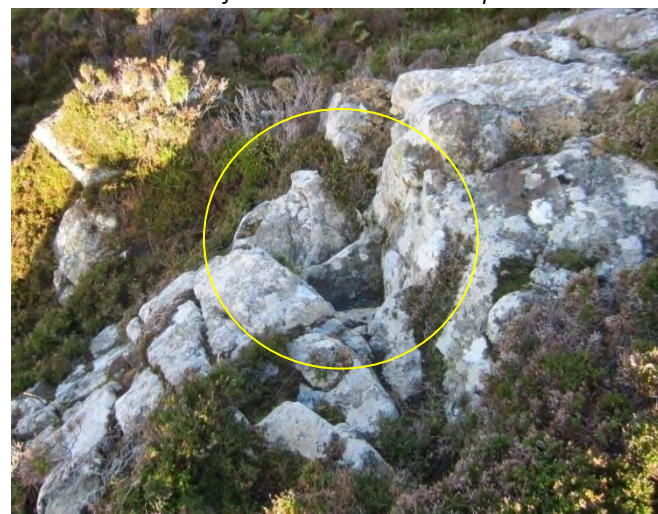
RBE 11: possible rock cut steps

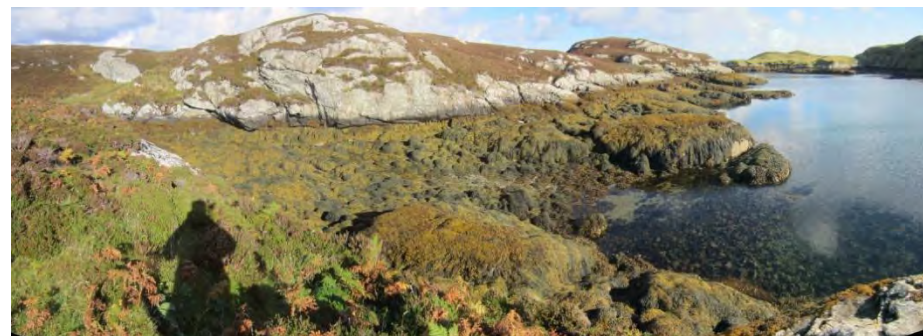
An area of beach around 30m long and 2-3m wide lying within a narrow inlet on the NE shore of Bàgh nam Fiasgan has been cleared of larger stones and may be the remains of a former landing point.

RBE 12: view from SW

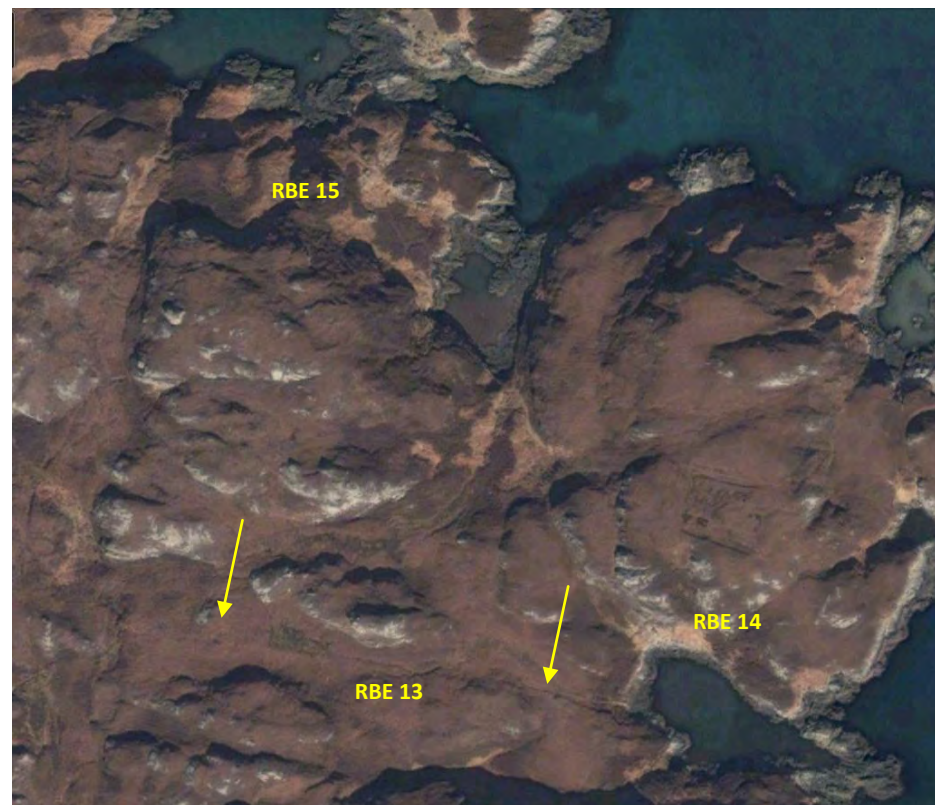
The faint remains of a ditch and turf bank dyke appear to represent the boundary between the croft lands relating to farmsteads RBE 5 and RBE 15. Starting on the shore of Bàgh an Eireannach (Bay of the Irishman) at NF 90640 56610, the line of the dyke extends in a WNW direction for a distance of around 200m to NF 90465 56650 where it stops short of what was probably a connection with the dyke RBE 3. Traces of peat cuttings and feannagan can be seen in the vicinity.

RBE 13, 14 & 15: Google Earth image

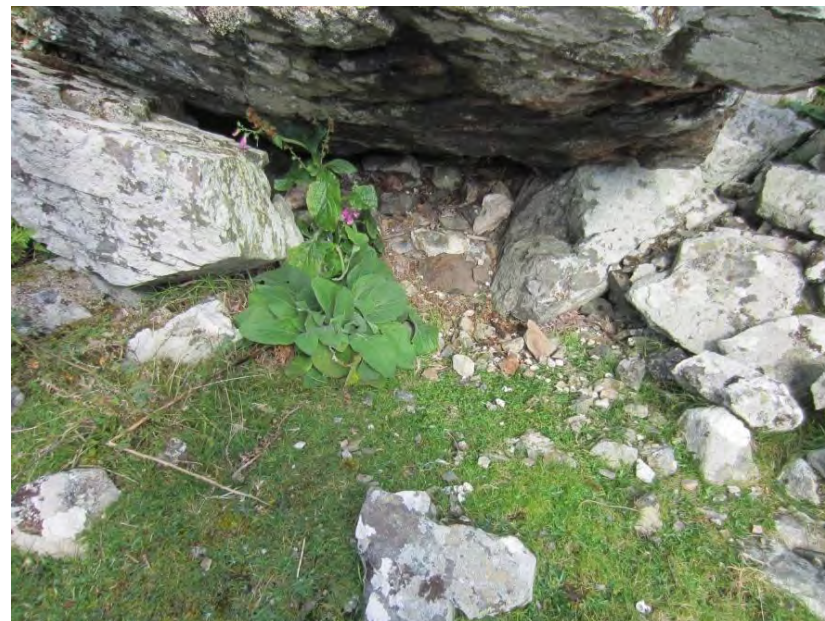
RBE 14: possible shelter underneath a rock overhang

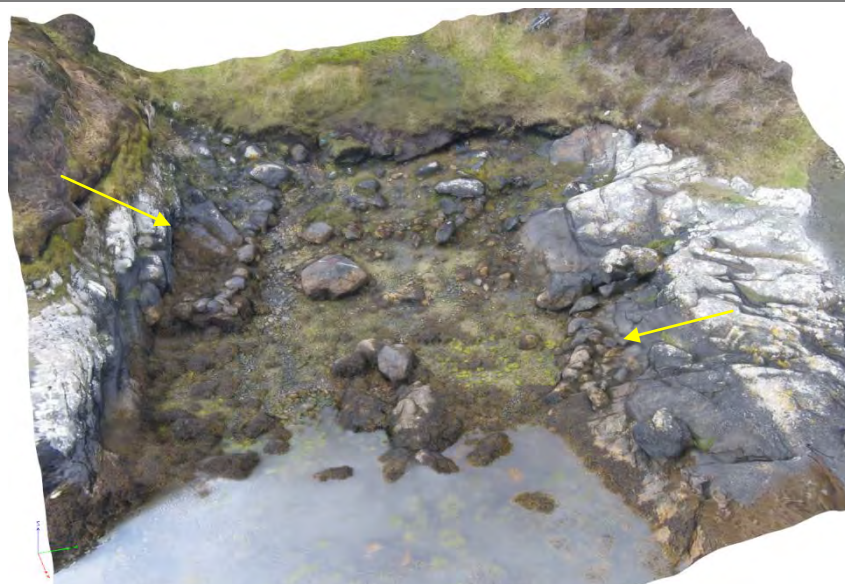
On the NW shore of Bàgh an Eireannach (Bay of the Irishman) a series of remains indicate former human activity, possibly related to kelp collection and processing. At the HWM at NF 90670 56640 a crude jetty around 9m long has been roughly assembled with stones and boulders, and on the shoreline behind other areas of disturbed ground may represent areas where kelp was stored or processed. A few m to the NW a rock overhang at the base of a low cliff may have been used as a shelter. Further S round the bay at NF 90665 56580 a landing point is marked by an area of cleared beach and two crudely built drystone jetties, the larger of which measures around 6m long and between 1 and 2m across.

RB 14: aerial view of landing point from NE with jetties highlighted

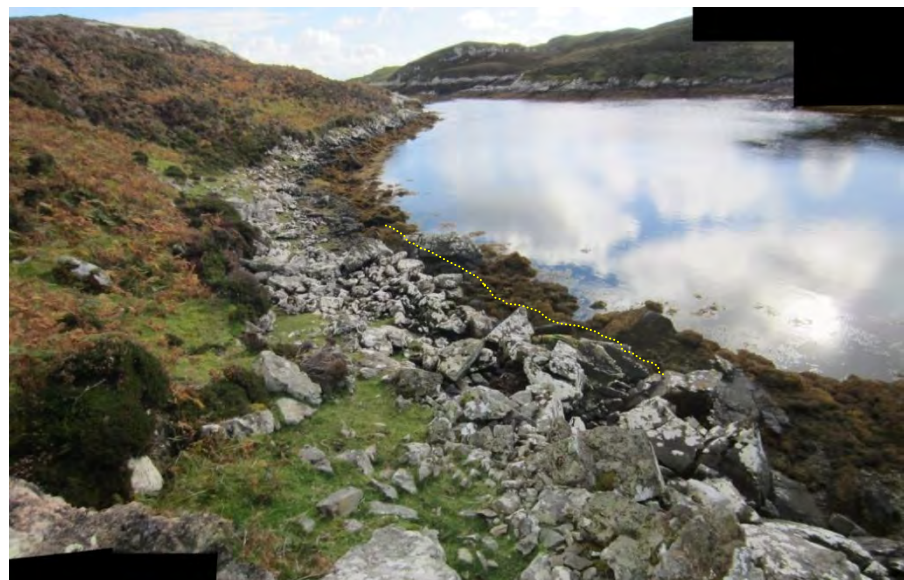
RBE 14: jetty (highlighted) and possible kelp working area

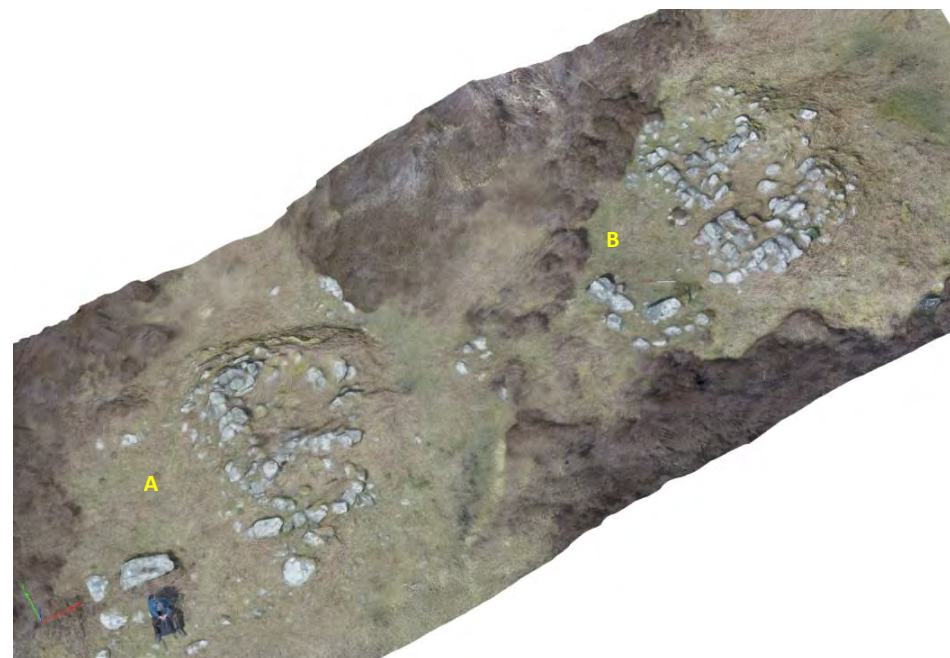
A farmstead overlooks the sheltered cove named Acarseid Fhalaich (Hidden Harbour) whose entrance is located on the SW side of the sound separating Ronay Beag from the island of Flodaigh Mòr. It comprises the remains of two rectangular buildings, A and B, which show indications of three phases of development. The original structures were both rectangular in plan and orientated SW - NE with building A measuring 8 X 4m and building B 6 X 4m, within drystone walls averaging 1m thick, although sections of these are entirely removed (or perhaps never completed?). The entrances were probably in their SE facing elevations. The second phase was the formation of two rectangular pens or huts within each of the NE gable ends of the original structures. Of similar construction and width to the original buildings these have entrances facing in the NE and SW elevations. Finally these structures have then be subdivided by drystone partitions to form pens, probably for lambs. The farmstead lies within a bounded area of land extending to some 11ha within which lie areas of formerly cultivated ground and peat cuttings. This farmstead could well be one of the original 26 crofts established on Ronay in the early 19thC.

RB 15: aerial view from S
