**Ronay Field Survey
2015-18**

**David Newman
June 2018**

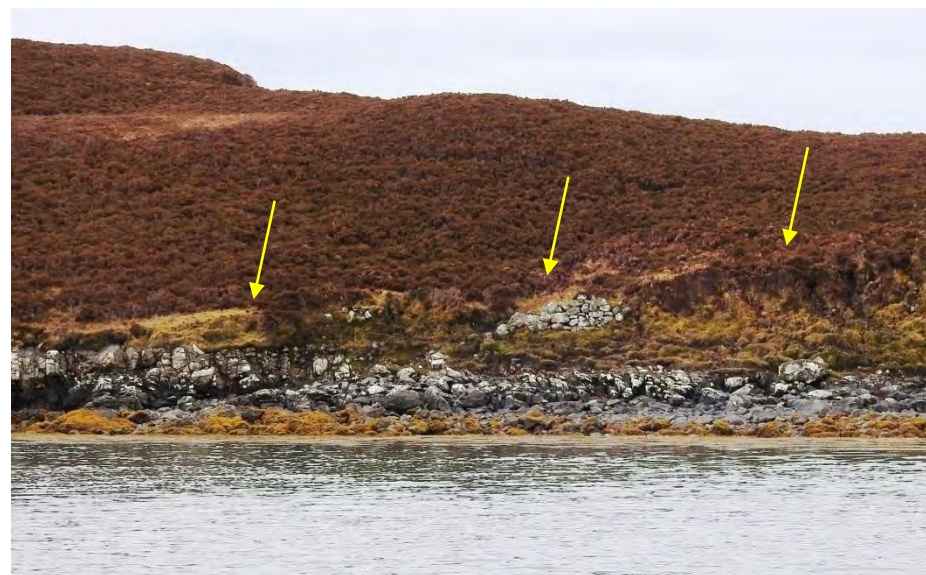
RBE 16: N termination on the shore of Bàgh nan Uamh

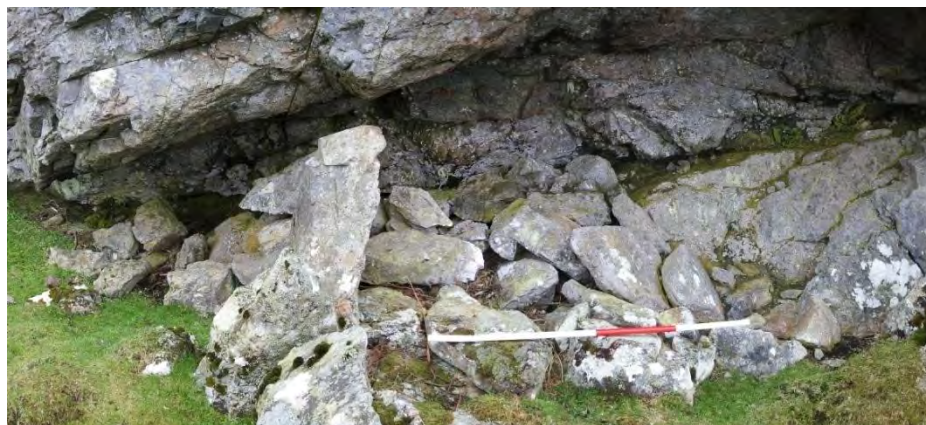
RBE 16: S termination in a rock overhang, survey pole 1m long

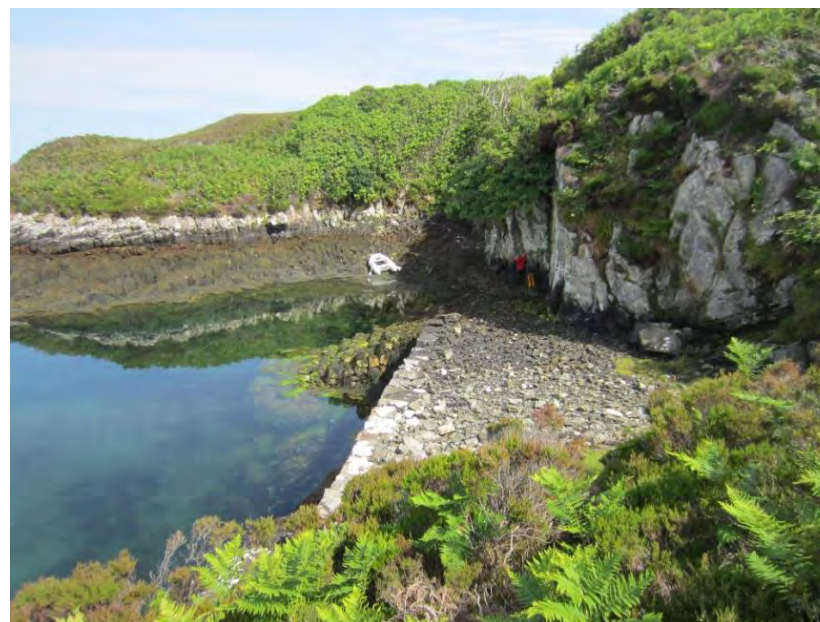
A 40m long jetty lies on the S shore of a small cove at the SW end of Bàgh na Caiplich. Constructed in quarried and part dressed stone, the main wall has been founded on a series of large stone blocks to form a seaward face nearly 3m high. Backfilled and part paved on the inside, it varies considerably in width between 7m near its W end to as little as 1 at its E termination as it follows the line of a low cliff. A flight of steps built near its centre helps facilitate landing during low tides. Built by Captain Allan Macdonald of Waternish to service a hunting lodge located some 125m to the SW, the work was probably carried out during the 1890s.

BNC 1: view from W

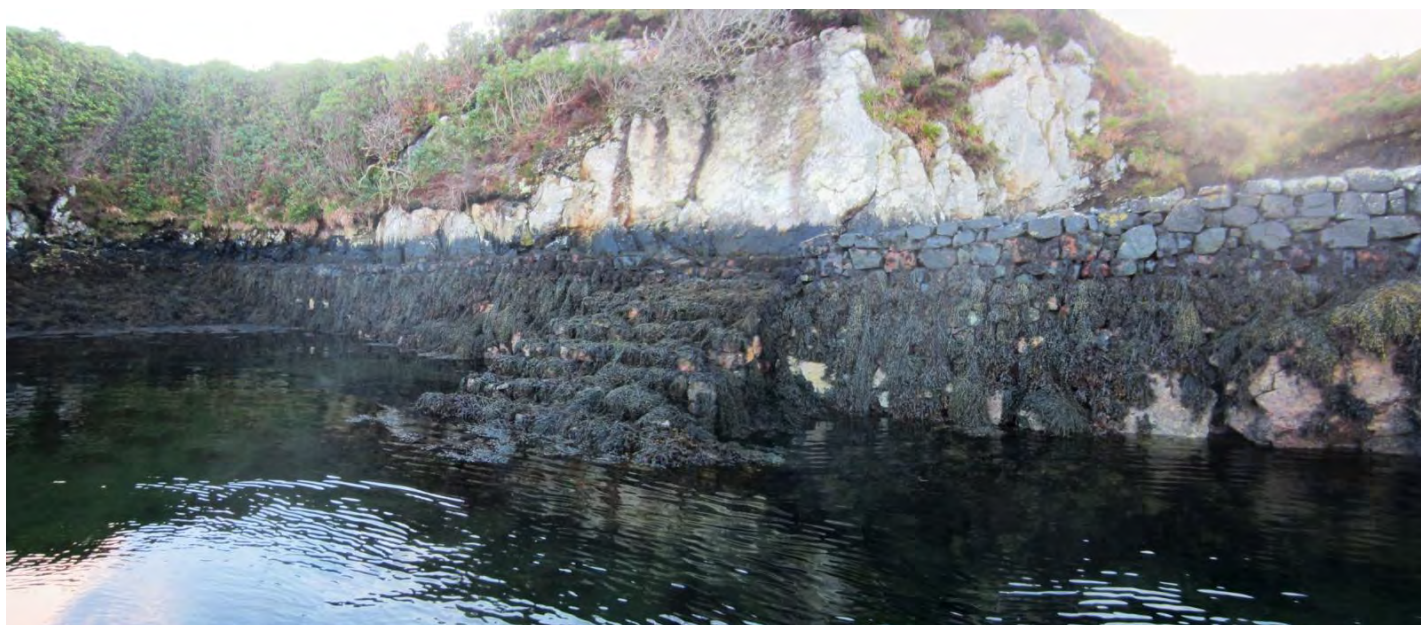
BNC 1: view from the NW.

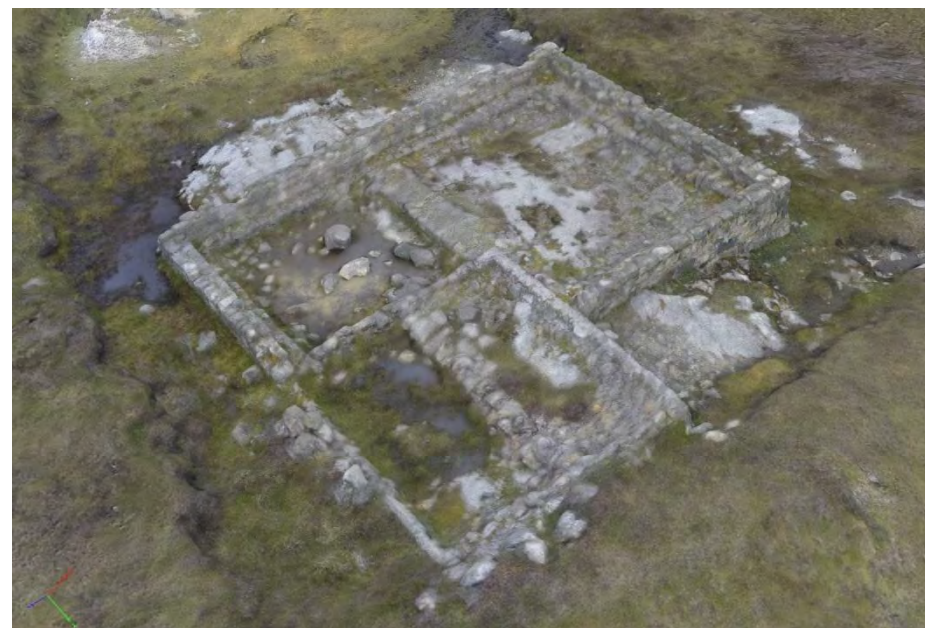
The foundations of an unfinished L shaped plan house and a rectangular walled garden lie on the N edge of a 15m high plateau overlooking Loch na Leig (or Làmhraig) and Bàgh na Caiplich. Intended as a hunting lodge for Captain Allan Macdonald of Waternish, the work was probably carried out during the 1890s.

BNC 2: aerial view from E

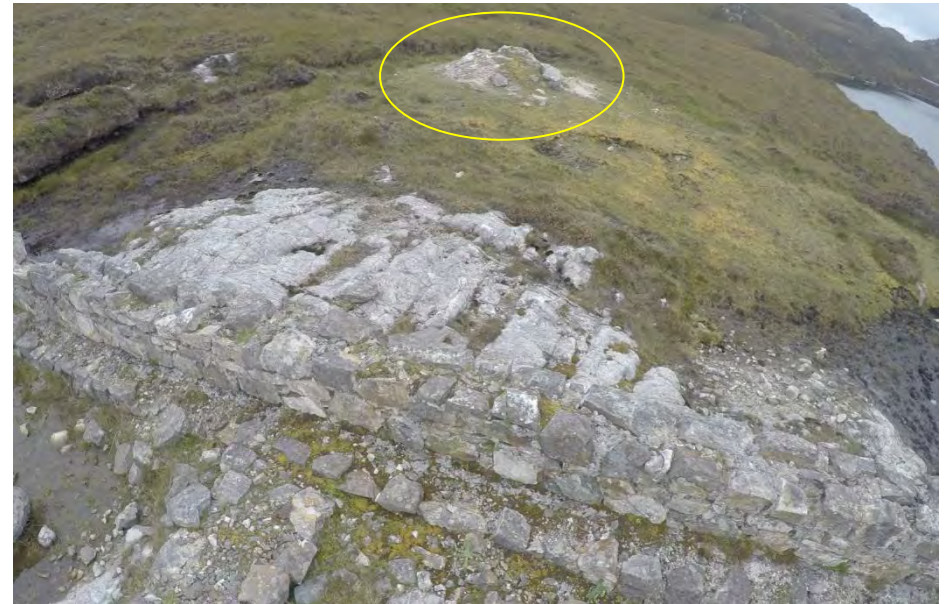
Lying around 8m SW of the house is a heap of partially reduced shell sand with some stones within and this is likely to have been a lime clamp. Around 25m SE of the house and lying against a rock outcrop is a pile of stone and this may well have been a stone quarry site for the foundation material.

BNC 2: SW footings looking SW towards lime clamp (highlighted)

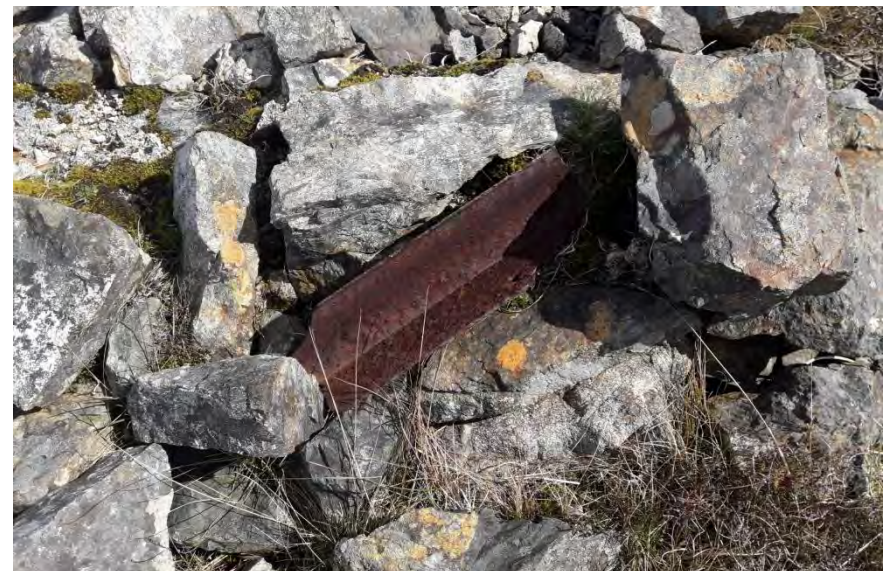
BNC 2: section of broken cast iron ogee gutter near E corner of building

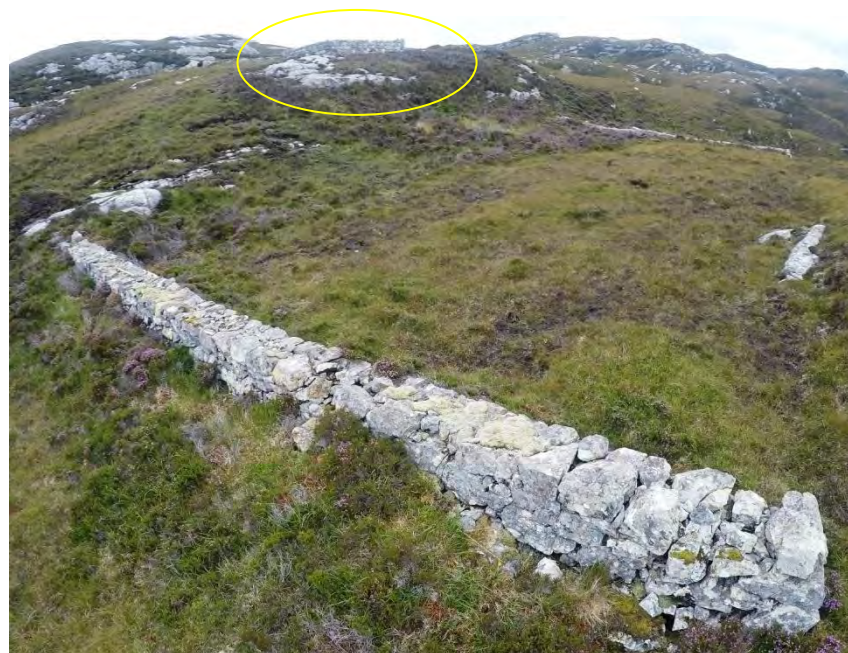
Around 15m N of the house, aligned on the same orientation, and lying some 6m lower at the base of a steep bank are the remains of the foundations of what was planned to be a walled garden. This measures around 30m SW - NE and 15m transversely and lies within an area of ground stripped of its peat cover to form a level surface. At both ends of this area, a 15m long section of drystone walling has been built. Around 0.6m wide and between 0.3 and 1m high these are most likely to have been foundations for enclosing walls.

Right: BNC 2: NE garden wall looking SW, house highlighted

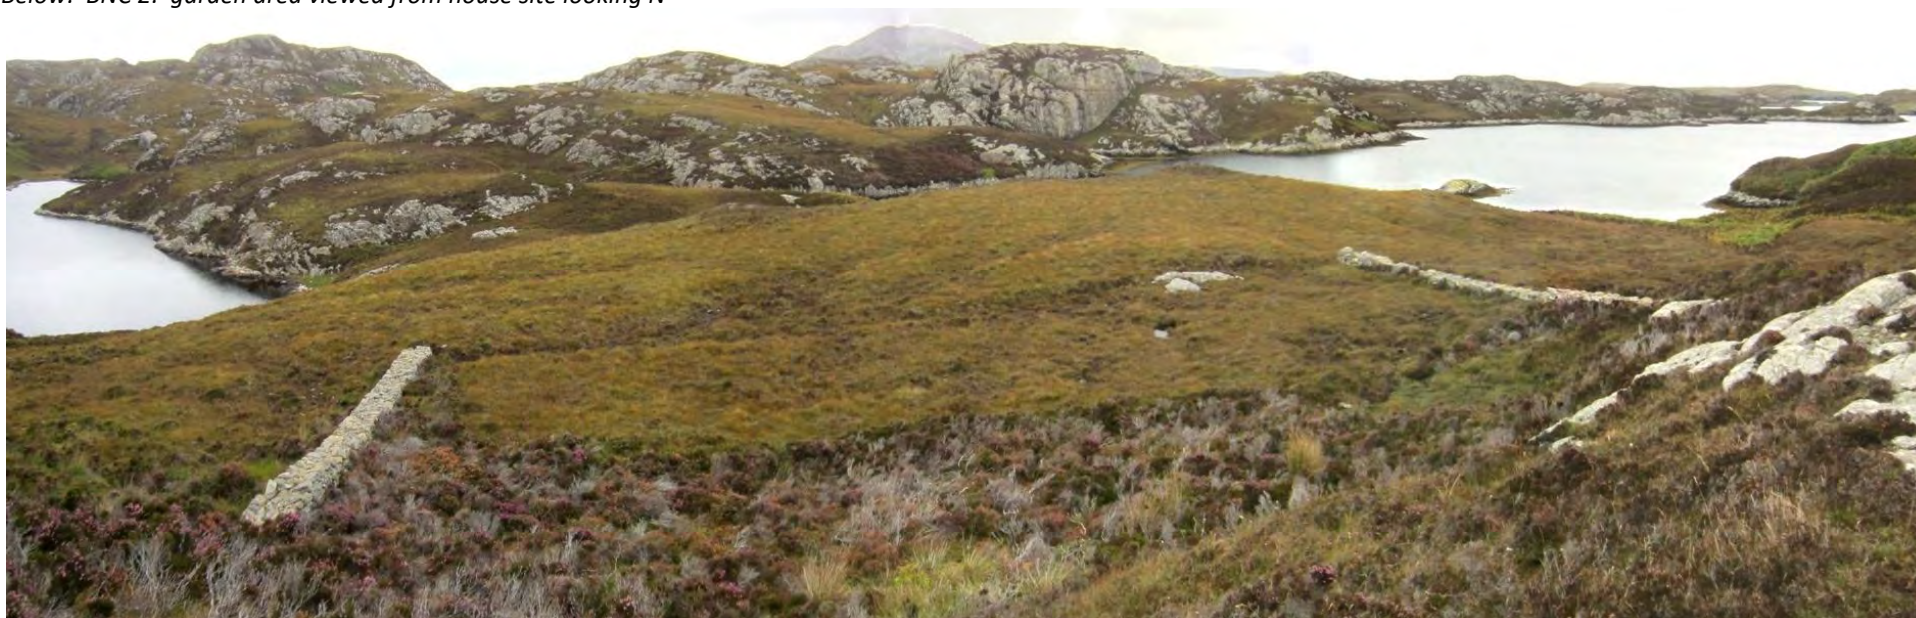
Below: BNC 2: garden area viewed from house site looking N

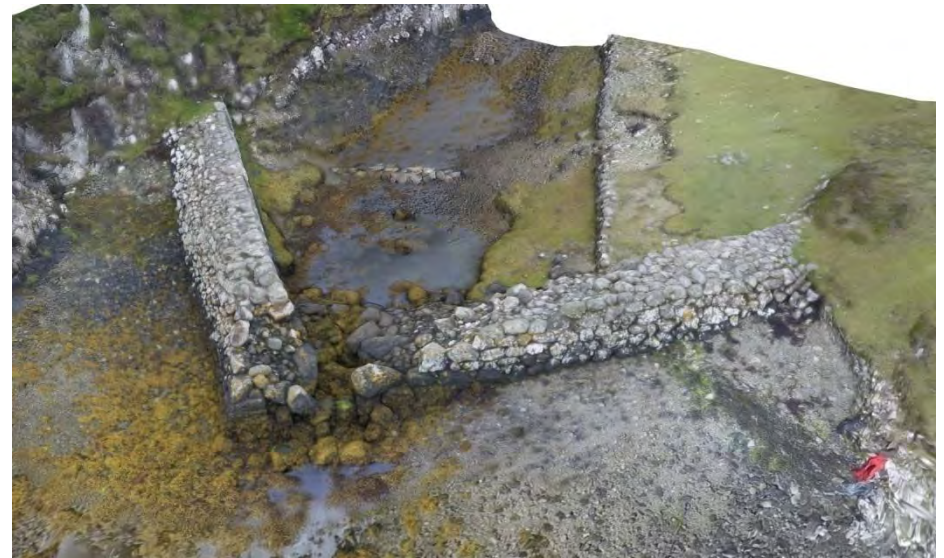
A series of stone structures lie in a 50m long gully which connects Loch na Leig (or Làmhaig) with Bàgh na Caiplich. They include a V shaped plan dam, and a canalised burn which may include the remains of an earlier dam structure, a possible quay, a weir and a set of stepping stones. The first hydrographic survey of this area by Cdr. F. W. L. Thomas R. N. dated 1861 shows the area as being completely open to the sea, and the relative water levels mean that the sea flows into the loch at highest spring tides. The structures are related to the purchase of Ronay by Captain Allan Macdonald of Waternish in 1886 as a hunting estate, and appear to be designed to control the level and flow of water in and out of Loch na Leig (or Làmhaig), perhaps to improve its qualities for fishing, otter hunting or pleasure boating purposes.

BNC 3: aerial view of dam from NE

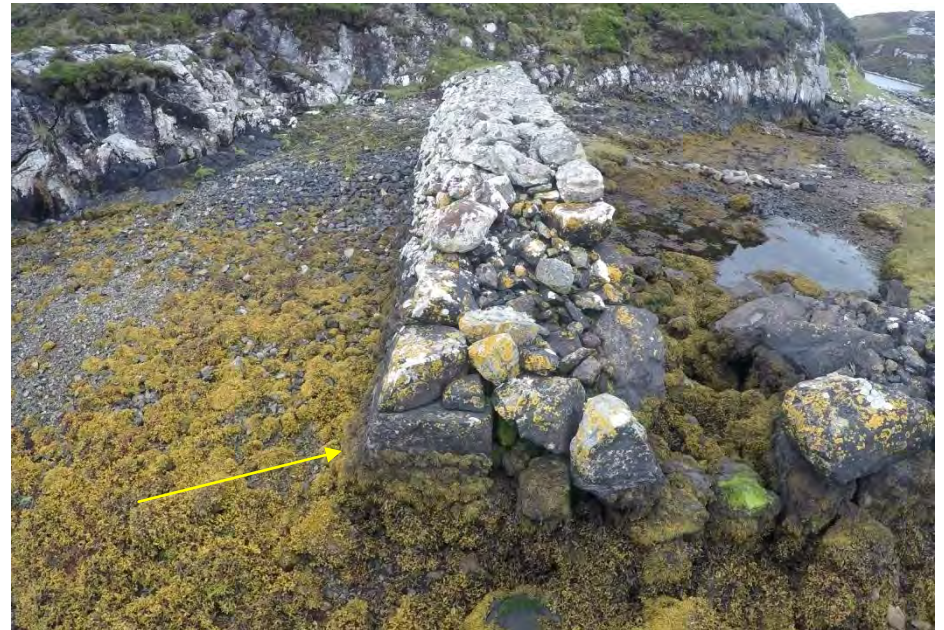
BNC 3: dam looking SW from centre, quoin stone highlighted

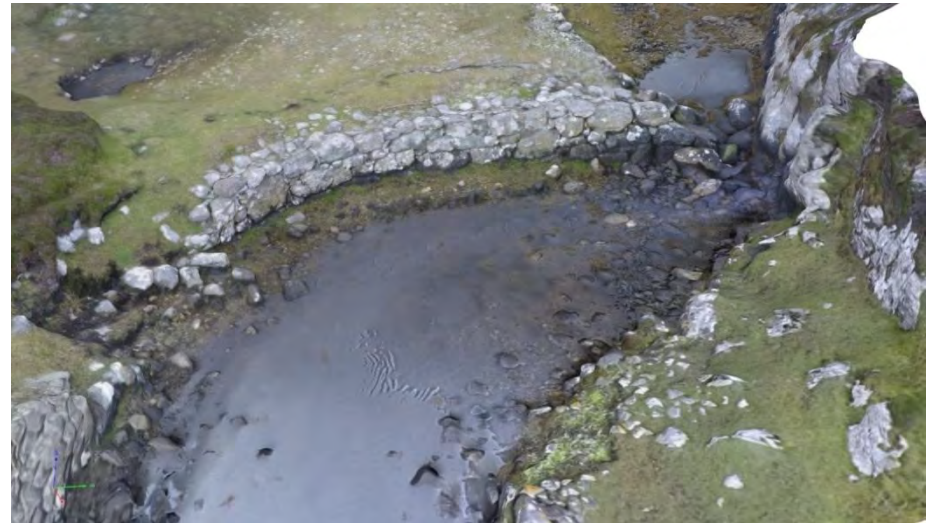
BNC 3: quay SW end looking E at what may have been an earlier dam structure

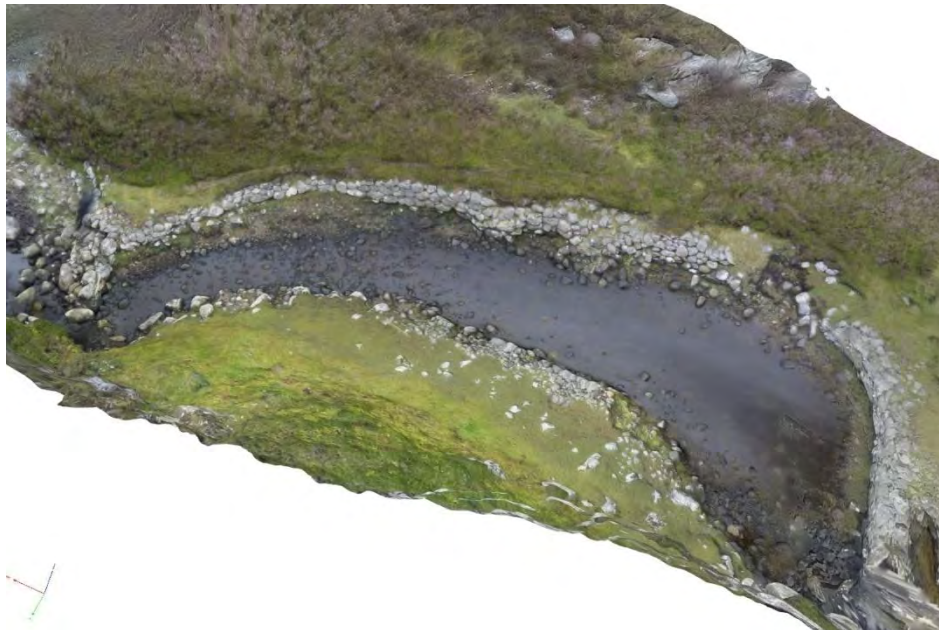
A 50m long artificial waterway has been created draining in a W - E direction between Loch na Leig (or Lámhaig) and the sea at Bàgh na Caiplich. It is divided into two pools W and E. The W pool is distinctly curved and measures around 25m W - E and 5m transversely. Its W end is defined by the remains of what appears to have been a roughly built rubble weir or temporary dam at a narrow point less than 6m wide between a low cliff on the S side and a heather covered bluff to the N. Rubble walls less than 1m high extend a few m NW from the weir along the loch shore, and also around the N side of the pool to the E for a distance of around 20m where a short section has collapsed at the point it meets the quay wall. The remains of a similar rubble wall also line the canal bank on the S side although some sections have been eroded away. This may be part of the remains of a dyke which once bisected Ronay W - E completely (see BD 4 and BNC 4).

BNC 3: W pool aerial view looking N; weir to L and quay to R.

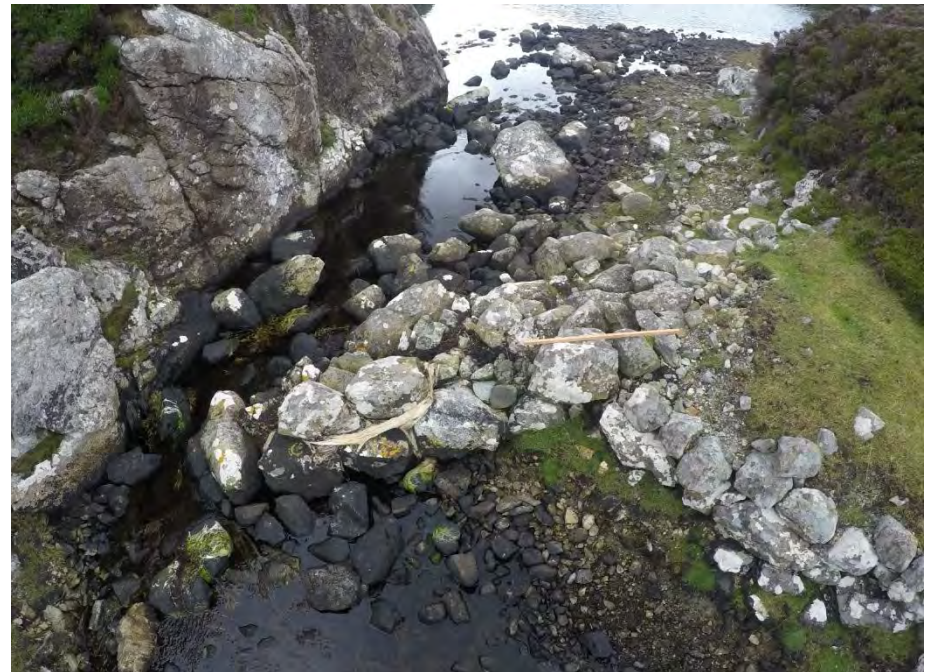
BNC 3: weir (poss) at the W end of canal looking W into Loch na Leig

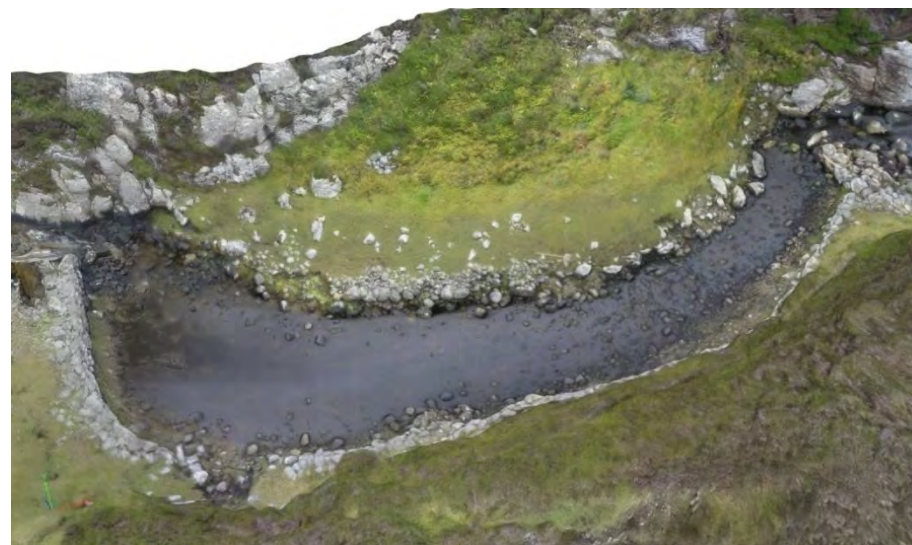
BNC 3: W pool aerial view looking S; weir to R. and quay to L.

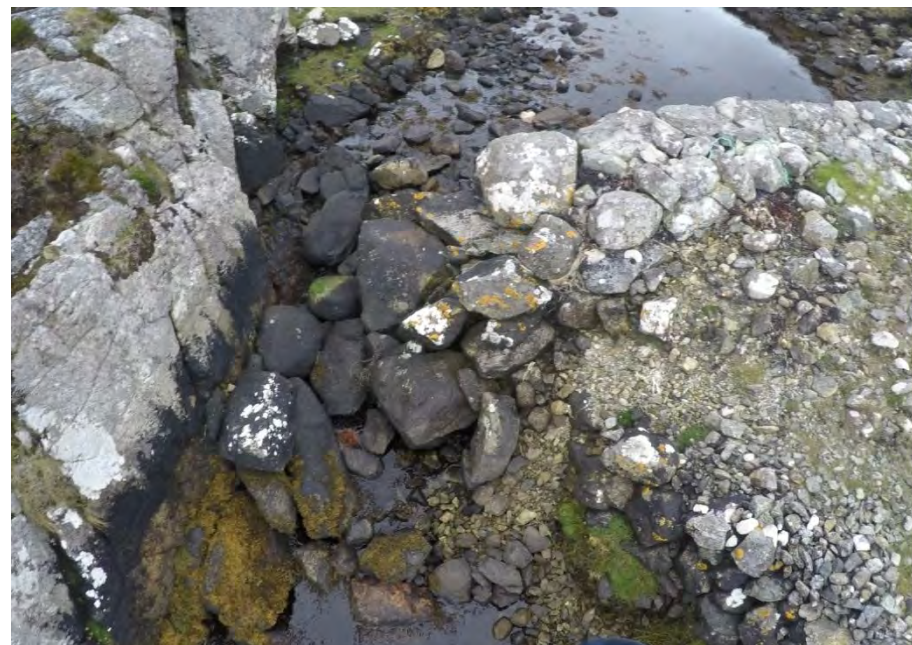
BNC 3: possible remains of original dam between E & W pools looking W. Quay to R.

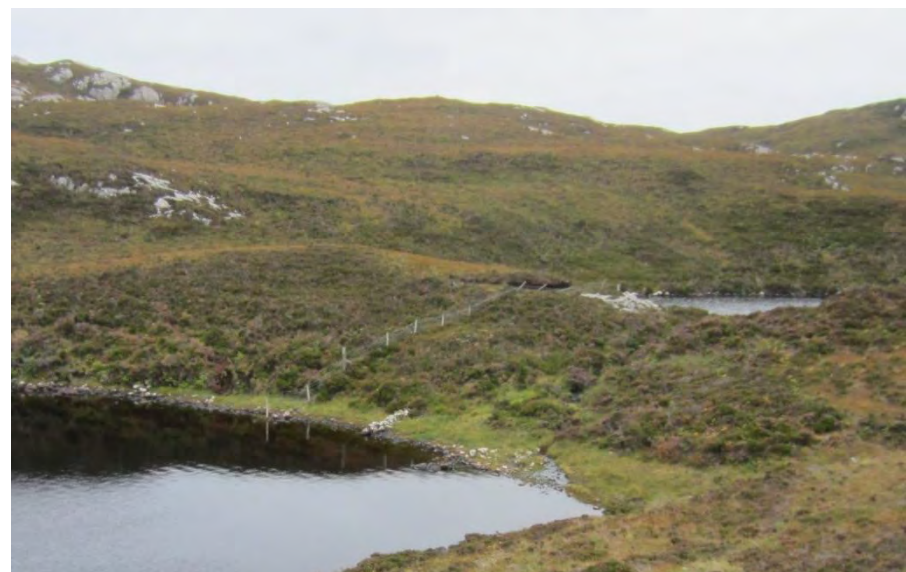
The remains of a drystone dyke cross a narrow neck of land between the shores of Loch nan Druidhneach and Loch na Leig (or Làmhhaig). Around 40m long the dyke appears to be a continuation of the dyke BD 4 which effectively divided the main part of Ronay into two sections N and S, and probably dates to the first half of the 19thC. It has since been replaced with a modern post and wire fence a few m to the S.

BNC 4: view from NE

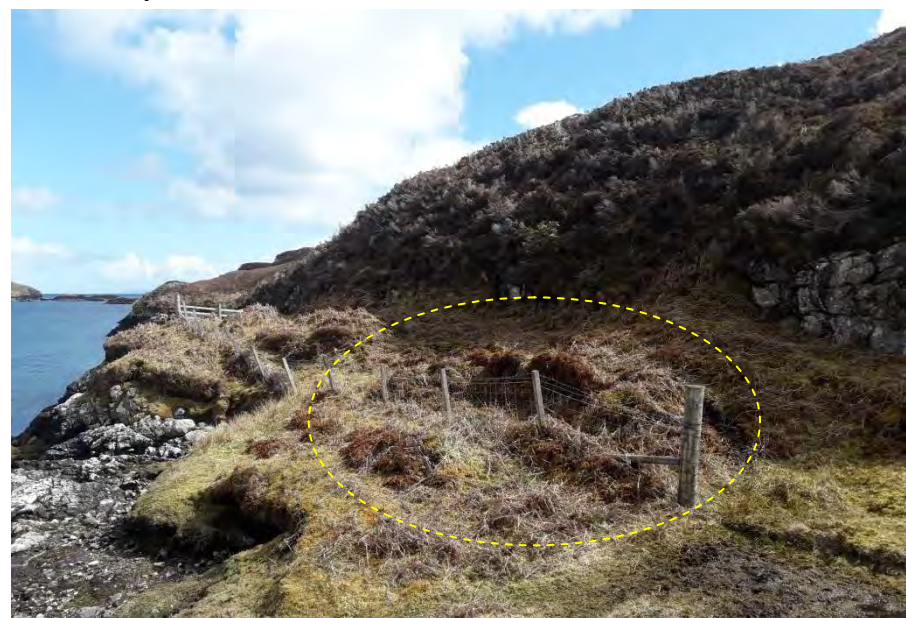
The remains of a possible rectangular turf walled structure lie just above the shore of a small inlet in the SW extremity of Bàgh na Caiplich. It measures around 7m SW - NE by 5m transversely and is defined by vertical excavations into a peat bank on its SE and NE sides and by an intermittent low turf bank on the NW and SW. The structure is bisected NW and SE by a modern fence and the SE wall might represent the remains of a former turf dyke which may have had the same function as the modern fence on a parallel but slightly different line. Between the H and LWMs on the beach to the NW there is an area which might have been cleared of larger stones and used as a temporary landing point.

BNC 5: view from NW

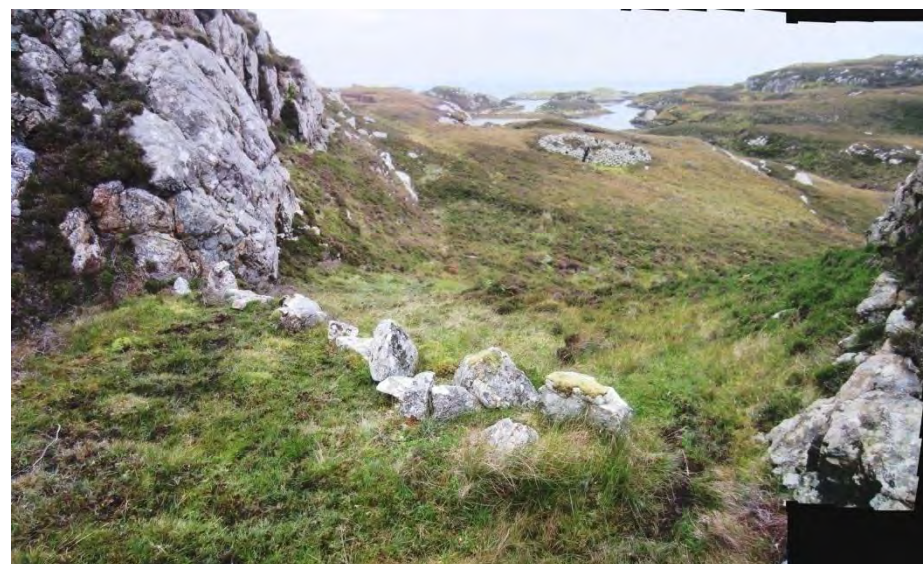
An 1150m long head dyke defines the N extent of the Sruth Beag township. Together with a second dyke on its S side (SB 14), and the natural boundaries afforded by loch and sea shores, they enclose an area of around 23ha, with a further 3ha contained within the two main islands adjacent. The W end starts on the N shore of Loch na Sruthan Beag at NF 89820 55315 where it heads N for a distance of around 25m to the base of a cliff as a turf bank. From there it heads in a generally E direction using natural rock outcrops where possible, then as a drystone wall for several sections, before crossing an extensive area of formerly cultivated peat moor as a ditch and turf bank, and ending on the Minch shore at NF 90750 55335.

SB 1: stone dyke remains at NF 89885 55375 with SB 9 in background

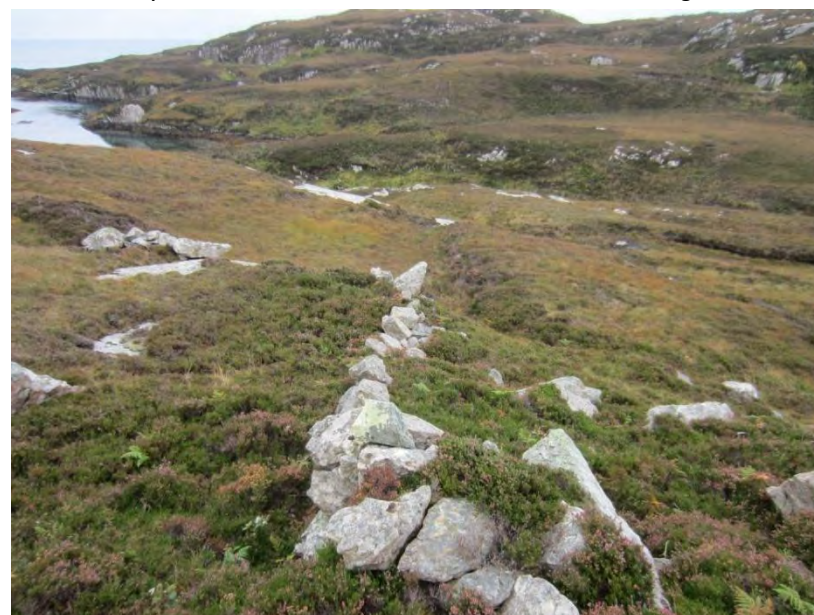
SB 1: stone dyke remains at NF 89960 55370

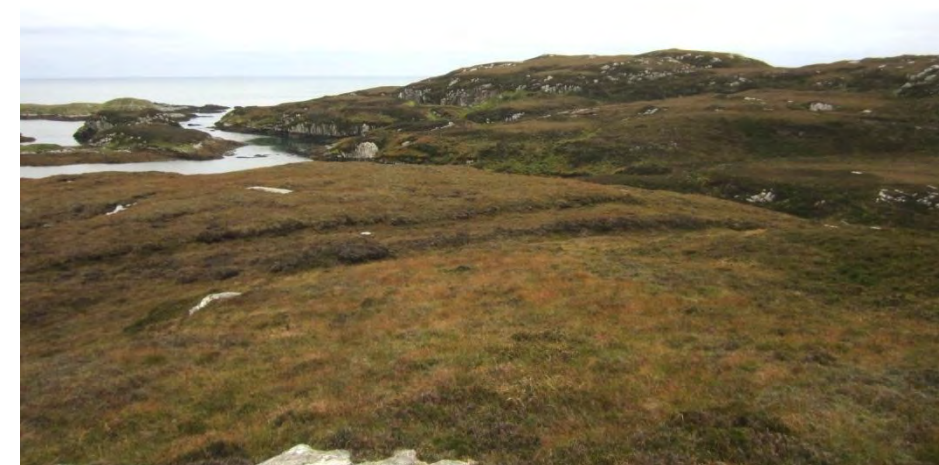
SB 1: ditch and turf bank dyke remains near NF 89990 55380

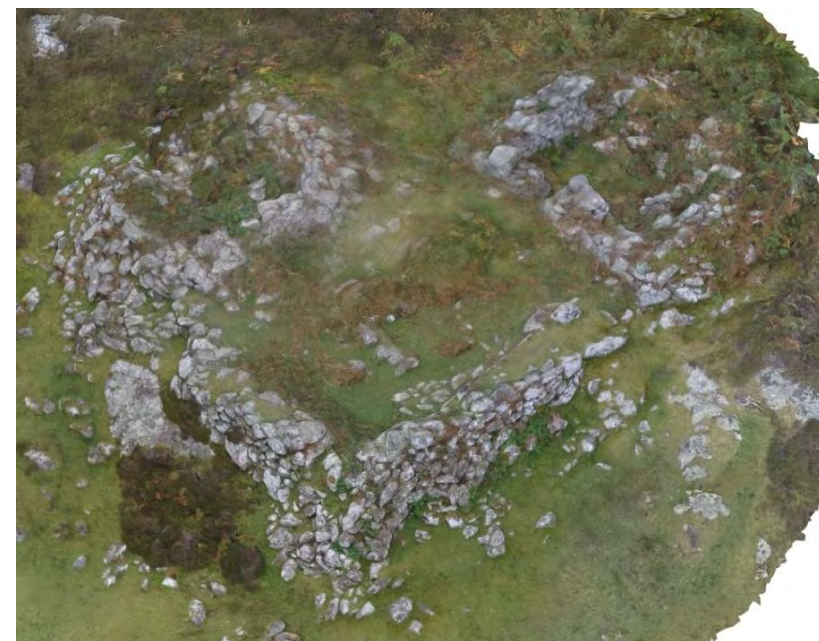
Site B is located on a rock outcrop around 8m SE of site A. The original building was rectangular in plan and measured 8.5m N - S and 3.3m transversely within drystone walls typically 1.2m thick and up to 1.5m high. Most likely built as a dwelling house, possibly as a replacement for that at site A, the entrance appears to have been located slightly N of centre of the E facing elevation. Adjacent to the S end of its W facing elevation is a rectangular hut or pen, perhaps an adaptation of a former byre attached to the original house, or one related to site A. This measures 2.7m N - S and 1.4m transversely within drystone walls up to 1.5m thick and 1.4m high and has an entrance in the middle of its E facing elevation. A second hut or pen has been inserted within the walls of the N end of the original house. This measures 3.3m E - W and 1.9m transversely and appears to have the remains of two partially blocked entrances in its N and S elevations. A sub-circular lamb pen has been constructed against the interior of the E wall. The space formed between these two structures and the now partially collapsed E and S walls of the original house may have been used as a small sheepfold.

SB 2: Site B aerial view from SE

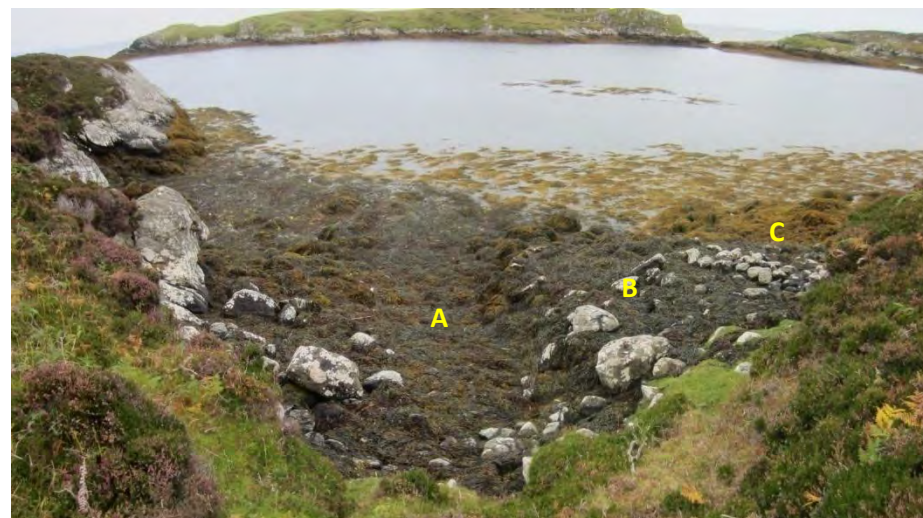
A set of structures on the shoreline 220m S of the farmstead SB 2 present a number of possible functions. An area of beach (A) measuring around 12m NW - SE and 3m transversely has been cleared of stones to form what might be a landing point. Alternatively it could have been a material source for a drystone and boulder wall on its SW side, which could in turn either be a revetment for a platform (B) to its W, (possibly for seaweed storage), or the seaward end of a possible dyke extending inland the faint line of which might be visible on aerial photography. The remains of a second drystone dyke (C) lie 4m further W, and that may have had a similar function.

SB 3: view from NW with Eilean nan Cloiche behind

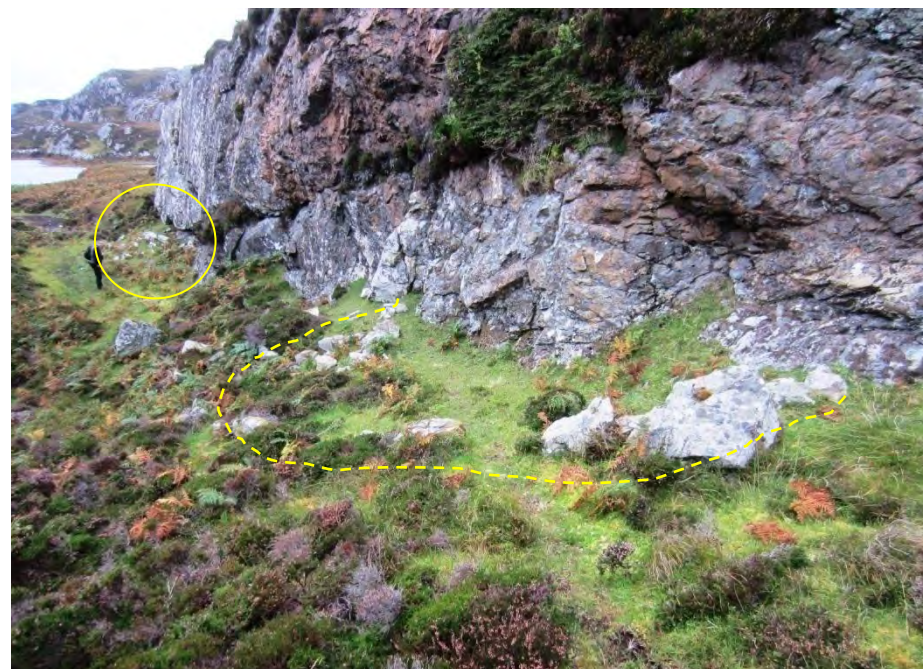
A curved line of embedded stones and boulders projects outwards from a vertical rock face. Measuring at its maximum extents around 7m E - W and 3m transversely this may represent the remains of a small enclosure.

SB 4: view from SE with SB 5 in distance

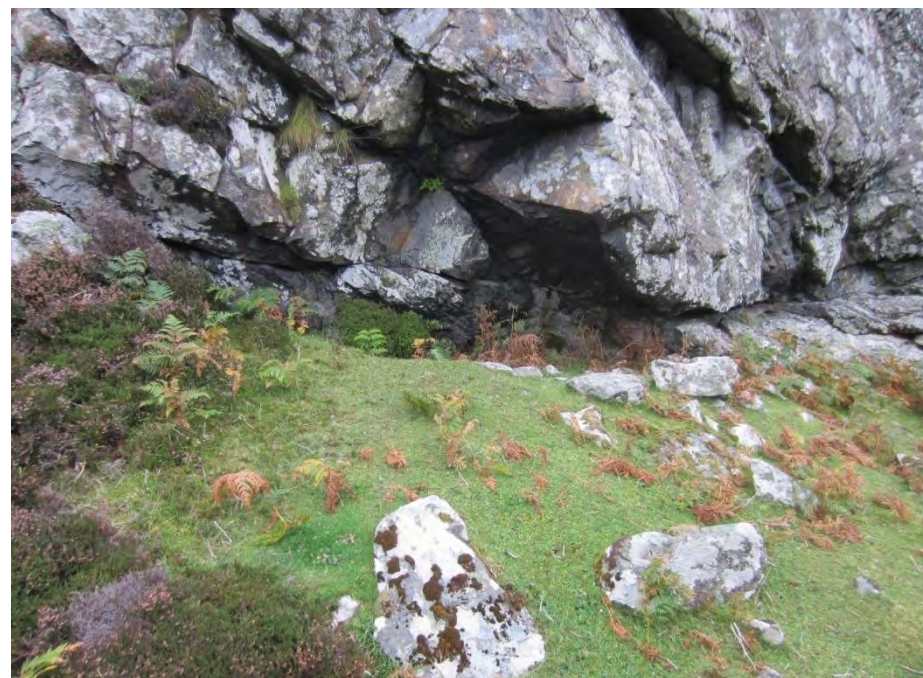
SB 5: view from SW

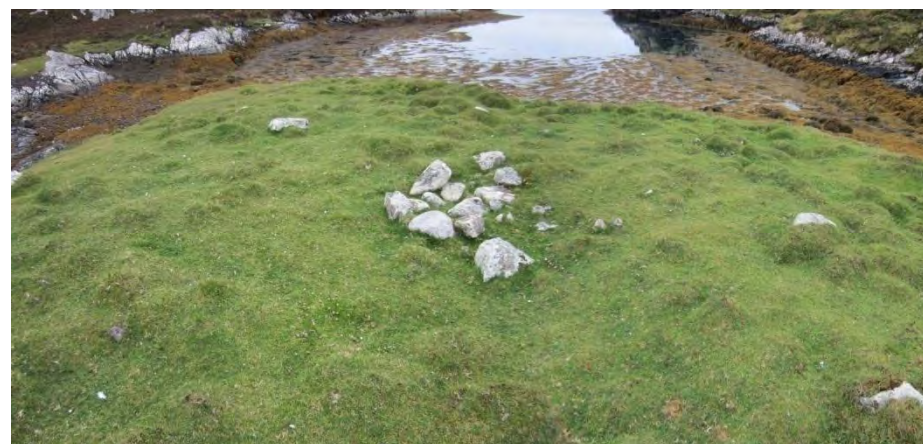
Two stone piles lie on tidal islands within Sruth Beag bay at NF 90260 55205 and NF 90225 55200. In this situation these are most likely to be related to kelp processing, but they could also possibly be clearance cairns.

SB 6: view from NW

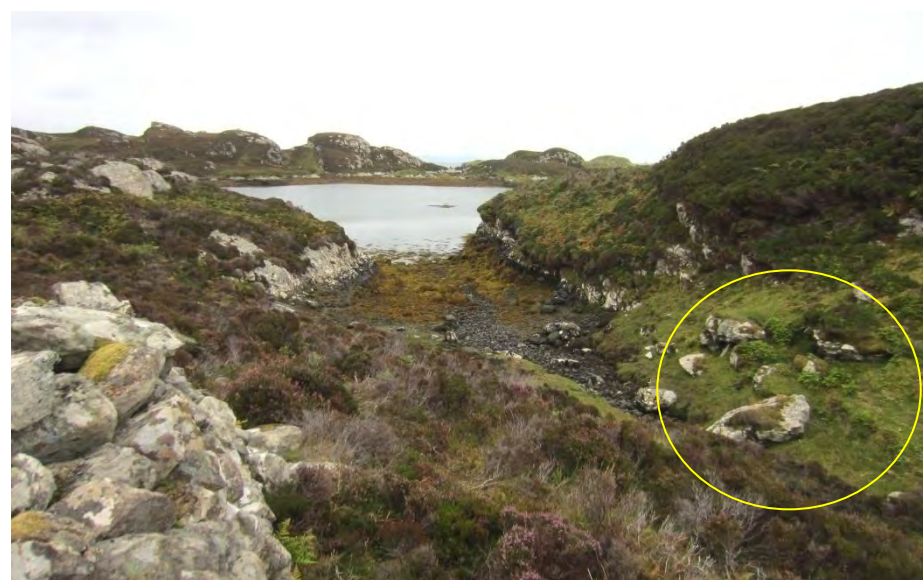
The intermittent remains of a drystone dyke lie on the shore of an inlet on the W side of Sruth Beag bay. This may have been a former head dyke for crofts on the N side which ran between Loch na Sruthan Beag and Sruth Beag bay, perhaps quarried for its stone for the farmstead SB 9 nearby.

SB 8: view from W

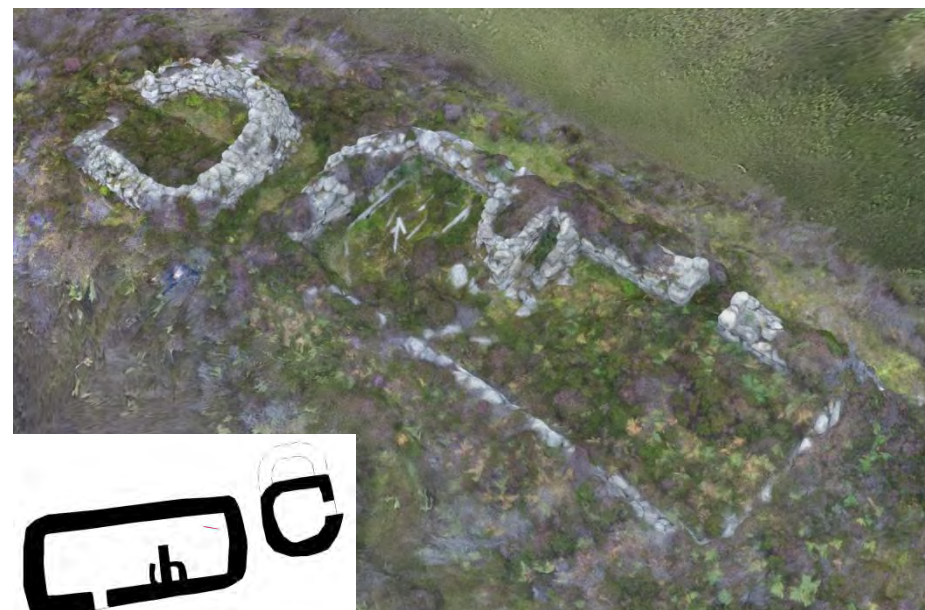
A farmstead comprising three buildings, lies on the S bank of a 60m long burn which connects Loch na Sruthan Beag with the sea. The larger structure, probably a former dwelling, measures 12m WSW - ENE by 3.3m transversely within drystone walls averaging 1.1m thick and up to 1.4m high. An entrance is located towards the SW end of the SE facing elevation. A drystone cross partition has been constructed just NE of the building's centre and stone cellular structures built either side - possibly lambing pens. A number of rotted lengths of timber lie on the floor near the ENE gable and this suggests the building may have been re-used more recently.

Just over a metre ENE of the dwelling lies a second drystone structure. Sub-rectangular in plan, this appears to overlie a slightly larger building, probably a byre, whose foundation remains are still visible to the NNE. The original building measured 5.4m SSE - WNW and 3.3m transversely within drystone walls averaging 1.1m thick. At some stage the NNE third of the building has been demolished and a new drystone gable built, reducing the SSE - WNW internal dimension to around 3.3m. This wall is around 0.8m thick and up to 1.6m high in the centre of its NNW gable which shows signs of having supported a pitched roof. The current entrance is located centrally in its NE facing elevation.

SB 9: aerial view from NW and thumbnail plan

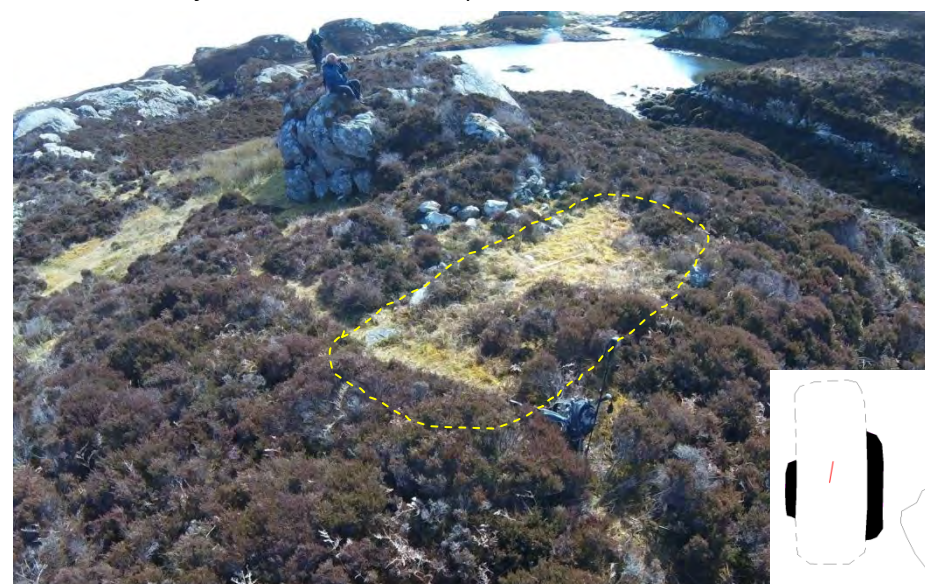
Around 30m ENE of the byre at NF 90020 55290 lie the remains of a third building now reduced to two short sections of drystone walling and a low mounded outline buried in heather. Rectangular in plan this appears to have had internal dimensions of around 8m N - S and 3.3m transversely. With most of its stone walling removed it seems likely that this predated at least one of the standing structures to the W.

SB 9: view of third building from NW and thumbnail plan

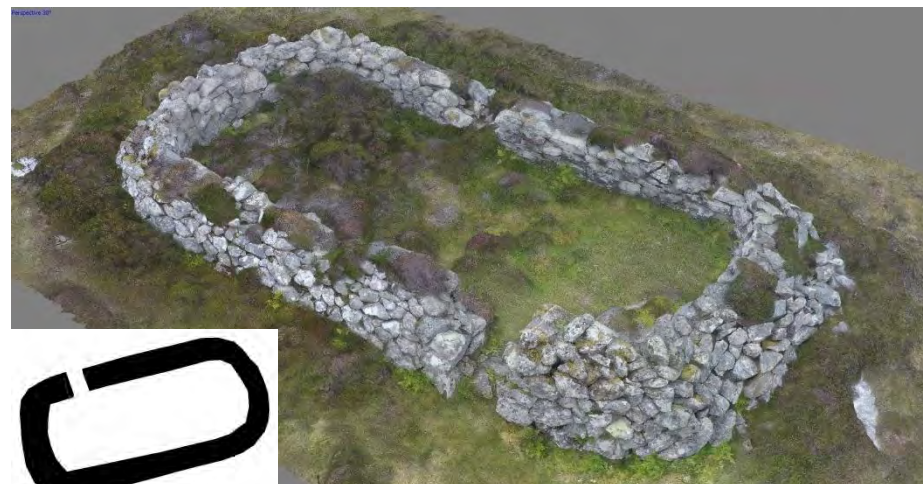
A second building, probably a dwelling house, lies within the same croft as SB 9, some 75m to its NW. This measures 9.3m WSW - ENE and 3.6m transversely within drystone walls around 1m thick and up to 1.7m high.

SB 10: aerial view from NW and thumbnail plan

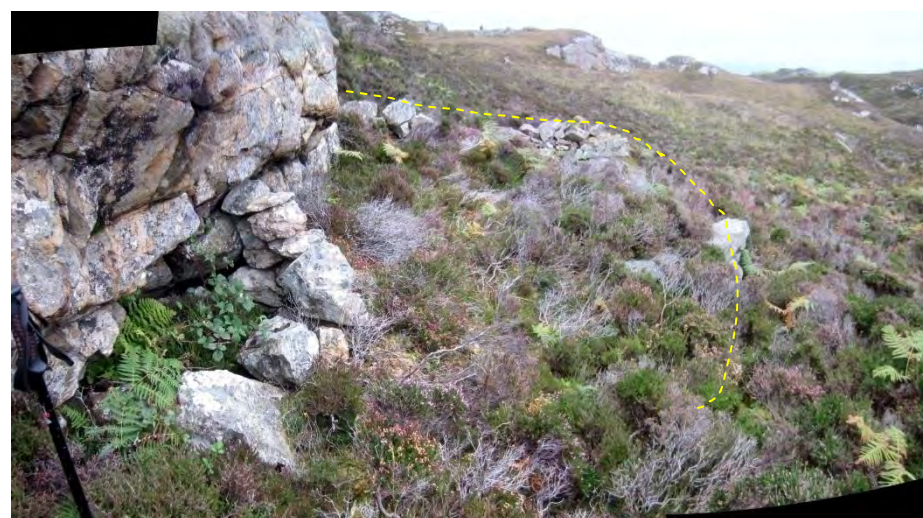
A curved line of sections of drystone walling, and embedded stones and boulders projects outwards from a vertical rock face. Measuring at its maximum extents around 7m E - W and 3m transversely this may represent the remains of a small enclosure. At its W end a drystone walled cellular structure less than 1m across internally has been built against the same rock face and this is probably the remains of a lamb pen. A second similar pen lies a few m further W.

SB 11: enclosure viewed from W with pen in foreground

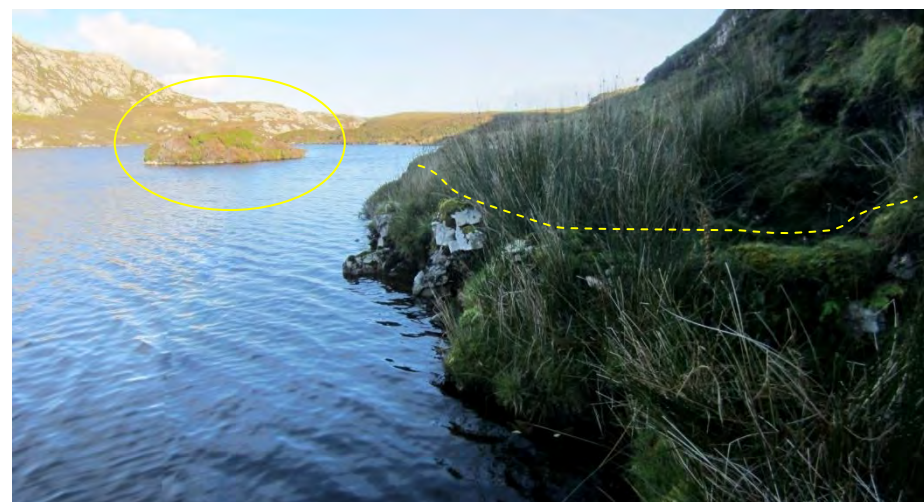
Described by Beveridge (1911) as follows: "*Upon the island of Ronay,.....is Loch na Sruthan Beag containing two islets. The southern and smaller of these is 5 or 6 feet in height, consisting of solid rock thickly covered with vegetation, and has been accessible over a curved causeway from the neighbouring shore, a distance of nearly 20 yards. This clearly represents the site of a former dun, of which some remains would no doubt be revealed by excavation.*" The island measures around 15m E - W and 8m transversely, but has not been visited. There is no evidence of a causeway, although on the shore to the S, a section of former drystone head dyke (SB 15) has collapsed into the loch perhaps giving the impression of a causeway starting point.

SB 12: view from W with 'dun' island highlighted to L and drystone head dyke termination (SB 15) to R.

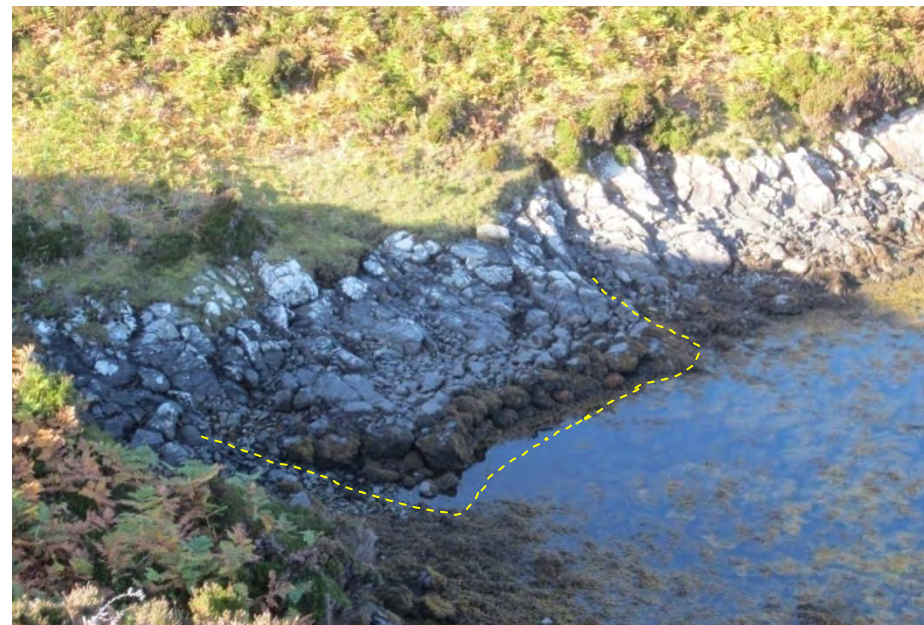
At the head of an inlet on the W shore of Sruth Beag, a rough wall of stones and small boulders near the HWM has been infilled behind to form a low platform. Measuring round 5m SW - NE and 2m transversely the structure is most likely to have been used as a seaweed storage platform. Around 40m further E near the LWM a 12m long line of stones running N - S across the inlet is visible on satellite imagery and this may be the remains of a fish trap.

SB 13: view from S

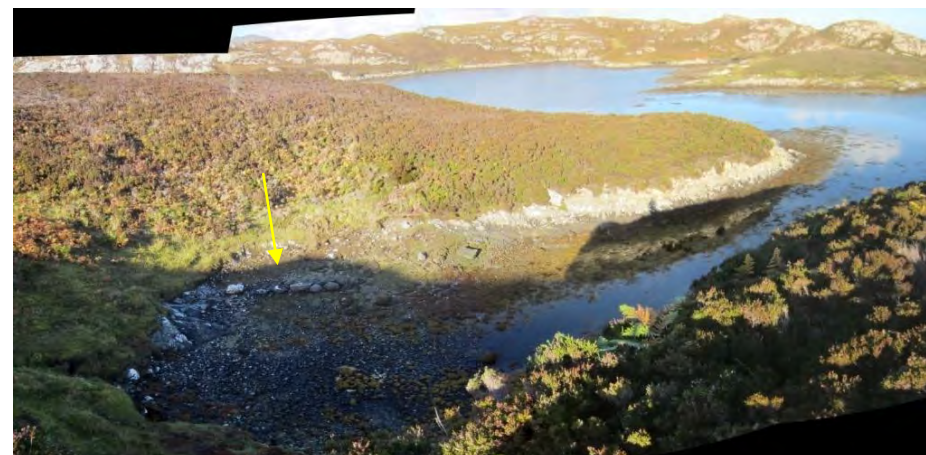
A line of 8 large stones extends E for a distance of around 6m from the HWM of an inlet on the SW shore of Sruth Beag. Its exact purpose is unclear, but it may represent either some form of boundary termination related to areas of formerly cultivated land inshore, or a landing point.

SB 14: view from S
