**Ronay Field Survey
2015-18**

**David Newman
June 2018**

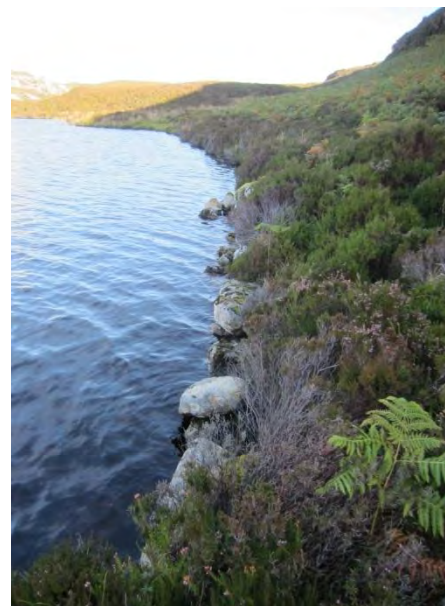
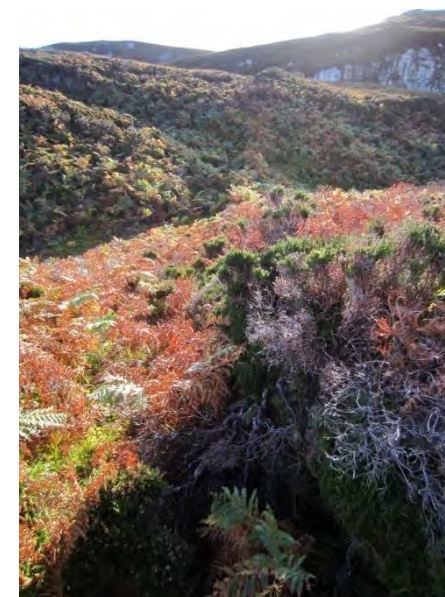
An 650m long head dyke defines the S extent of the Sruth Beag township. Together with a second dyke on its N side (SB 1), and the natural boundaries afforded by loch and sea shores, they enclose an area of around 23Ha, with a further 3Ha contained within the two main islands adjacent. The W end starts on the S shore of Loch na Struthan Beag at NF 89710 55315 where it follows the shoreline E for a distance of around 40m as a drystone wall, before turning S for a further 10m where it terminates at the base of a low rock outcrop. From there it heads in a generally E direction using a combination of natural rock outcrops, drystone walling and ditch and turf bank before terminating on the edge of a 20m high cliff on the Sruth Beag shore at NF 90215 55080.

SB 15: L = drystone dyke following Loch na Sruthan Beag shore near its W termination looking E; R = view of ditch and turf bank from E termination looking SW.

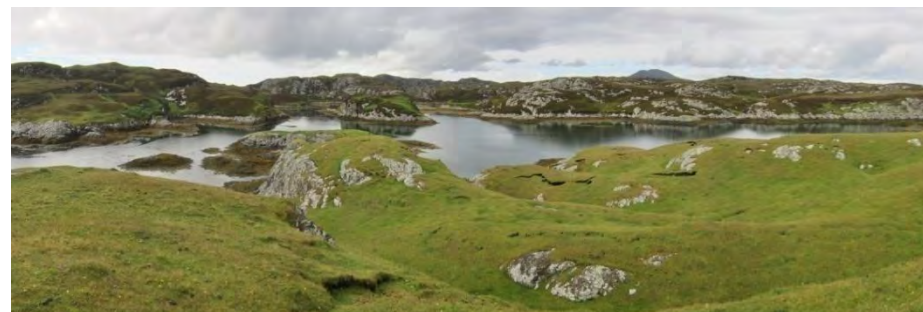
SB 16: view looking W across Eilean na Cloiche into Sruth Beag showing peat erosion lines

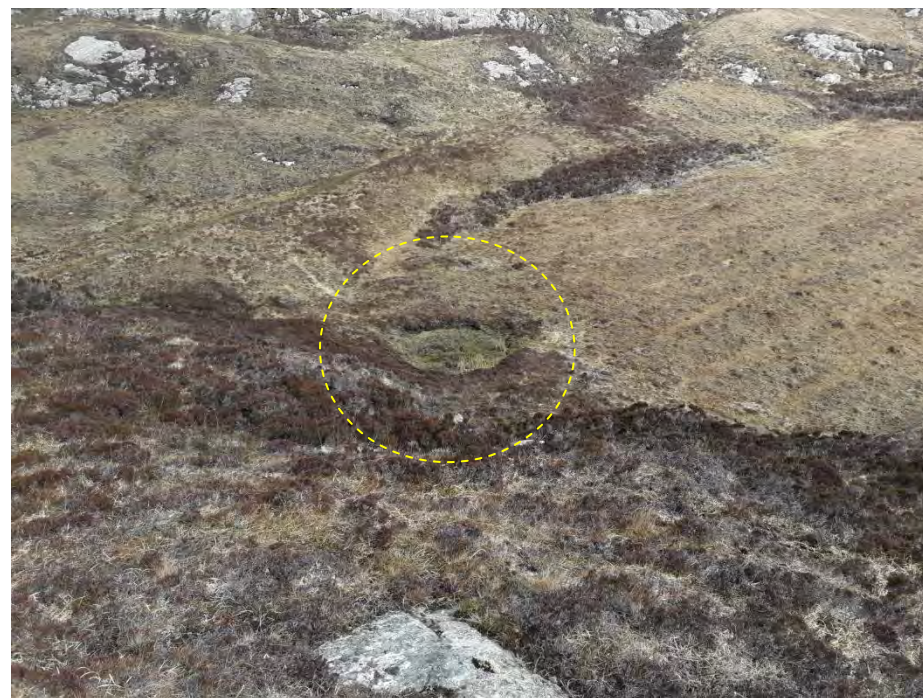
A sub-rectangular stack stand or clamp base, most likely used for peat or root crops lies on the edge of an area of former cultivation within which lines of drainage ditches or feannagan can still be seen. The slightly raised central base measures around 4m NE - SW and 2.5m transversely and is surrounded by a ditch around 1m wide and up to 0.8m deep.

SB 17: view from SW

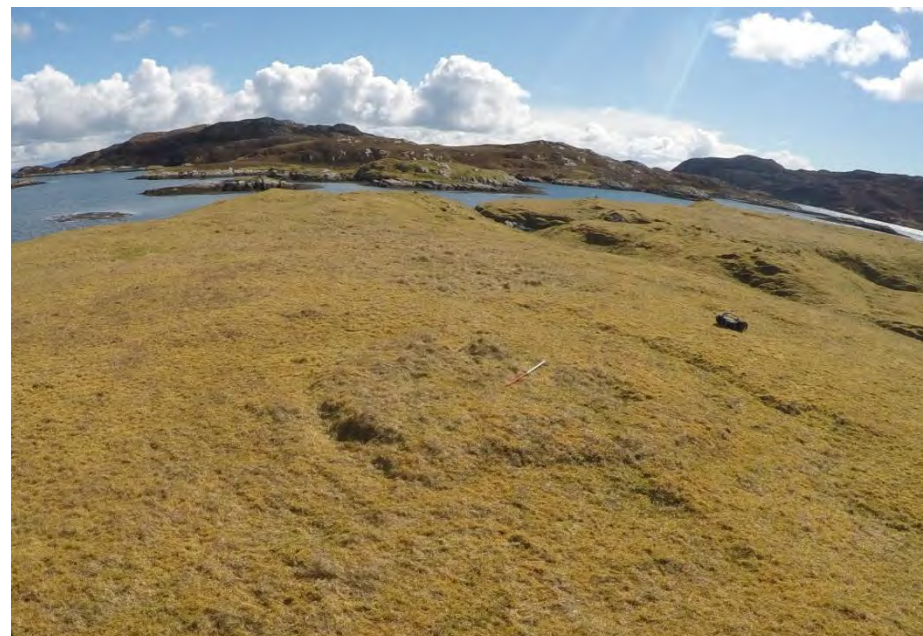
A turf structure lies near the N shore of Eilean Leathann. Rectangular in plan it measures 2.7m N - S and 1.4m transversely within a low turf wall around 1m thick and up to 0.4m high. A shallow ditch immediately outside the wall and further lower ground beyond may represent the area where the turf was cut from. Although there are no signs of cultivation on the island, many of the small islands in the Kyle of Ronay were used by surrounding communities for peat cutting, grazing and growing crops and this structure most likely represents the remains of a stack stand or perhaps a temporary hut.

EL 1: view from NW with Rubha nan Brisgein behind

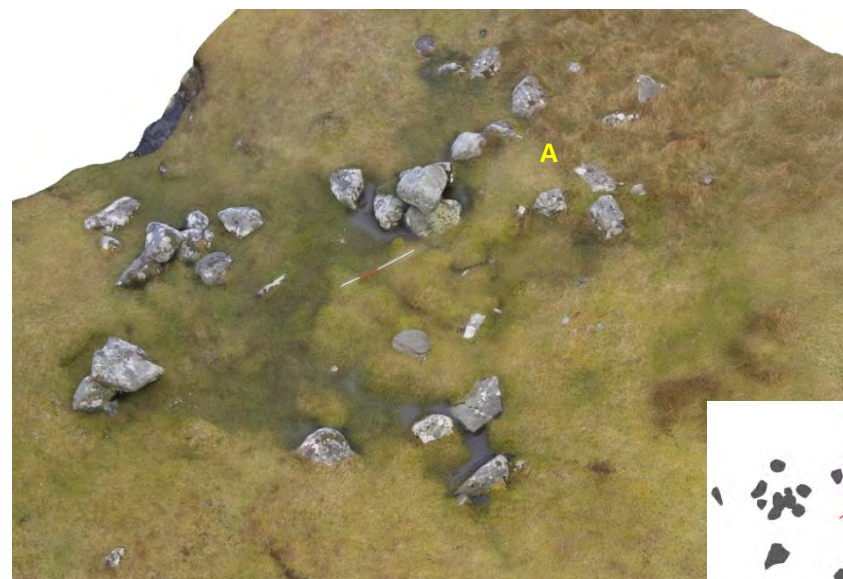
FB 1 aerial view from S and thumbnail plan

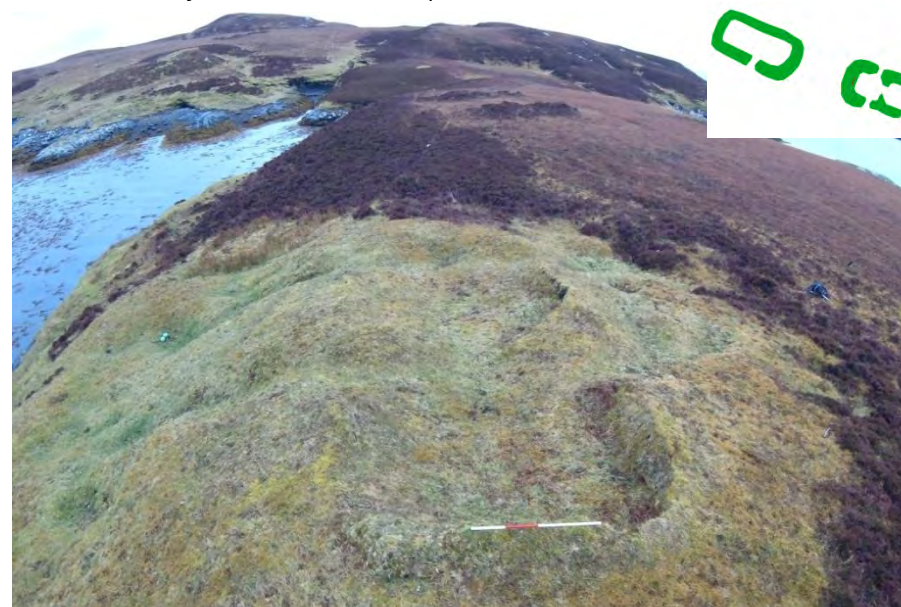
Two rectangular turf walled structures lie on the edge of the N facing coastal slope on a peninsula at the W end of Flodaigh Beag. That to the NW is rectangular in plan and measures 9m ESE - WNW by 3m transversely within slumped turf walls up to 1.5m thick at their base and 0.5m high. Possible entrance slightly SE of centre on the SW facing elevation. That to the SE has two compartments and is similarly orientated and constructed. The NW compartment measures around 3 X 3m, the SE 6 X 3m, and both have entrances in both SW and NE elevations. This structure is similar in form and dimensions to others recorded on Ronay Beag (see site RB 24), Garbh Eilean Mòr (see site GEM 3), and at Kallin on Grimsay, and on Eilean Flodaigh in Loch Maddy, where a total of 8 with cell numbers varying from 2 to 6 exist. All five locations have common historic links with both fishing and kelping industries and it is presumed they these structures are related in some way to processing one of these products.

FB 2: aerial view of SE structure from NW and thumbnail plan

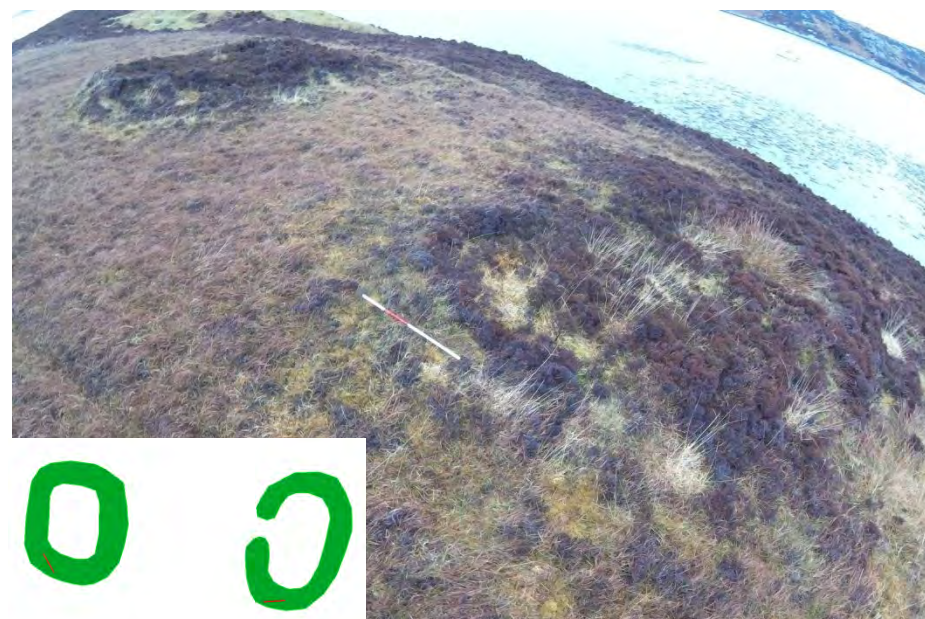
Two turf walled huts lie on the edge of the N facing coastal slope on a peninsula at the W end of Flodaigh Beag. That to the W is sub-rectangular in plan and measures 3.5m S - N by 2.5m transversely within slumped turf walls up to 1.3m thick at their base and 0.5m high. No entrance identifiable. That to the E is sub-circular in plan and measures 4.5m SSW - NNE by 2.5m transversely within slumped turf walls up to 1.2m thick at their base and 0.3m high. Possible entrance centred on the W facing elevation. It is known that Flodaigh Beag was used as a temporary base by both fishermen and kelpers in the past and it is likely that these huts are related to these uses and the turf structures lying a few m to the W (FB 2).

FB 3: view from SE and thumbnail plan

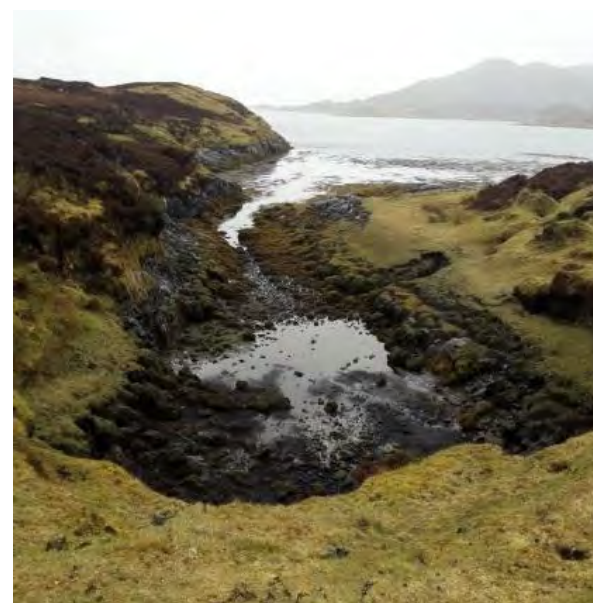
FB 4: view from E

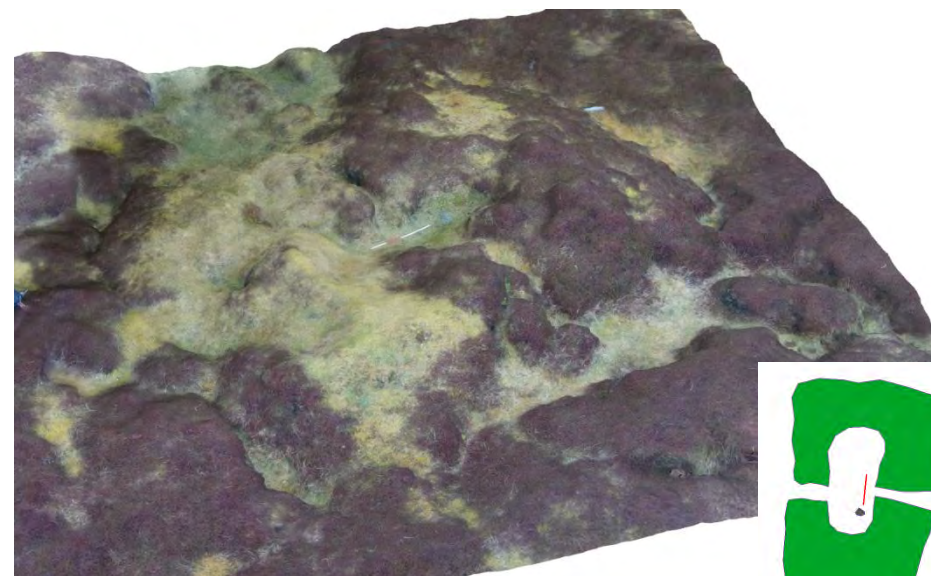
An area of disturbed ground extending to around 0.1ha lies 20m E of the W shore of Ronay Beag. Near its centre are the remains of one, possibly two kelp kilns. The best preserved comprises a mound of peat measuring around 7m N - S and 5 m transversely surrounded by a ditch which may have acted as a material quarry. Within the mound is a sub-rectangular depression measuring around 3.5 X 1.5m which is connected to the exterior by a narrow opening on both sides which may have been vents. A single stone lies within.

FB 5: aerial view from SE and thumbnail plan

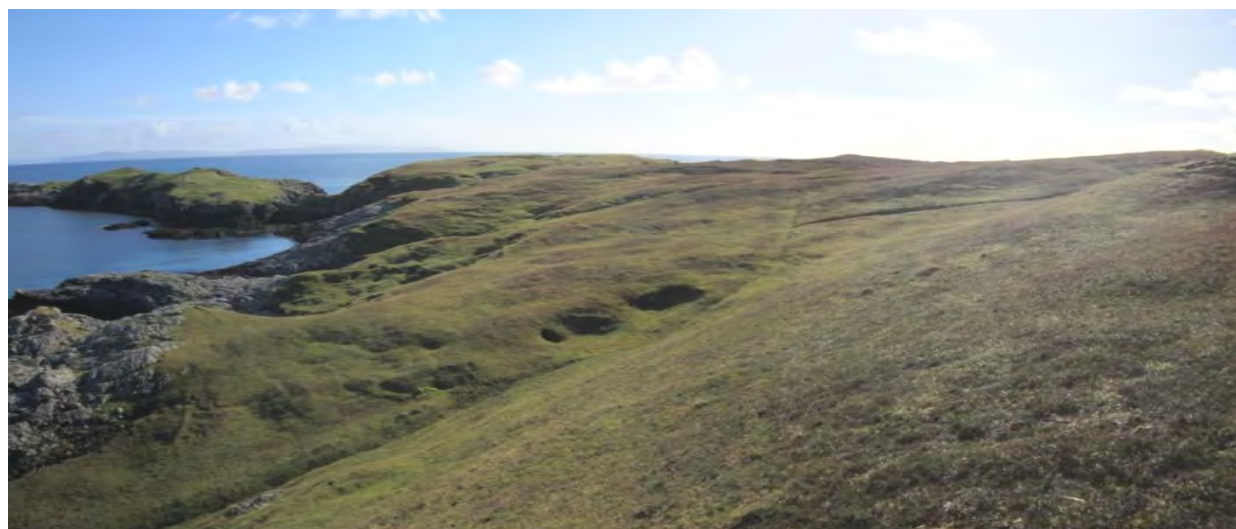
Several hundreds of metres of drainage ditches have been dug on Flodaigh Mòr presumably to help drain both the marshy hinterland, and some of the better grazing areas on the E side. Although most are now overgrown or silted up, their condition suggests the work was probably carried out less than 100 years ago. There are no signs of any attempt at cultivation on the island.

(Above) Plan of Flodaigh Mòr drainage ditches visible on aerial photography

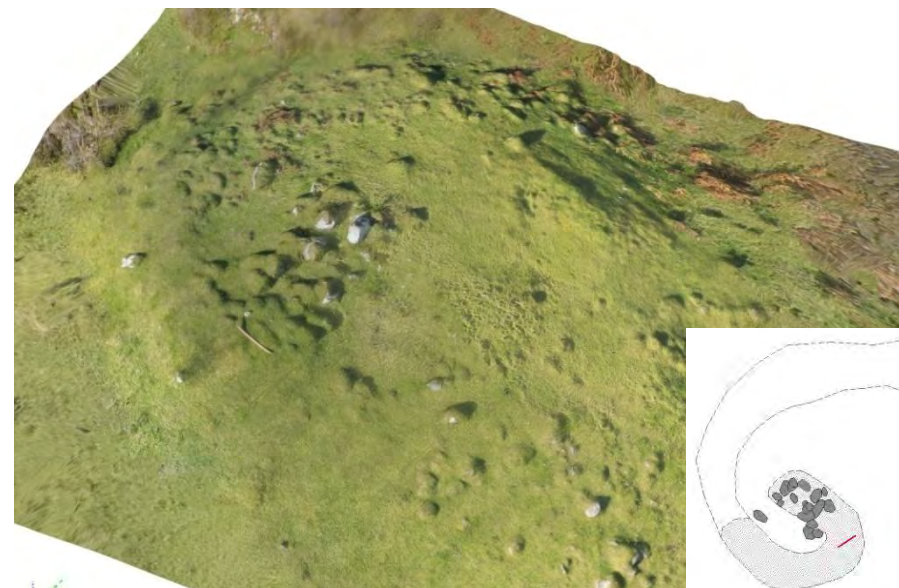
FM 2: aerial view from SE and thumbnail plan of possible kelp kiln

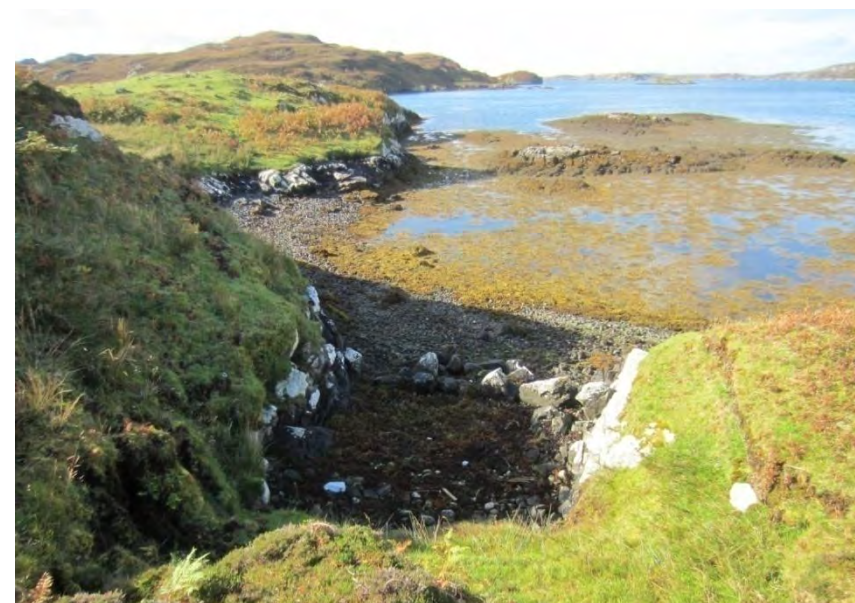
The entrance to a small inlet 60m ENE of the kelp processing site FM 2 has been closed up to form a kelp storage platform. The inlet measures 6m NW - SE by 4m transversely and a rough drystone wall of small boulders and larger stones has been built across the open end on its NW side.

FM 3: view from SE

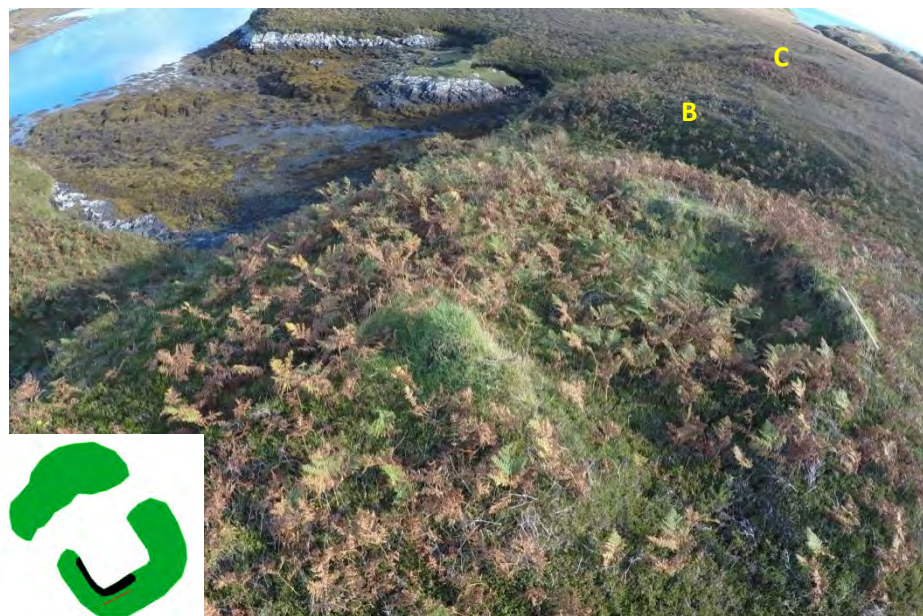
Three turf walled huts, A, B and C, are arranged in an 50m long line along the S shore of an inlet on the N coast of Flodaigh Mor. Each is positioned on a low mound and the interior space has been formed partly by excavating into the mound and partly by building a turf wall around. Typical internal dimensions are 4m X 1.7m and all are orientated so their long axes are aligned approximately NW - SE. All three have an entrance located on their SW long elevations. Two also have openings in their NE facing elevations, although these may be due to subsequent livestock damage. At the bottom of the coastal slope below hut C an area of relatively clear beach may have been used as a landing place.

FM 4A: view from W and thumbnail plan with B and C behind

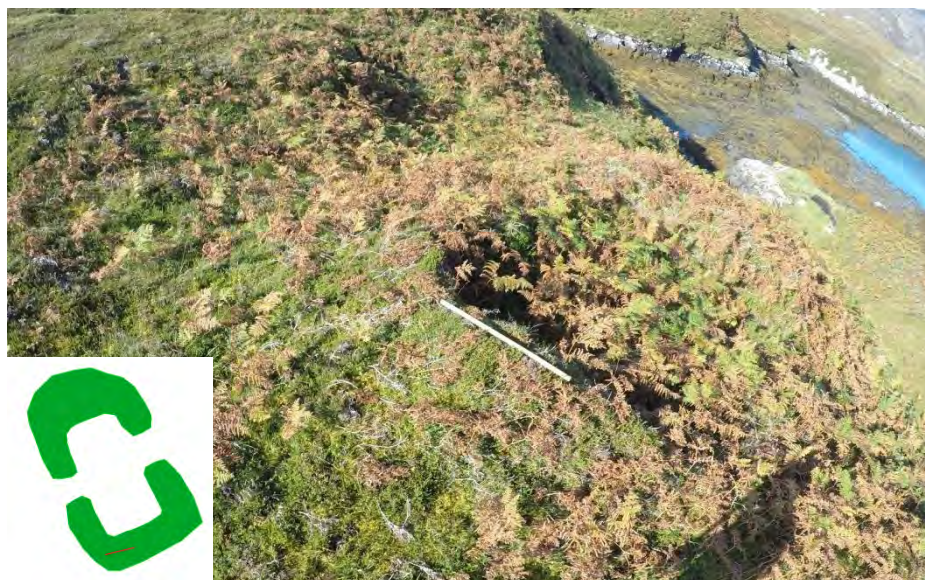
FM 4C: view from SE and thumbnail plan

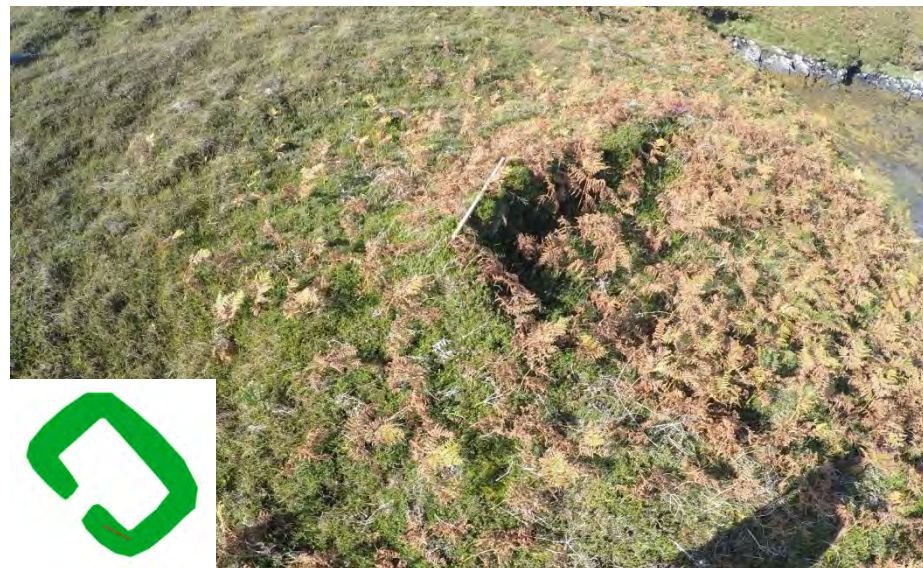
FM 4B: view from E and thumbnail plan

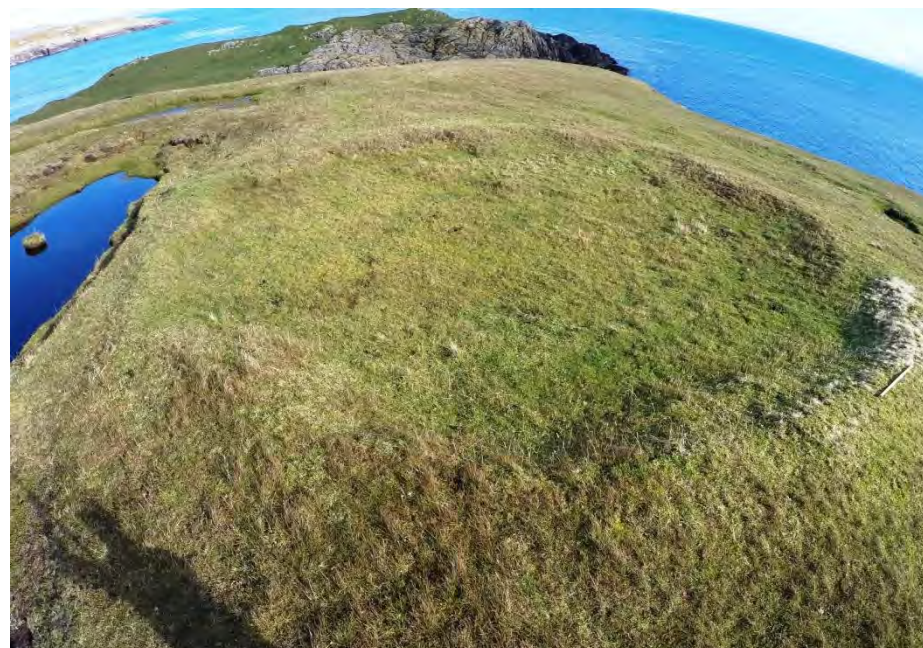
A turf feature of unknown origin lies on the top of the cliffs on the E side of Flodaigh Mor. Sub-circular in plan it measures between 9 and 10m in diameter and is surrounded by a slumped turf bank between 1 and 2m thick at its base and up to 1m high at its highest point on the S side. Possibly a natural feature.

FM 5: view from SW

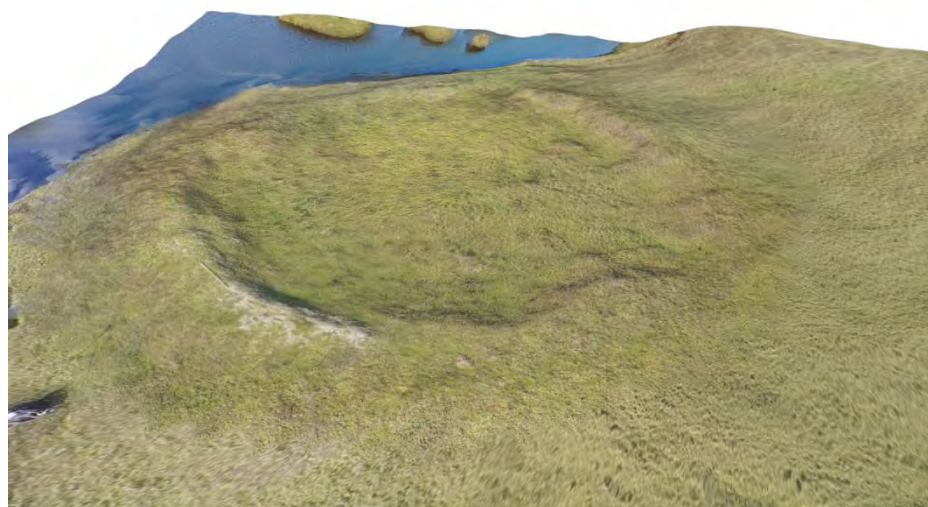
FM 5: aerial view from SE

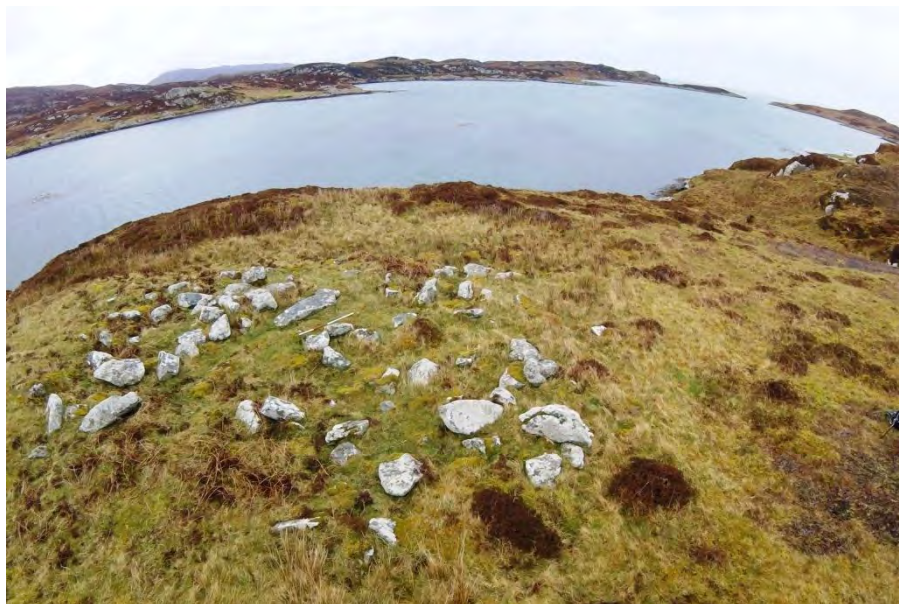
The remains of a stone structure of unclear form or purpose lie on a plateau around 15m above sea level on the NW side of Haunaraigh overlooking the Kyle of Ronay. The spread of stones covers a roughly circular area around 9m in diameter and one or two embedded stones, possibly in their original locations, lie on the inside of a low bank around 1.5m wide which possibly lay within. Only three further features can be identified: a larger rectangular stone (A) which might be a lintol slab, a set of four stones arranged in a circle near the site centre (B) which might be a hearth, and a rectangular plan area of more tightly packed stones (C) which may be the base of a wall fragment.

H 1: view from SW with Kyle of Ronay beyond

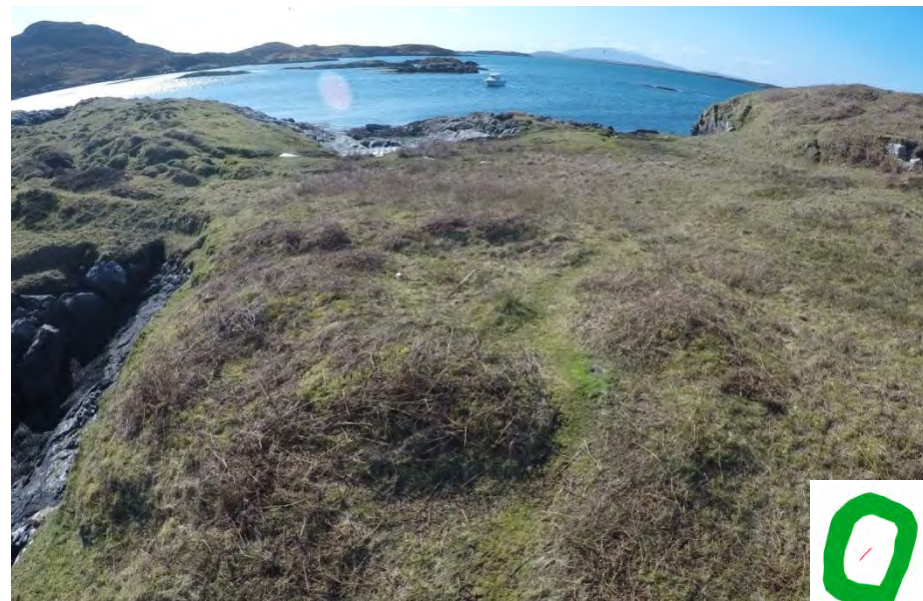
GEM 1: view from N and thumbnail plan

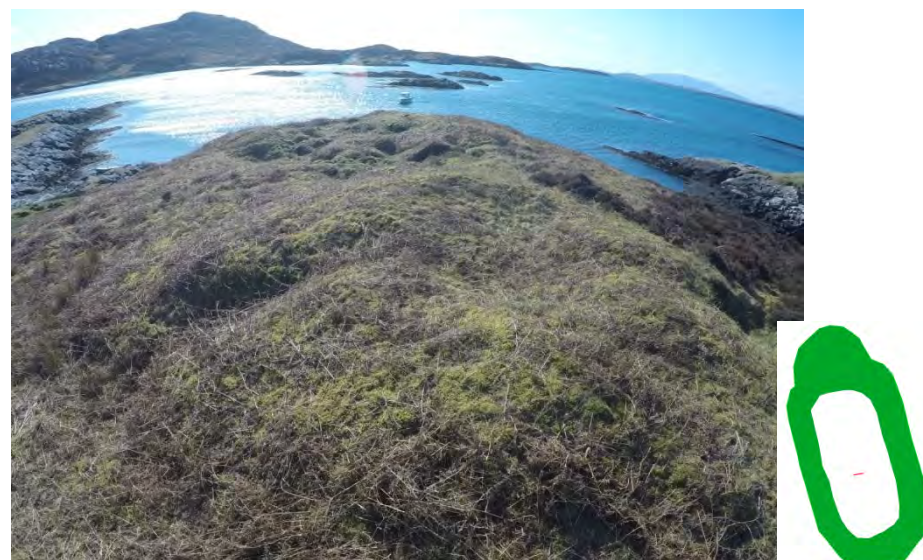
The remains of a large rectangular turf structure lie on the S edge of the promontory at the far SE end of Garbh Eilean Mòr. With external measurements of 25m SSE - NNW and 12m transversely, and its top surface up to 1.5m higher than the surrounding ground, the structure has a number of depressions within. Its original form and origins are not clear, but in this location it is most likely to be related to kelp processing.

GEM 2: view from N and thumbnail plan

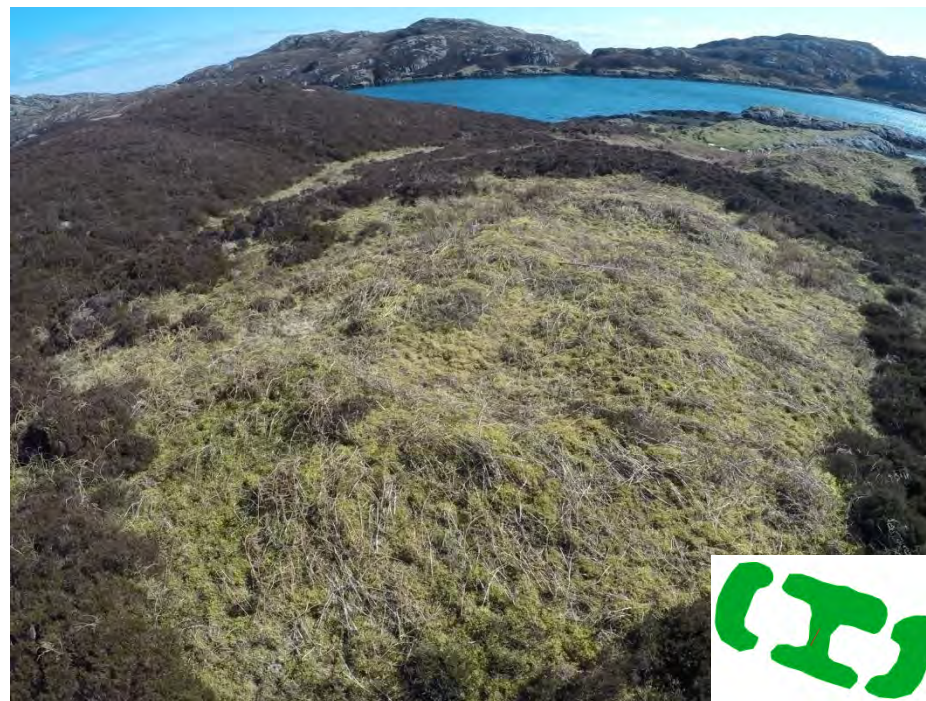
The remains of a two compartment rectangular turf structure lie in the centre of the promontory at the far SE end of Garbh Eilean Mhòr. The NW compartment measures around 3.2m NW - SE by 2.4m transversely; the SE 4m X 2.2m respectively and both have an entrances in both SW and NE elevations. This structure is similar in form and dimensions to others recorded on Ronay Beag (see site RB 24), Flodaigh Beag (see site FB 2), at Kallin on Grimsay, and on Eilean Flodaigh in Lochmaddy where a total of 8 with cell numbers varying from 2 to 6 exist. All five locations have common historic links with both fishing and kelping industries and it is presumed they these structures are related in some way to processing one of these products.

GEM 3: view from W and thumbnail plan

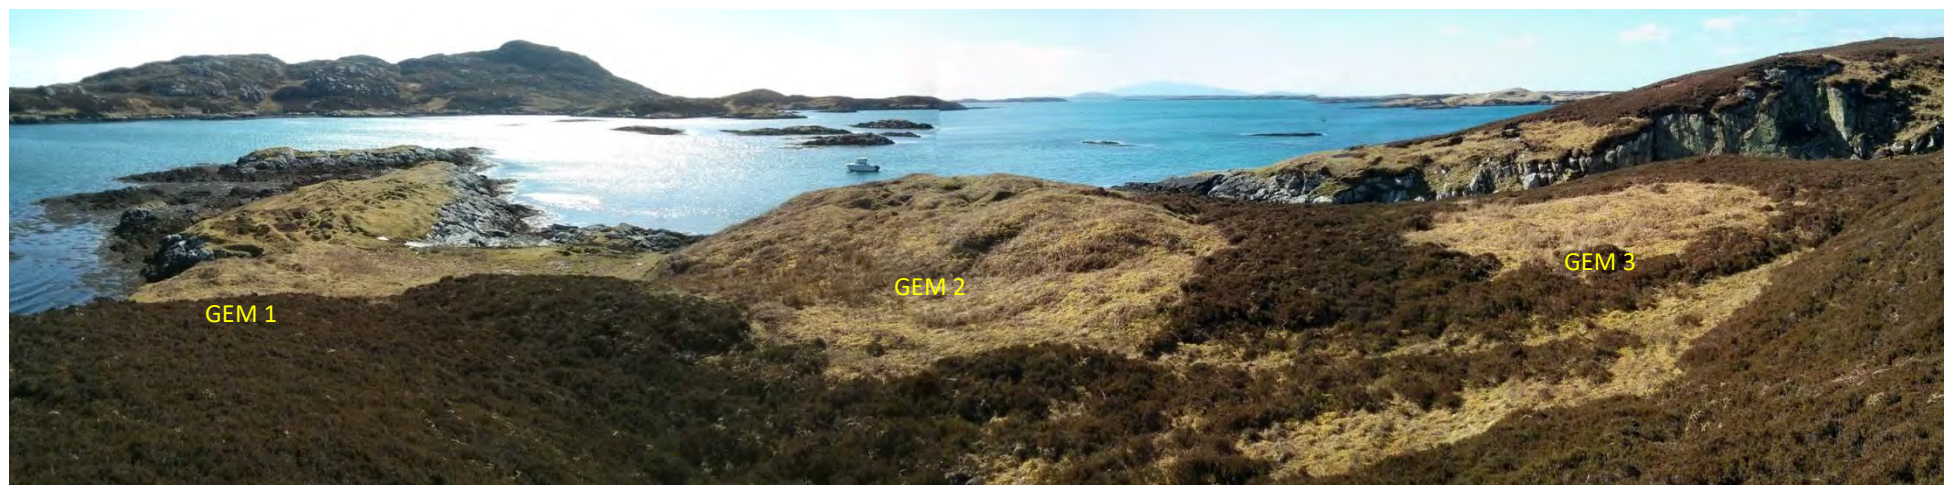
GEM 1-3 panorama looking S and E with Ronay in background
